Examination of Accident at Tokyo Electric Power Co., Inc.'s Fukushima Daiichi Nuclear Power Station and Proposal of Countermeasures

October 2011

Japan Nuclear Technology Institute

Examination Committee on Accident at Fukushima Daiichi Nuclear Power Station

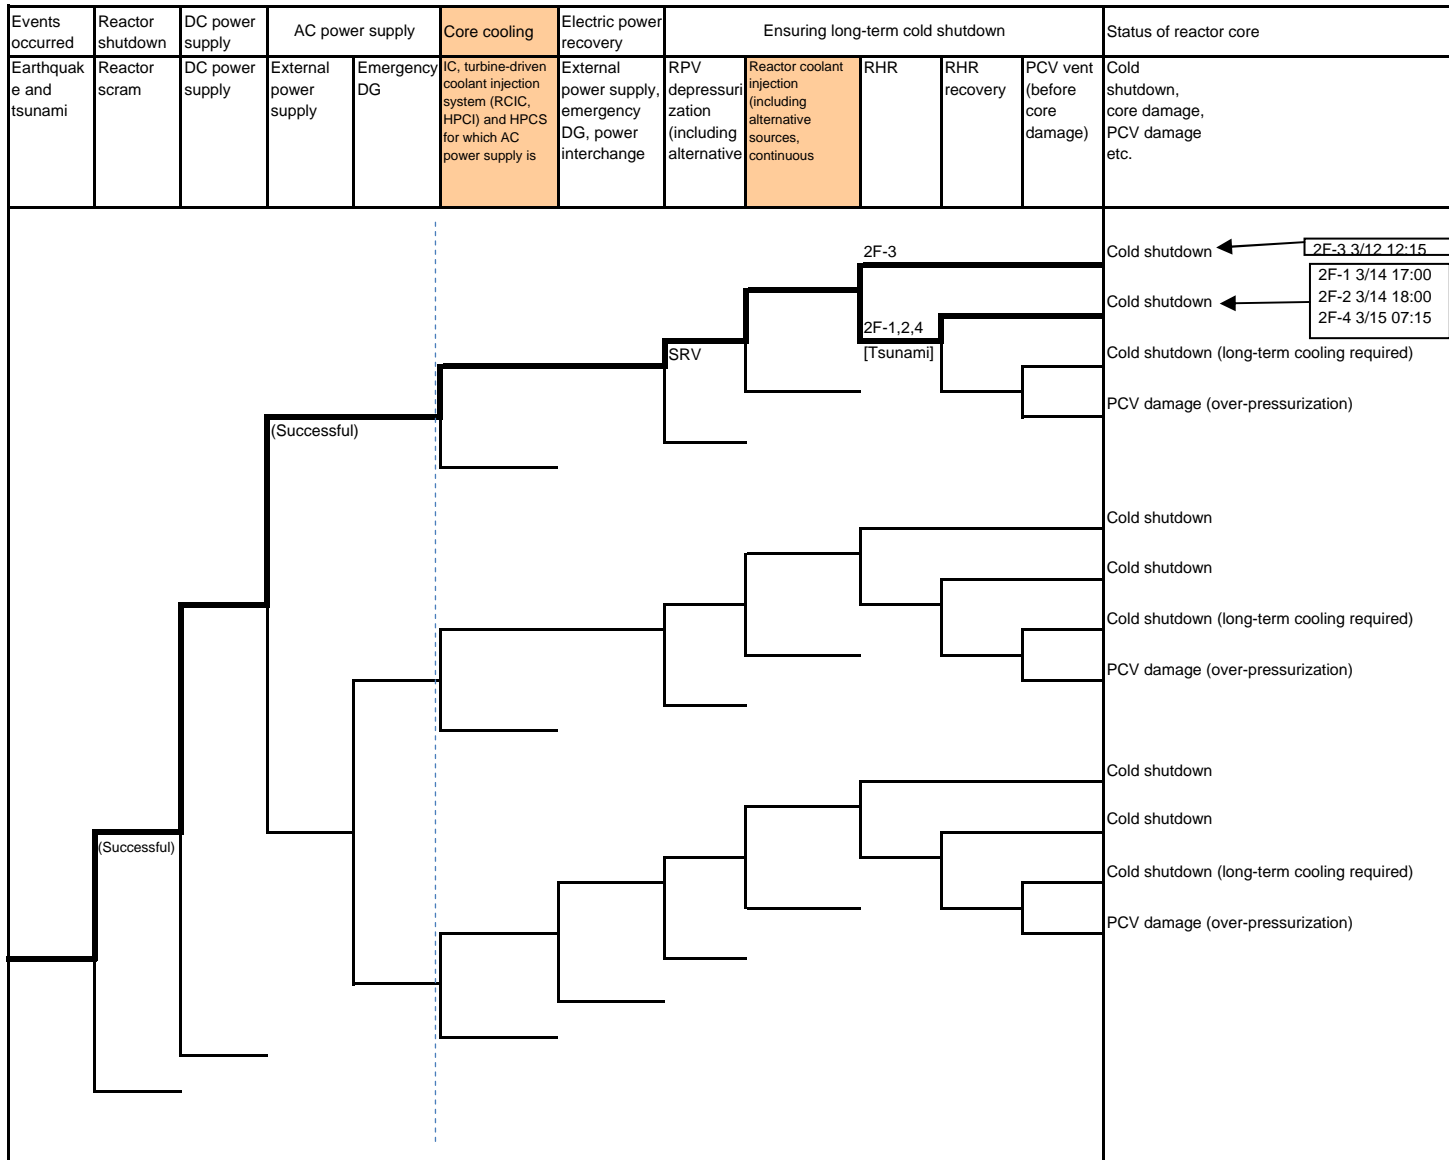
Figure Appendix 1-1 Fukushima Daini Nuclear Power Station disaster identification events tree

The course of events at Fukushima Daini is shown in an event tree in Appendix 1-1.

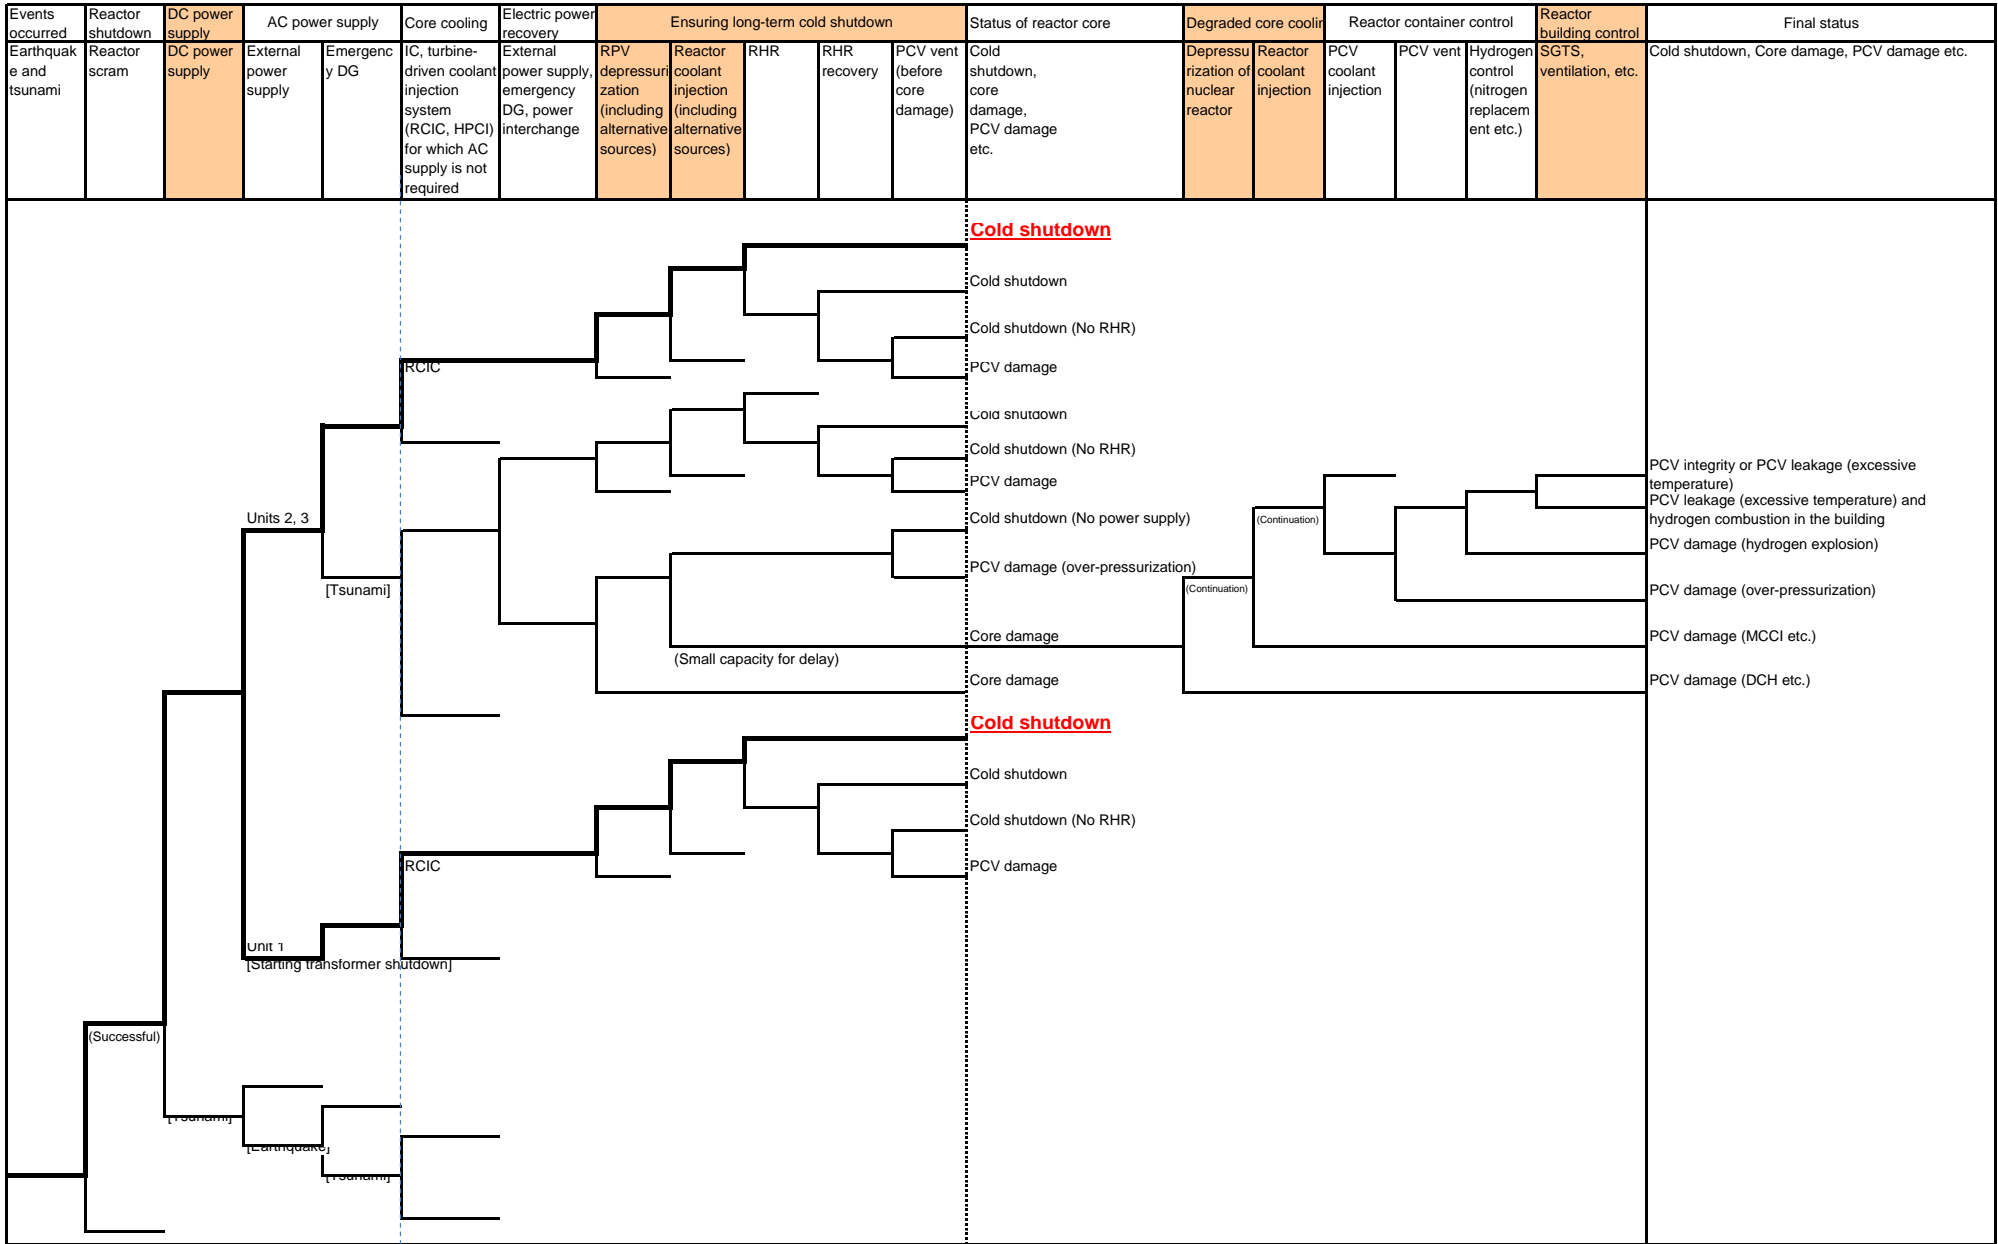
Diagram Appendix 1-2 Onagawa Nuclear Power Station disaster identification events tree

The series of events on Onagawa are shown in Figure Appendix 1-2 with the event tree.
