Examination of Accident at Tokyo Electric Power Co., Inc.'s Fukushima Daiichi Nuclear Power Station and Proposal of Countermeasures

October 2011

Japan Nuclear Technology Institute

**Examination Committee on Accident at Fukushima Daiichi Nuclear
Power Station**

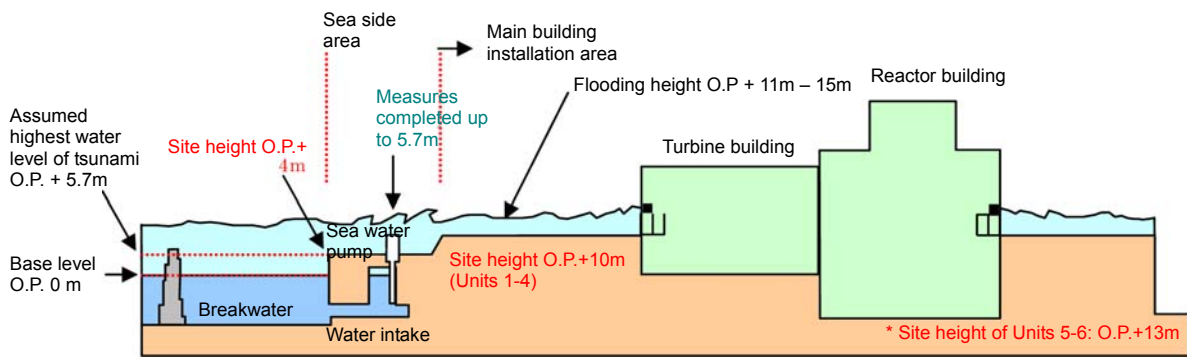
Figure 2.1-3 Situation of tsunami

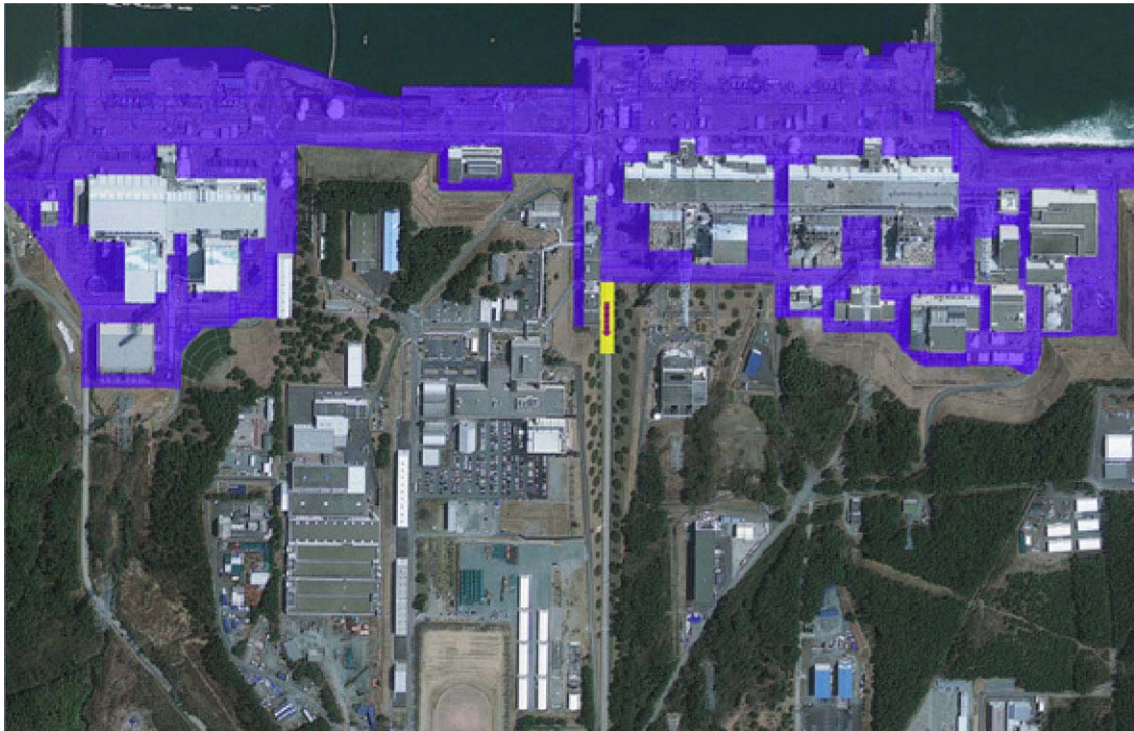
Figure 2.1-4 Extent of flooding within the power plant

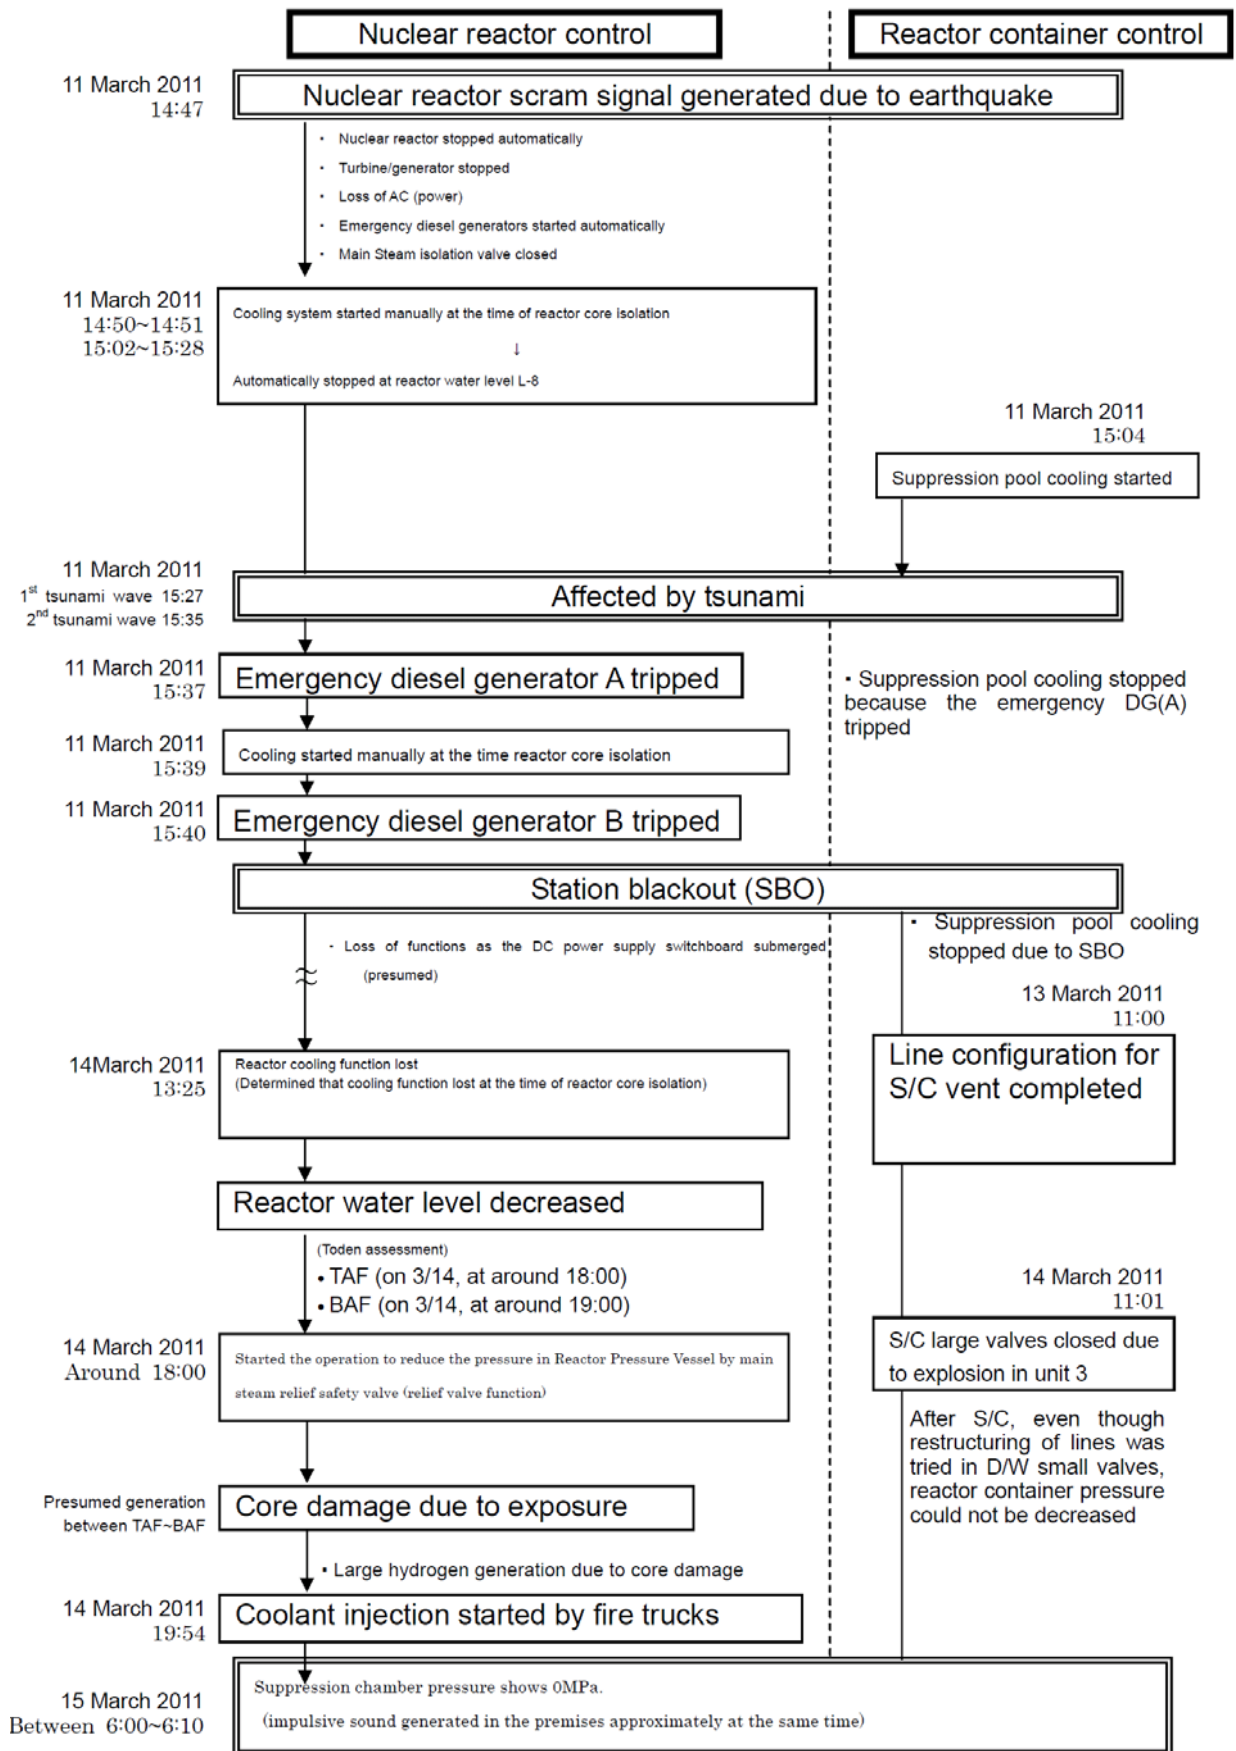
Fig. 2.3-1: Flows of the Accident at Unit 2 of the Fukushima Daiichi Nuclear Power Station after the Earthquake

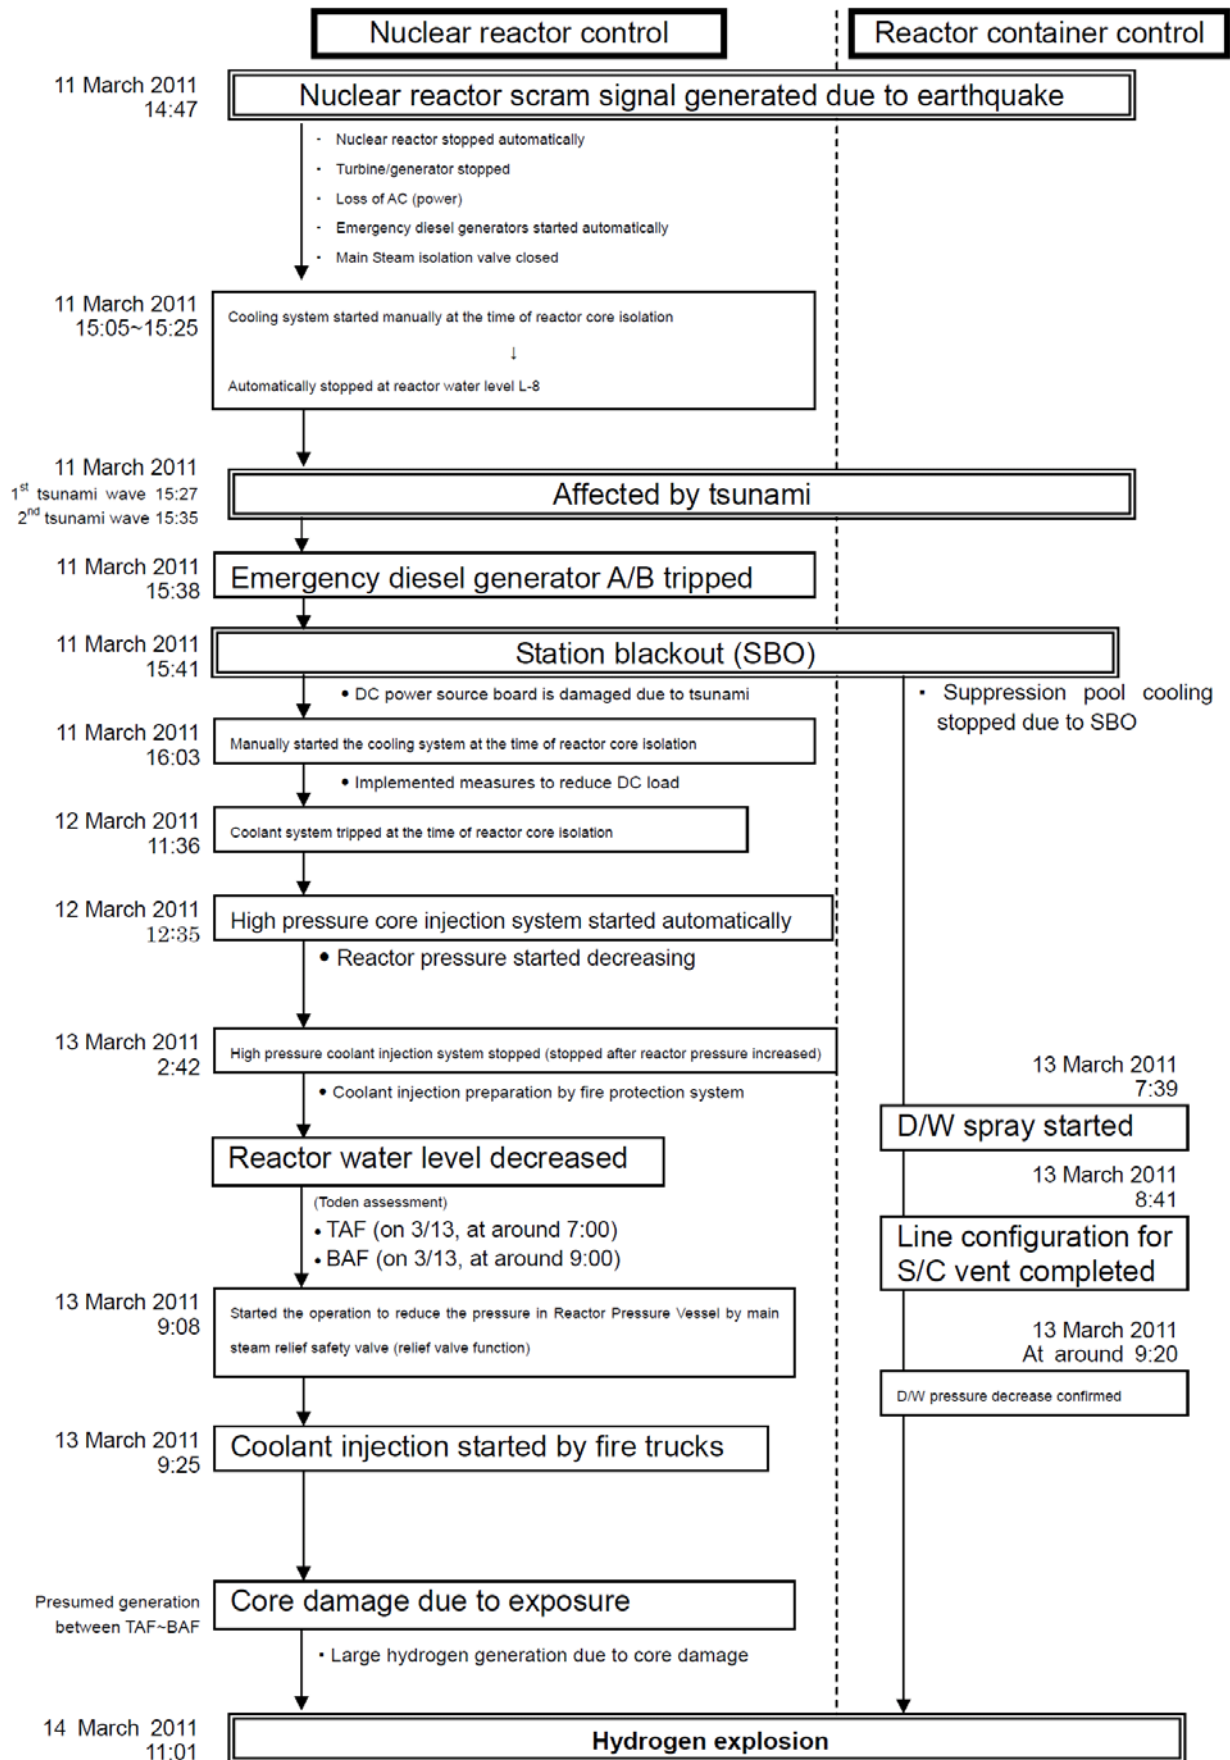
Fig. 2.4-1: Fukushima Daiichi Nuclear Power Station Unit 3 accident progress flow after the earthquake

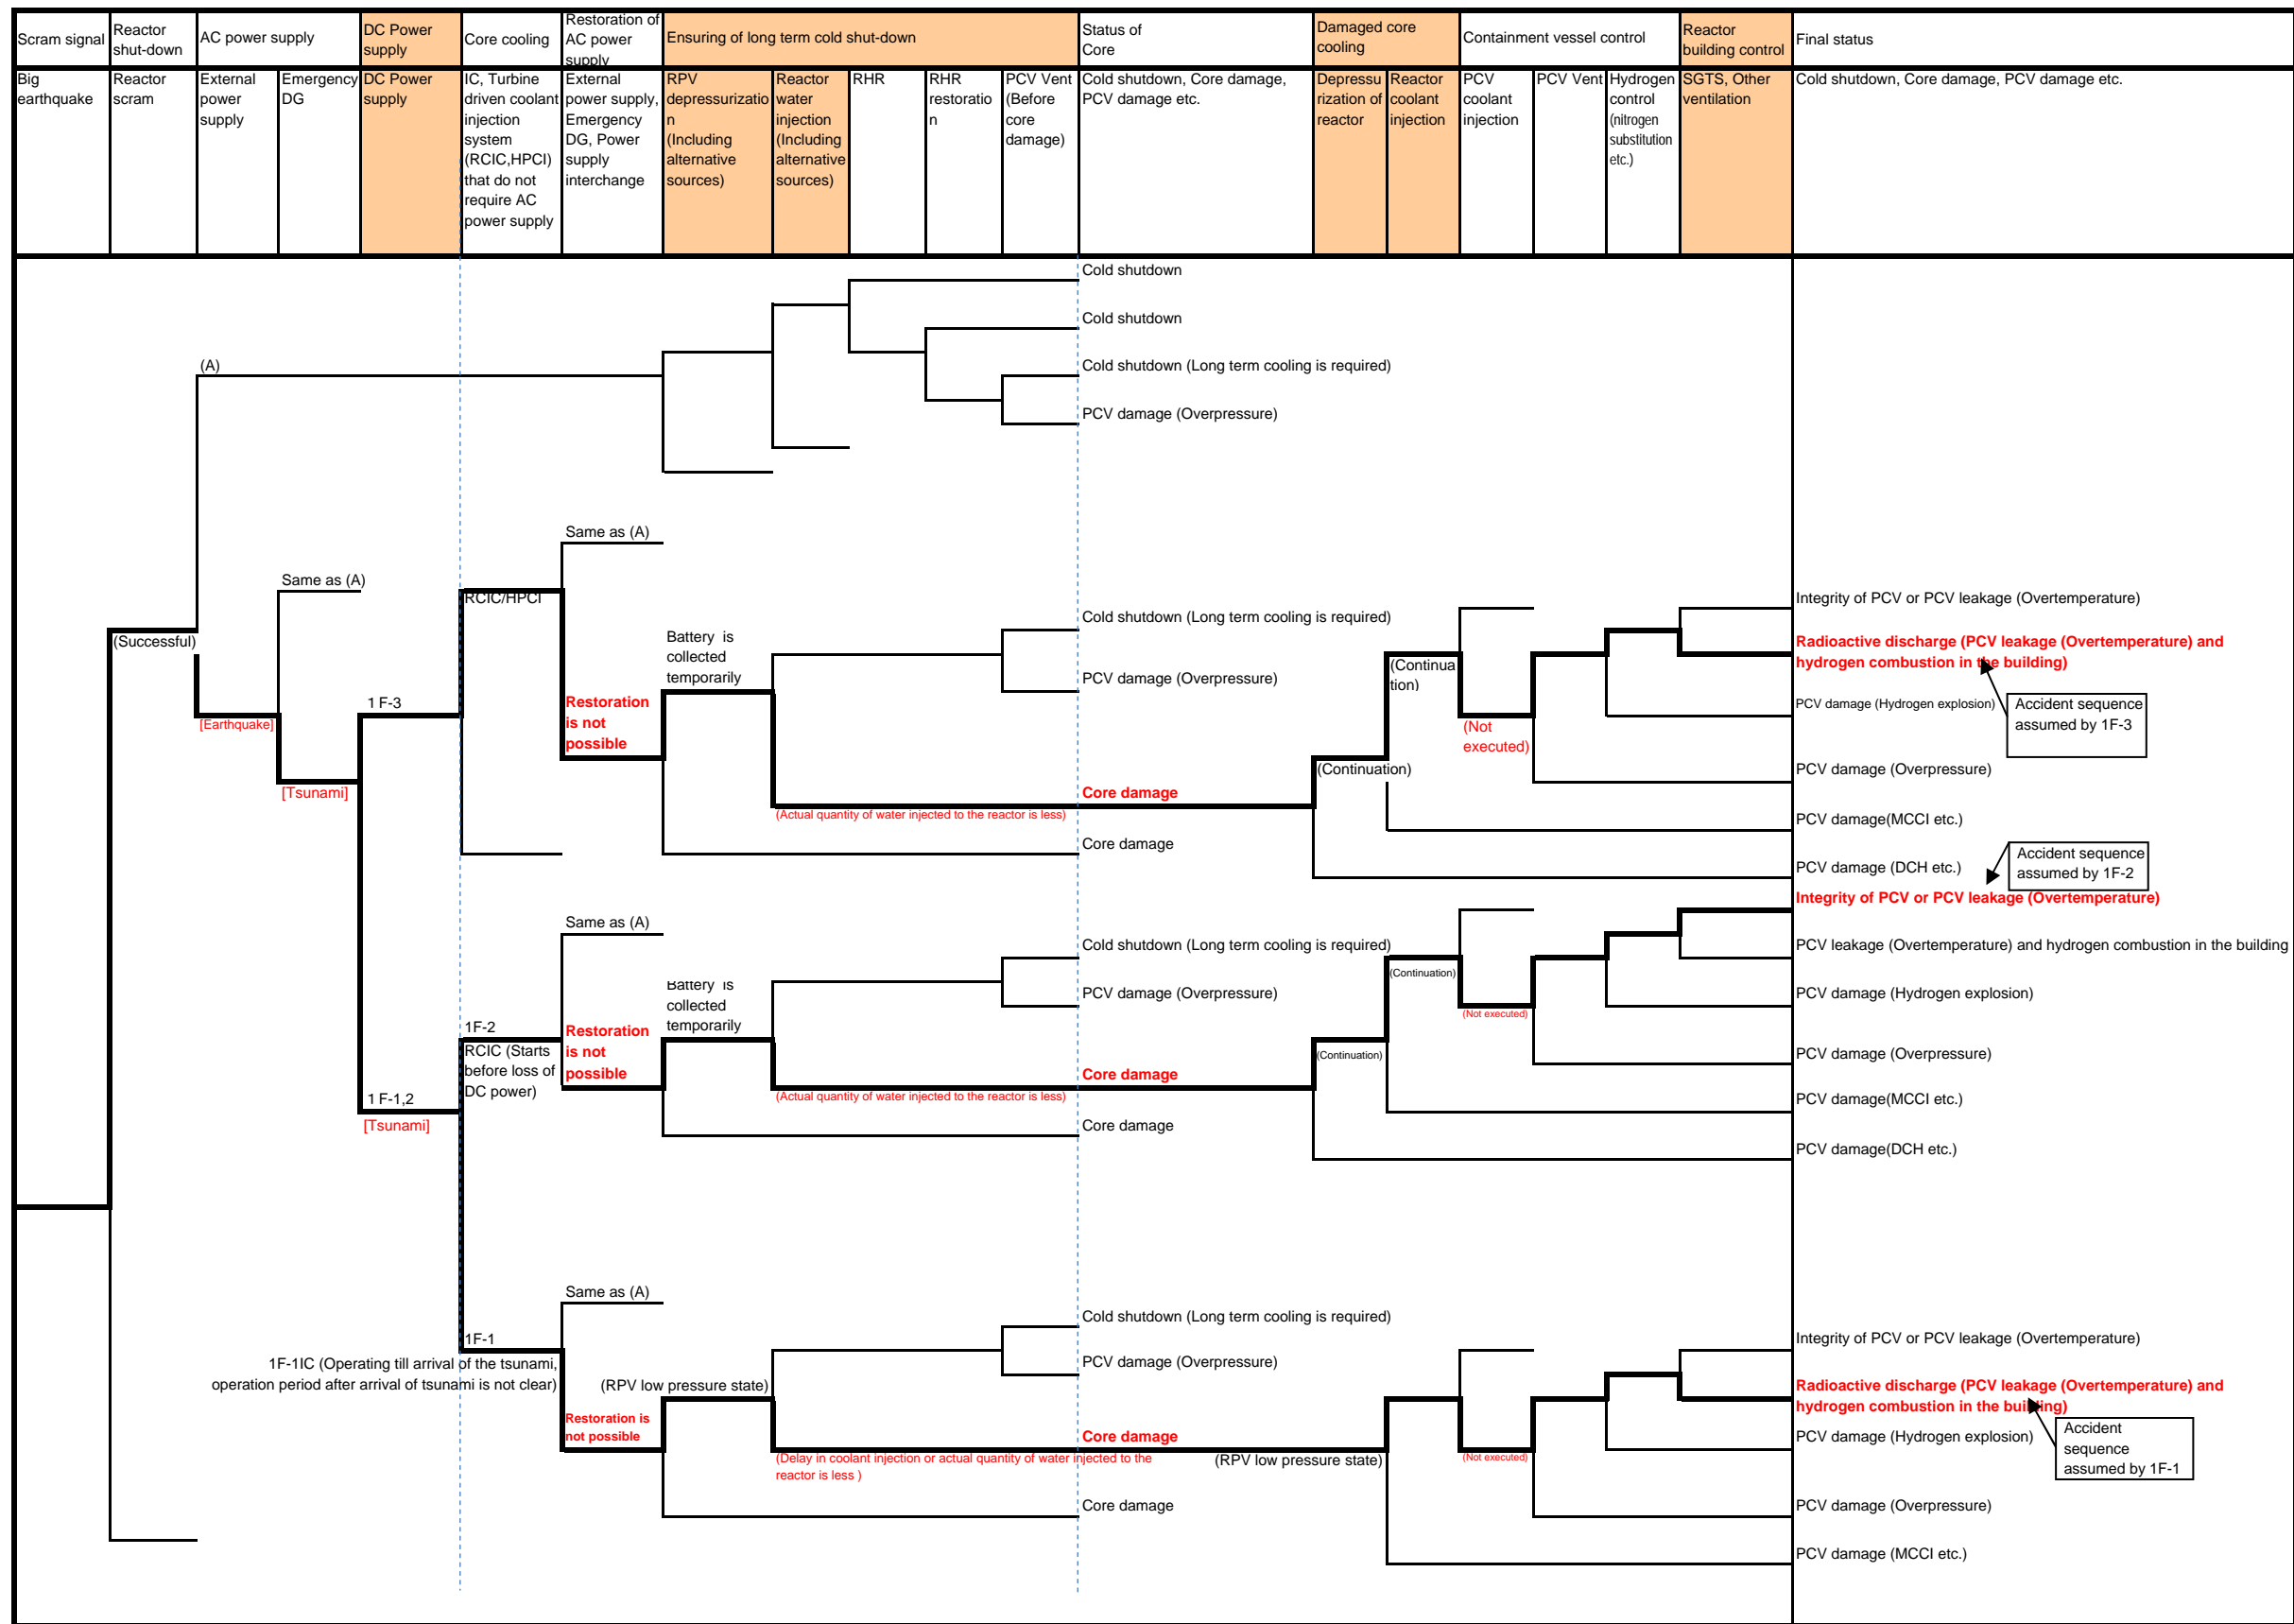
Figure 3.1-1 Disaster identification events tree in Fukushima Daiichi Nuclear Power Station, Units 1 to 3

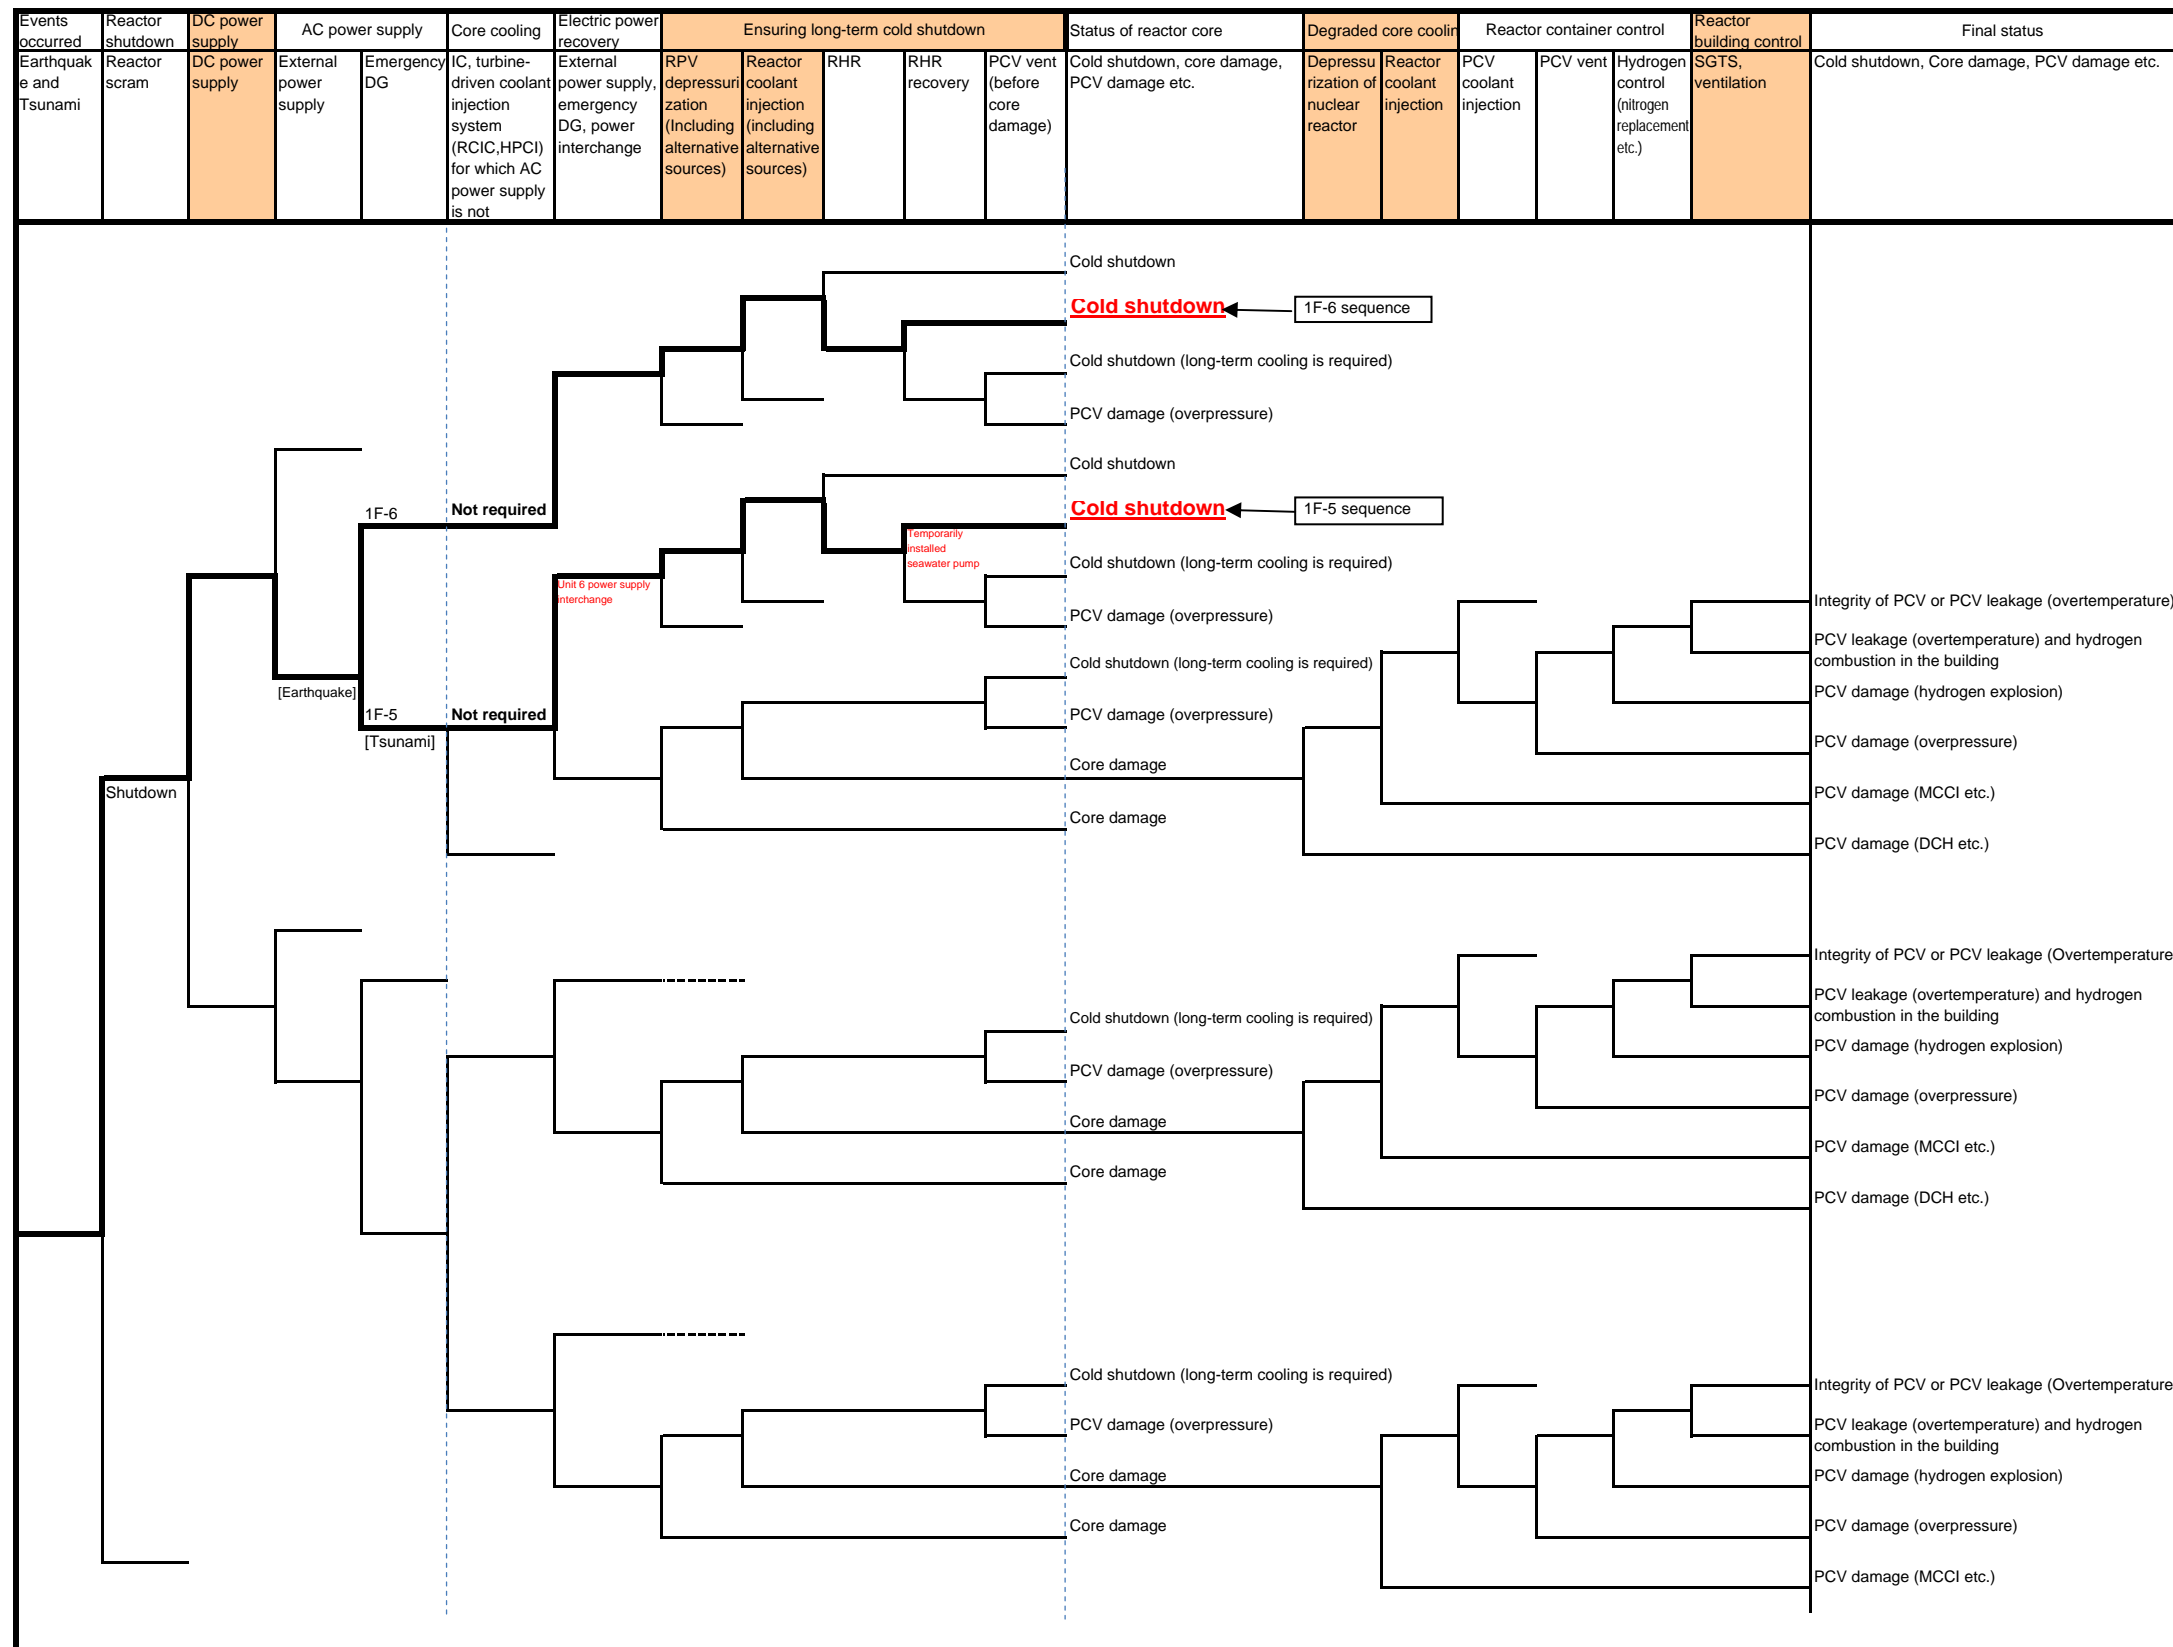
Figure 3.5-1 Disaster identification events tree in Fukushima Daiichi Nuclear Power Station Units 5, 6

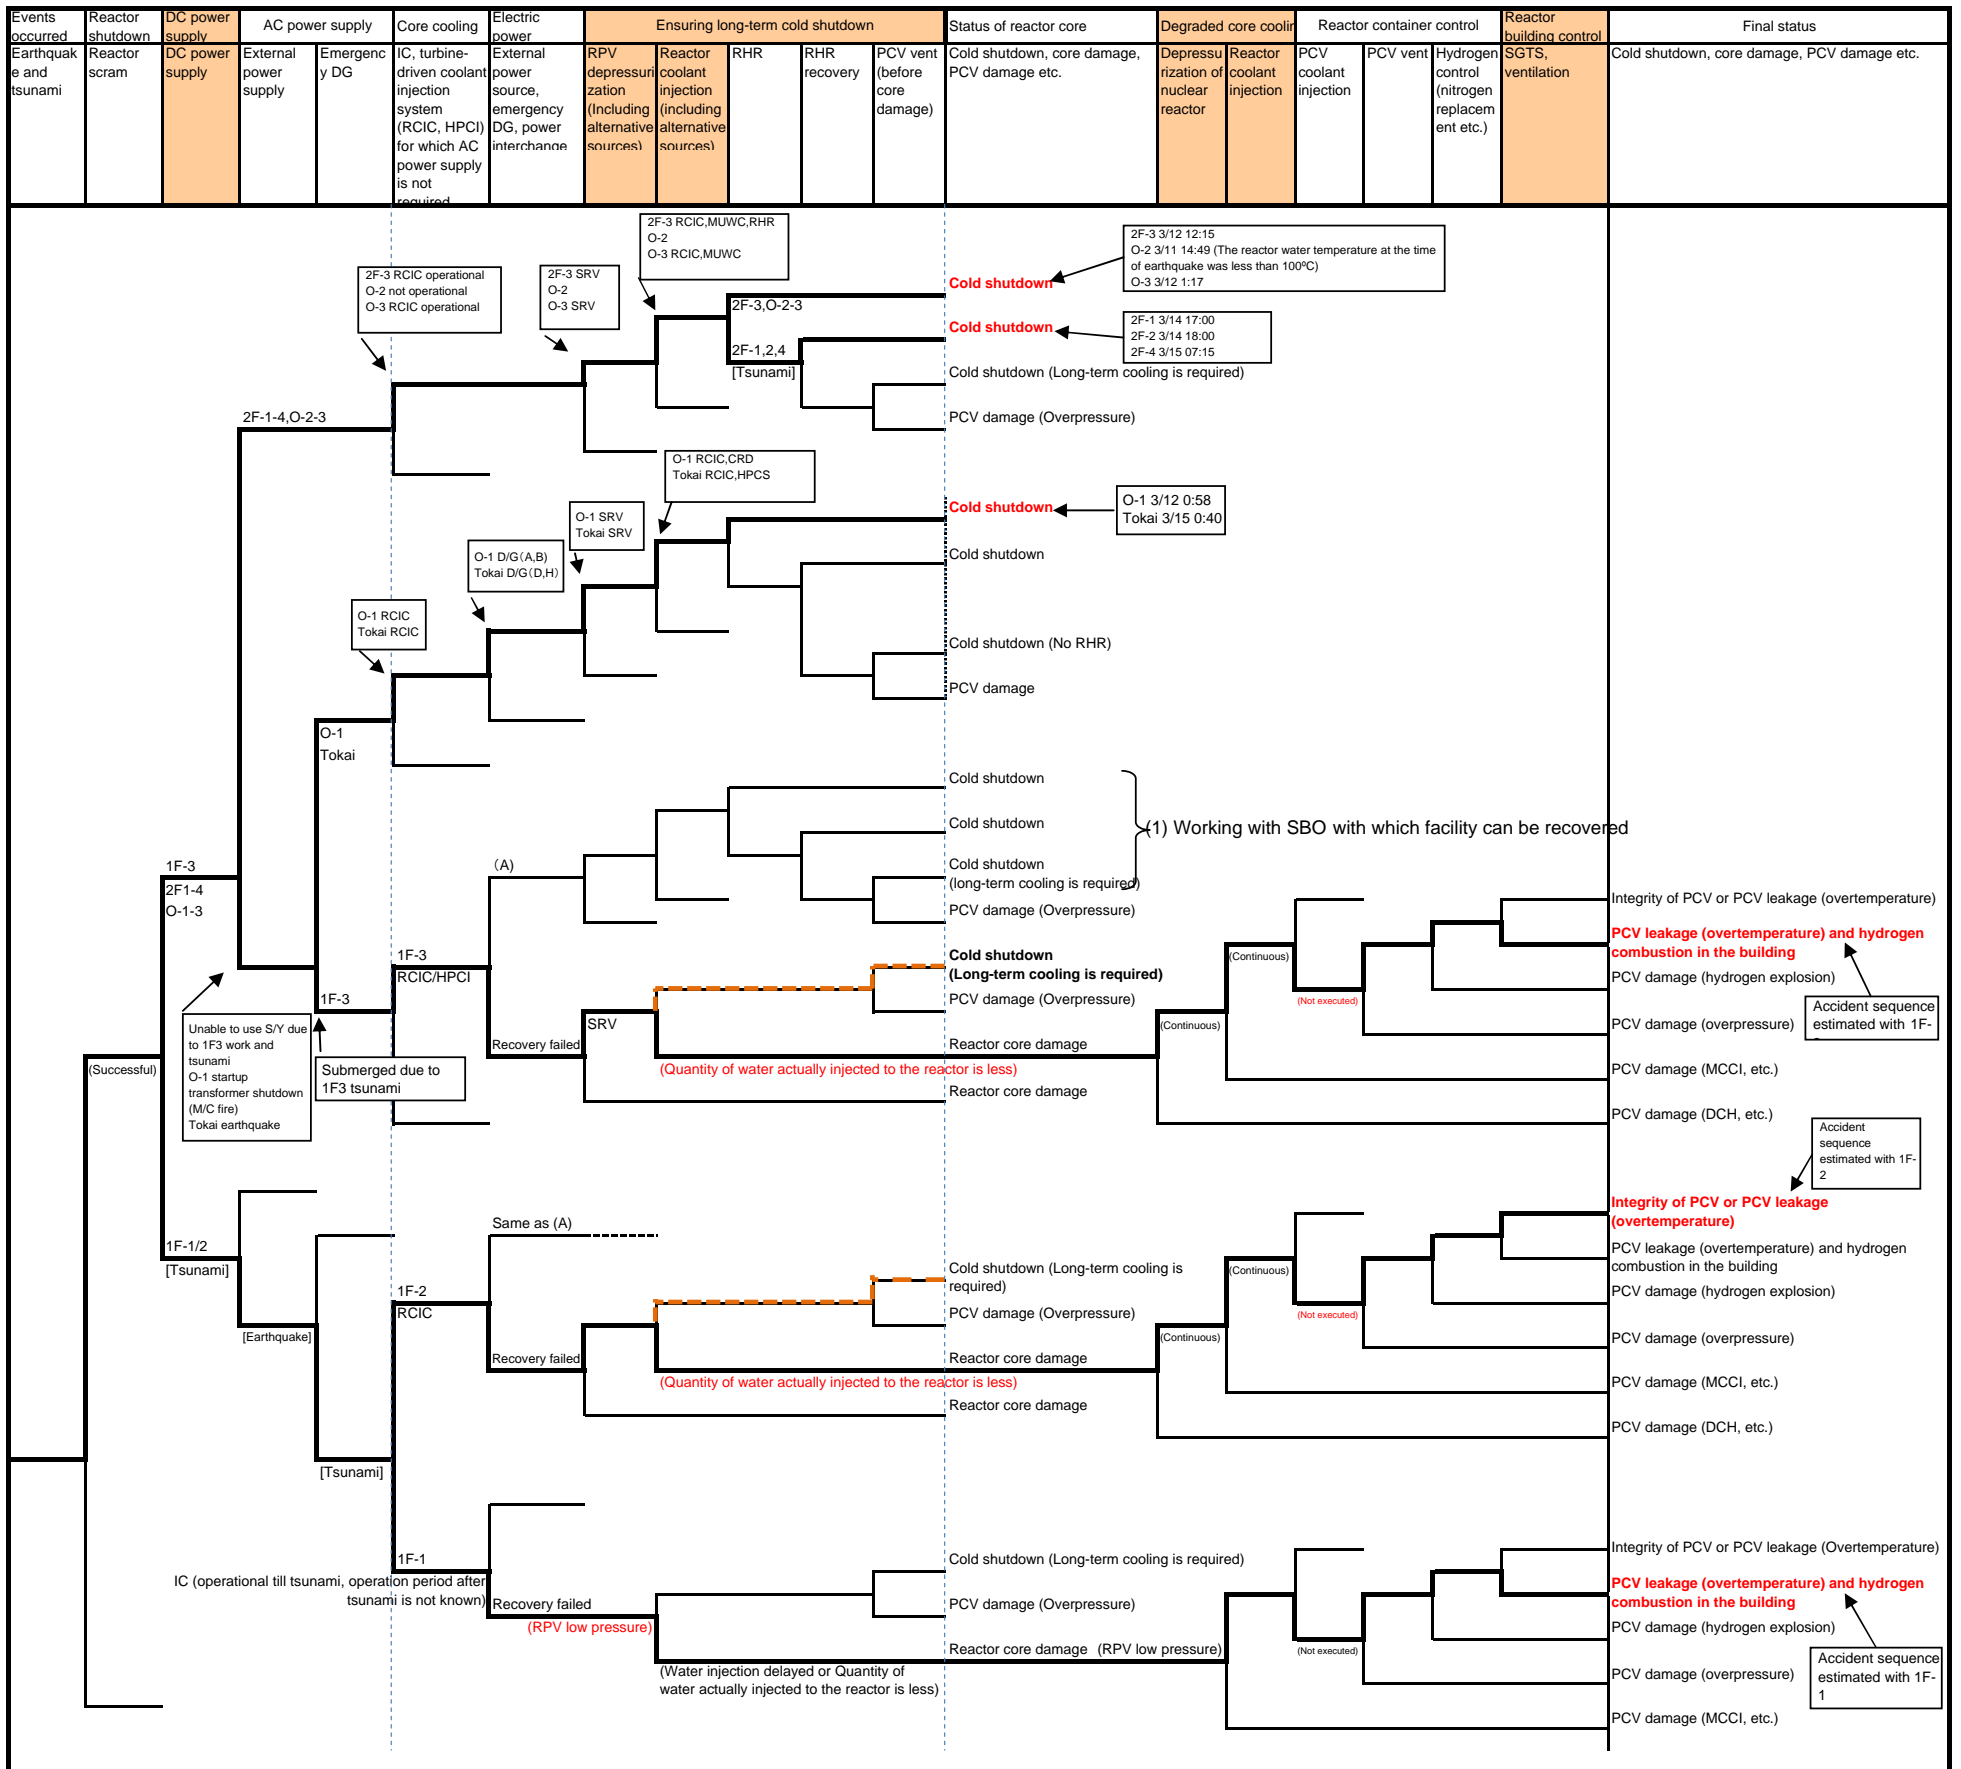
Figure 3.6-1 Disaster identification events tree in Fukushima Daiichi Nuclear Station Units 1 to 3, Fukushima Daini, Onagawa, Tokai Daini

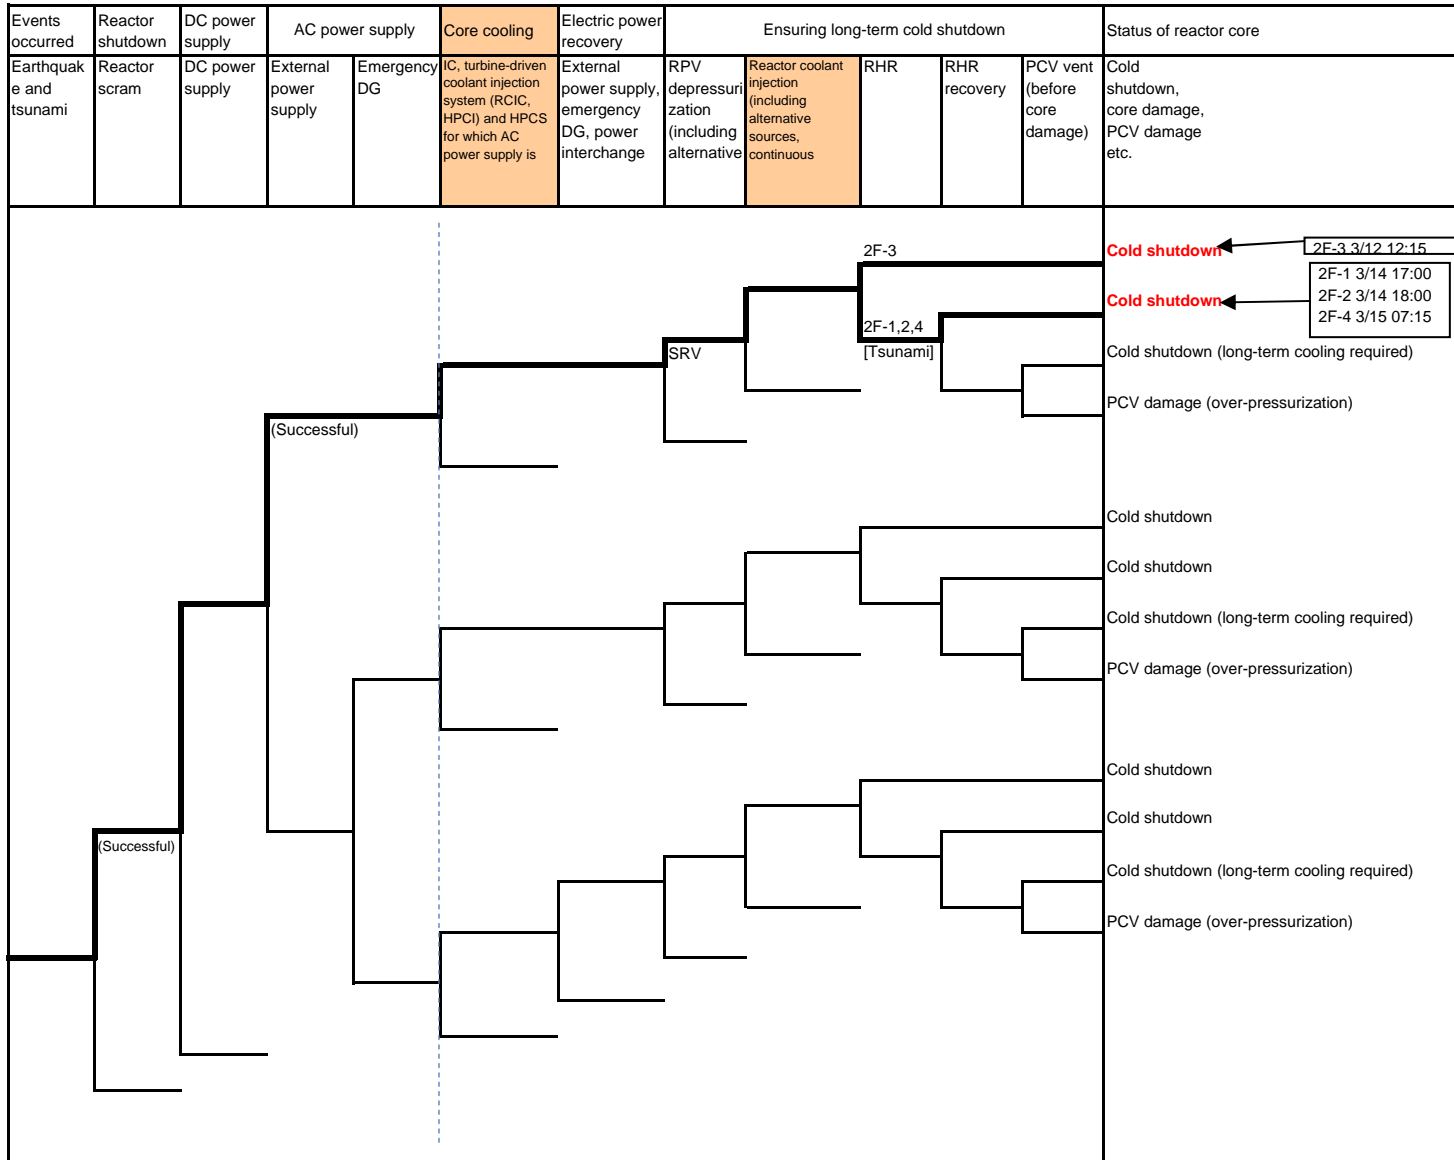
Figure Appendix 3-1 Fukushima Daini Nuclear Power Station disaster identification events tree

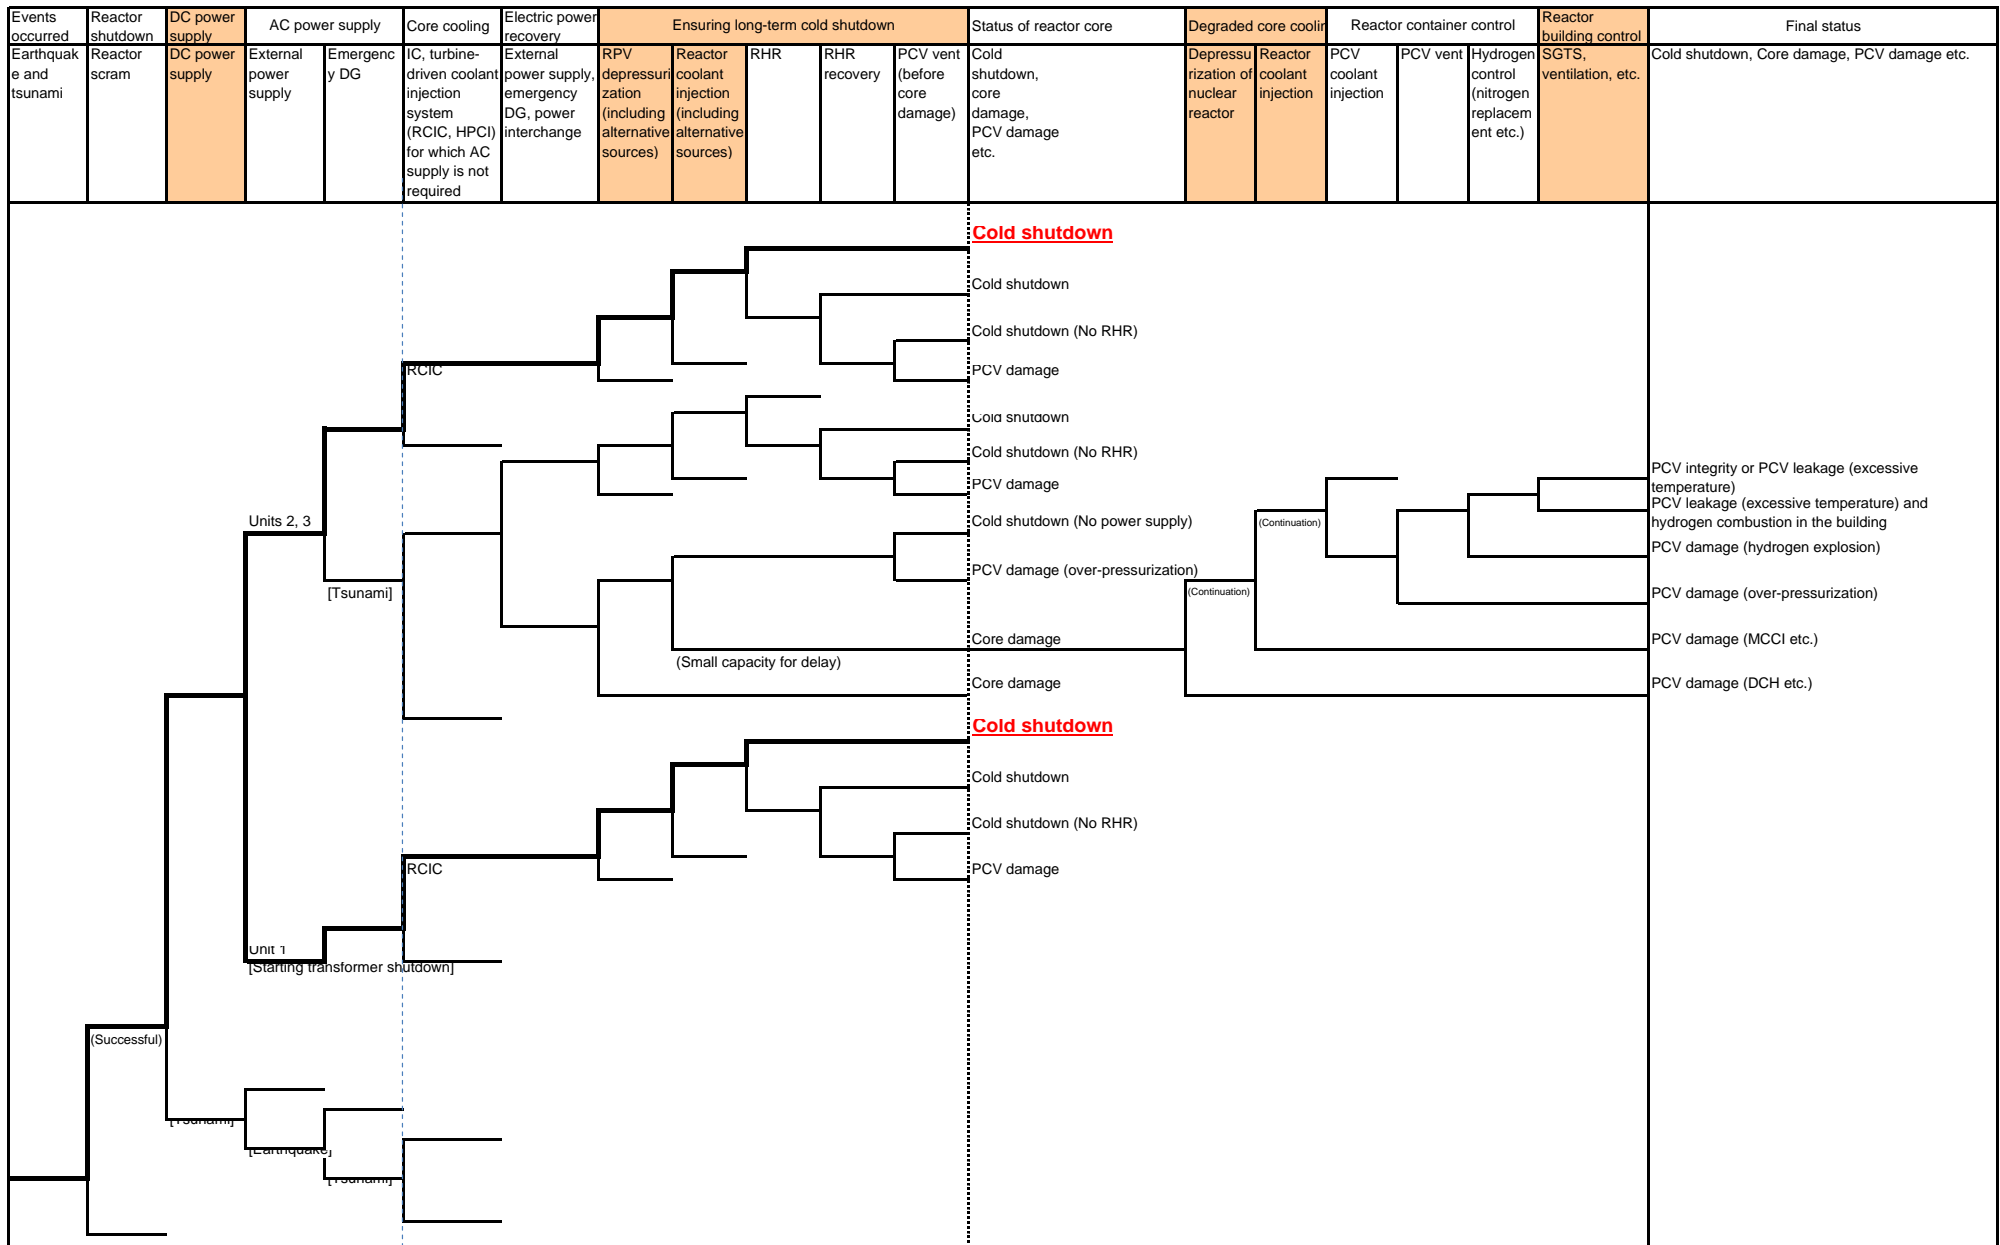
Diagram Appendix 3-2 Onagawa Nuclear Power Station disaster identification events tree
