# **Examination of Accident at Tokyo Electric Power Co., Inc.'s Fukushima Daiichi Nuclear Power Station and Proposal of Countermeasures**

**October 2011**

**Japan Nuclear Technology Institute**

**Examination Committee on Accident at Fukushima Daiichi Nuclear  
Power Station**

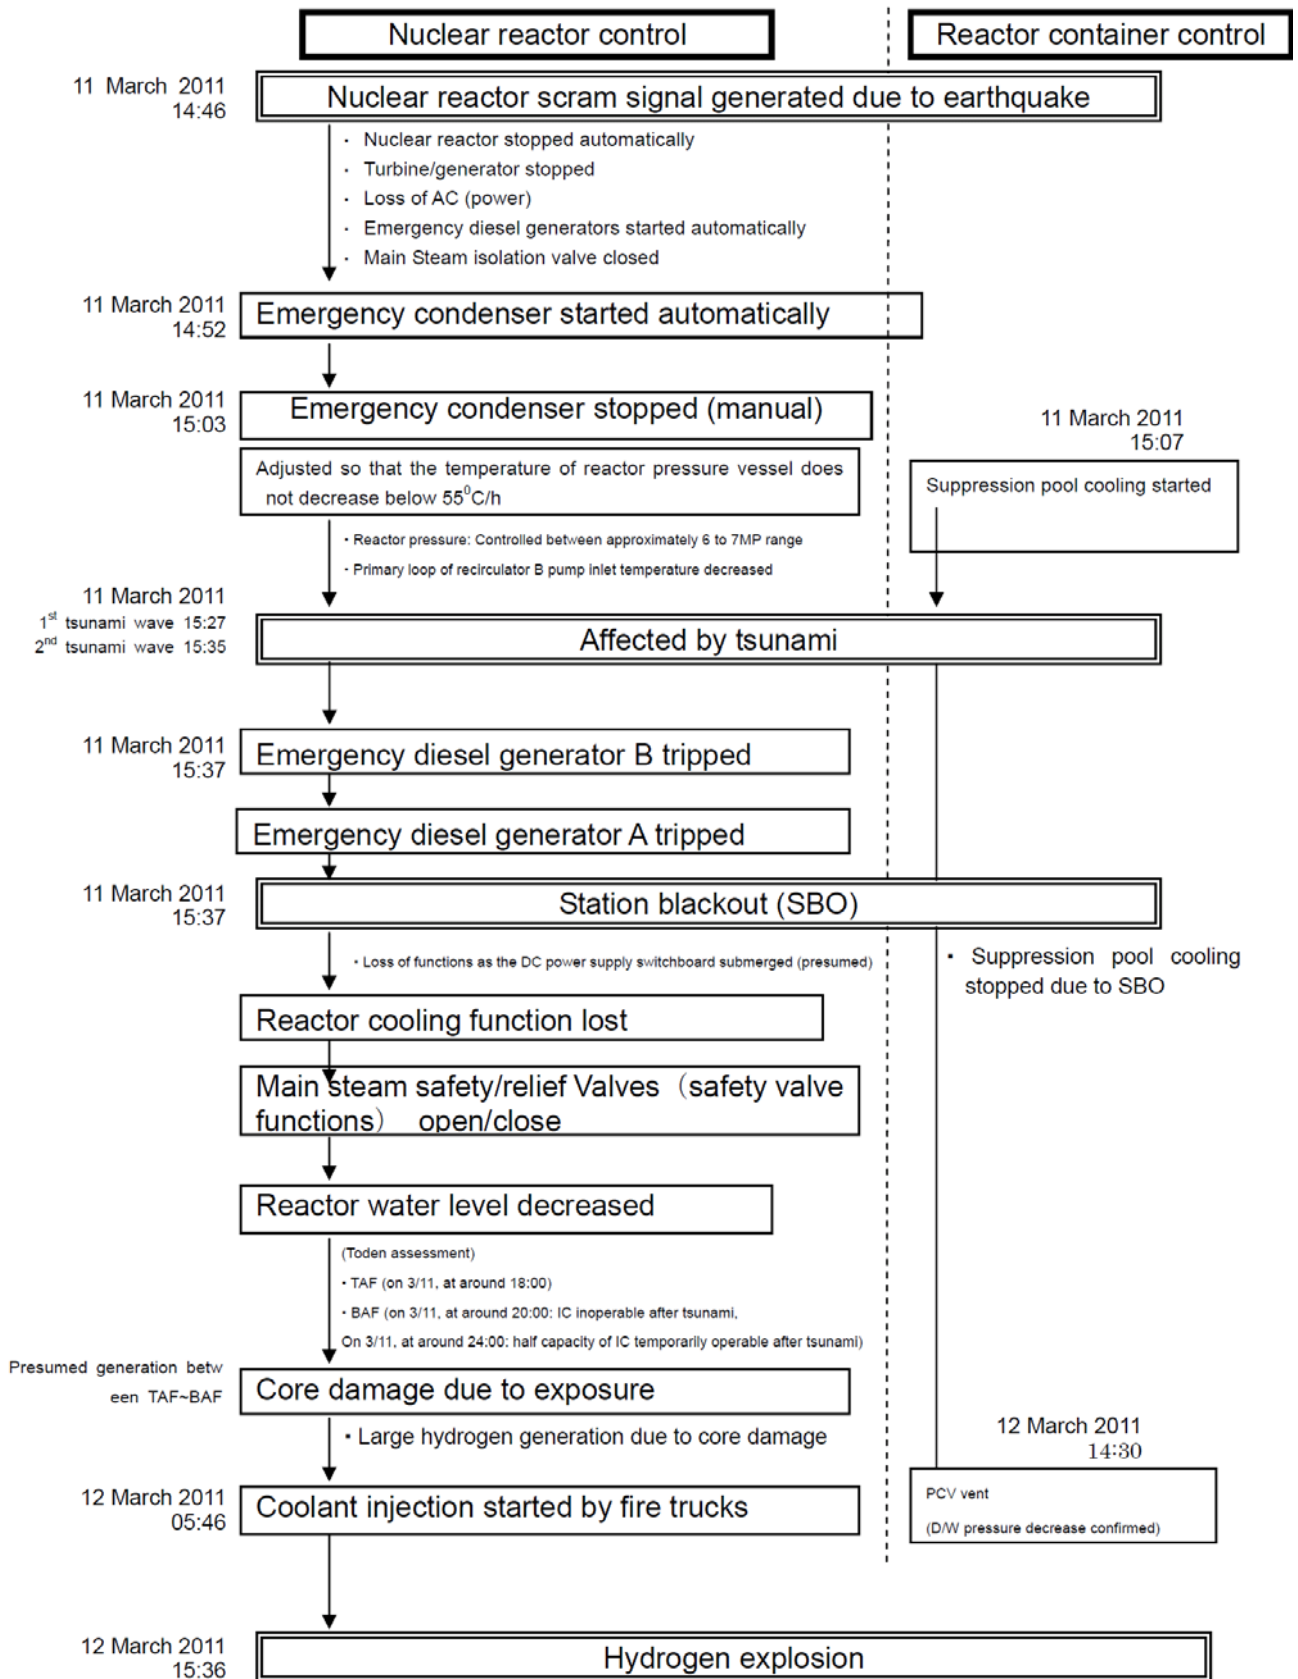
**Figure 2.2-1 Course of accident after earthquake at Unit 1 of the Fukushima Daiichi Nuclear Power Station**

Note: The meter indication showed that the water level of the reactor core was being maintained, but thinking about the period of reactor damage and such like, it was possible that the meter was not showing a proper indicated value.

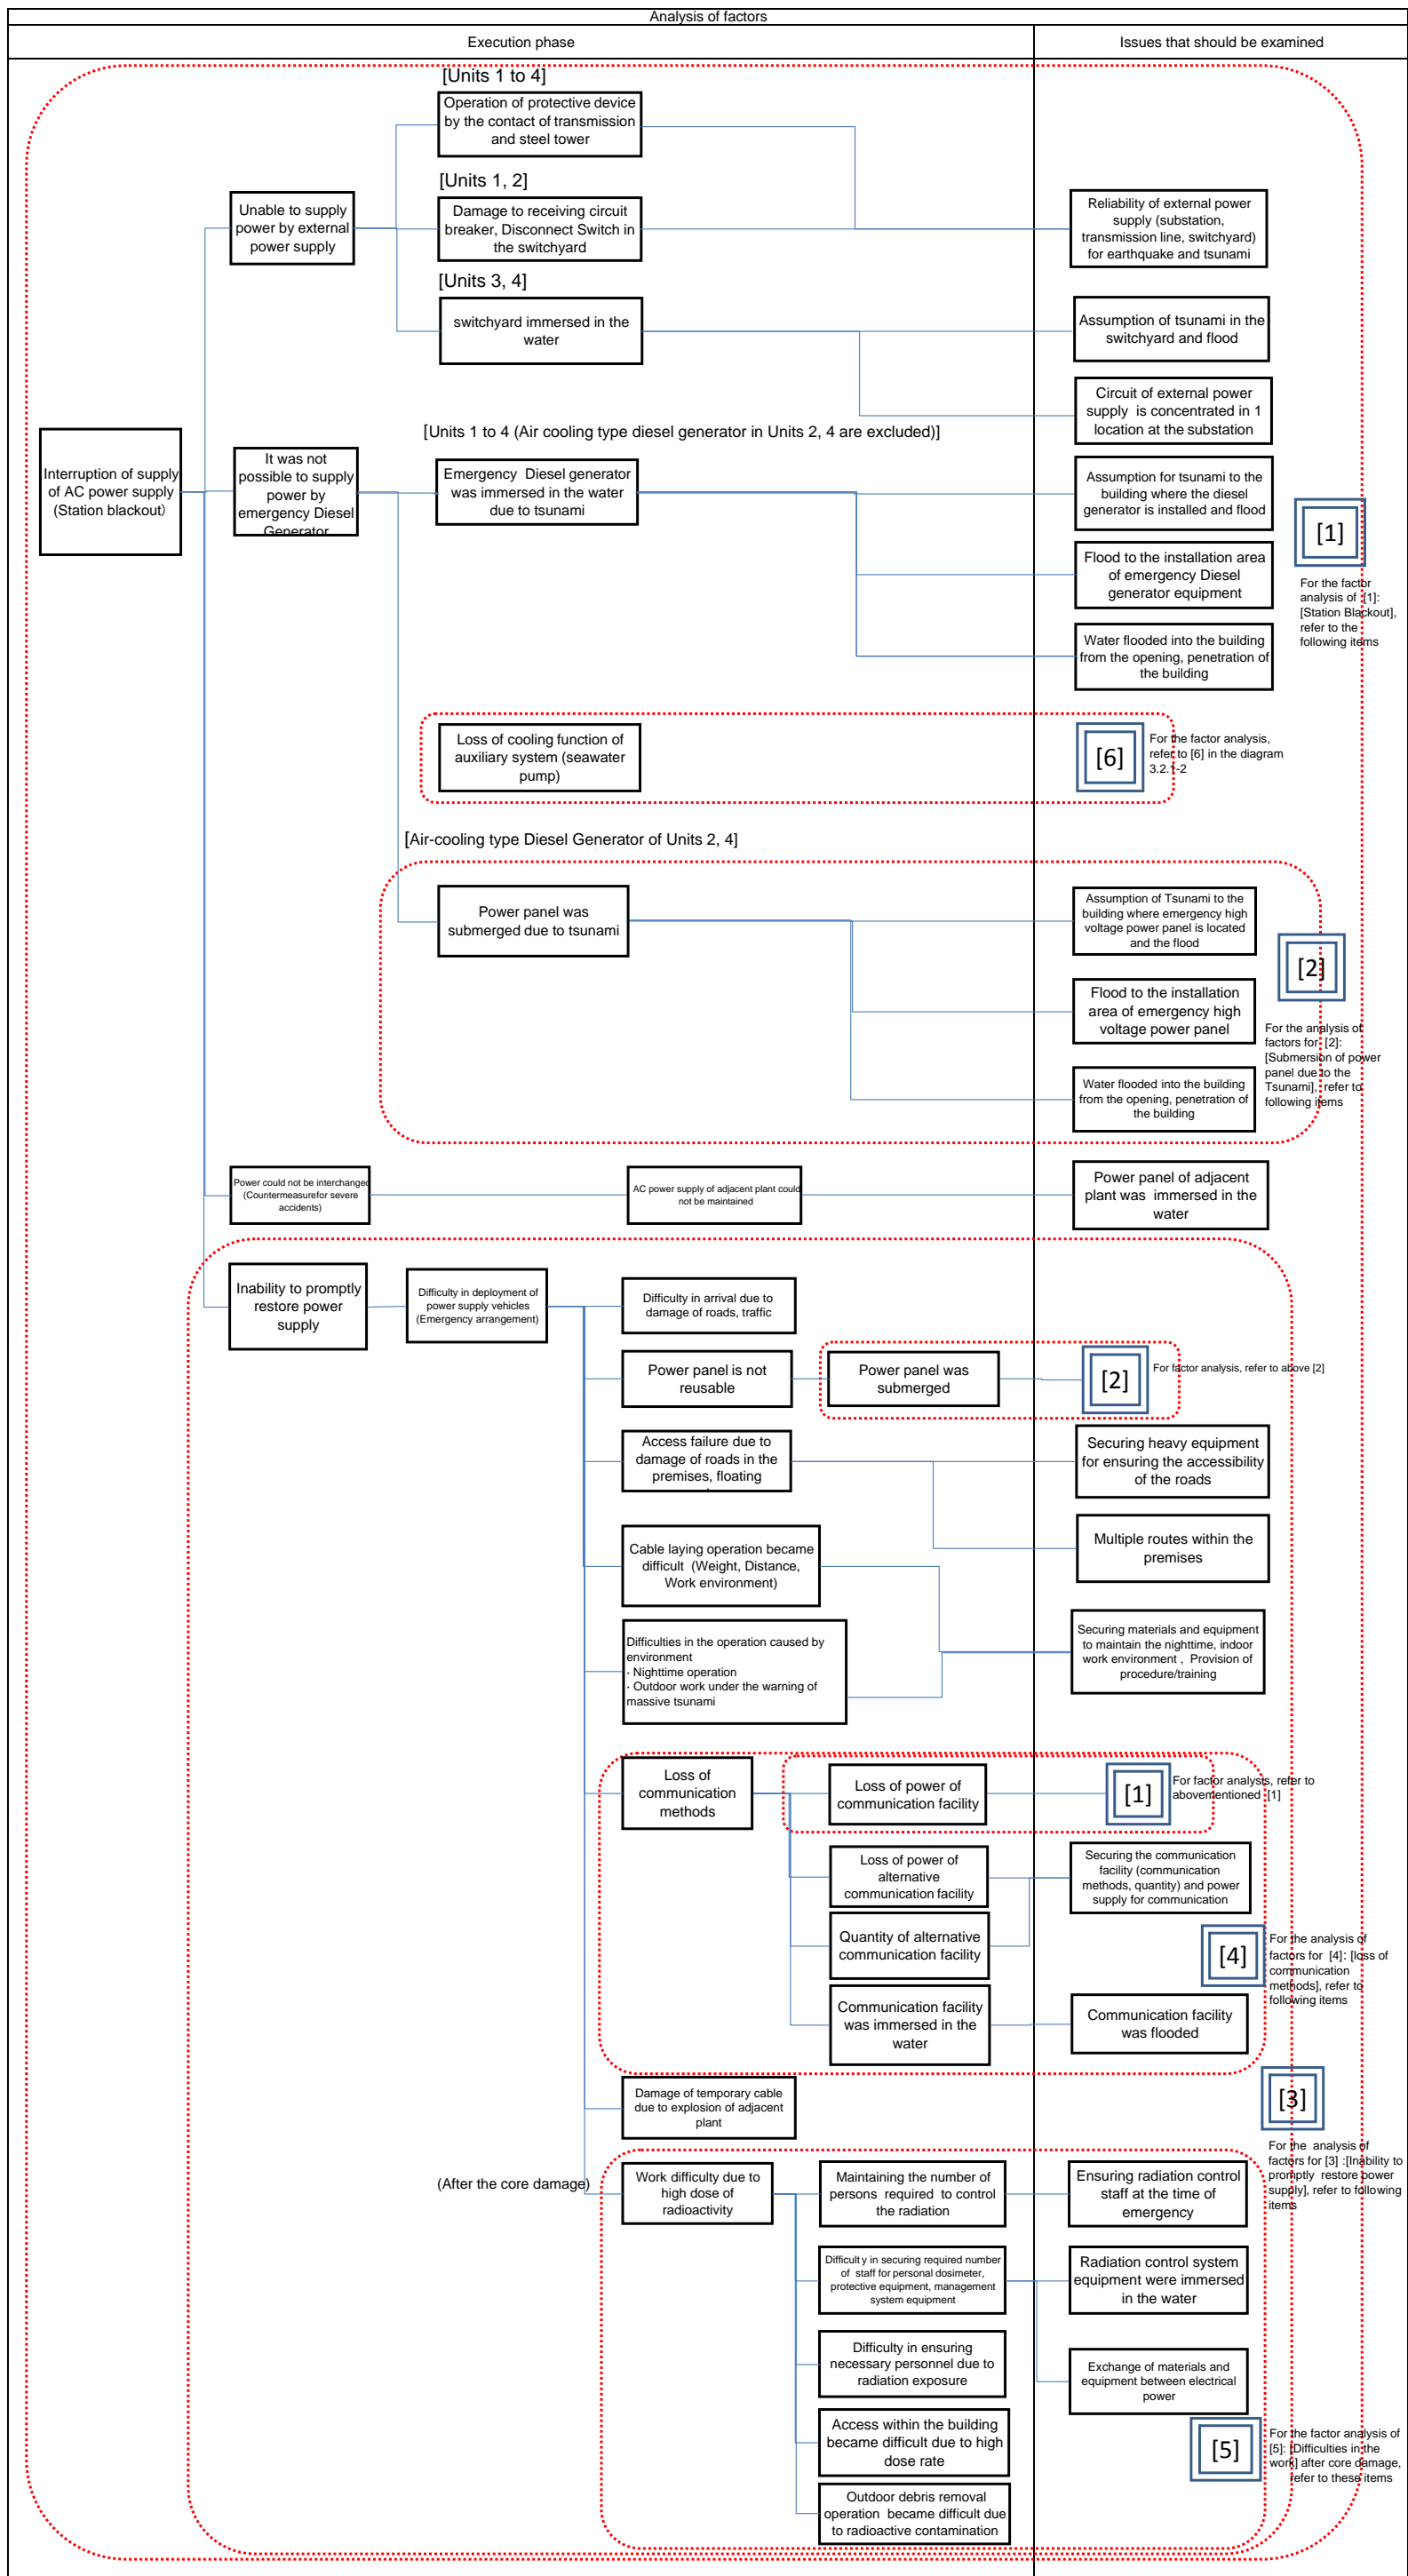
Figure 3.2.1-1 Analysis of causes for interruption of AC power supply

The AC power could not be supplied to the equipment and for operation for reasons including the inability to supply power from the external source, inability to supply power with an emergency DG, inability to jointly use power supply and inability to restore power supply at early stage.

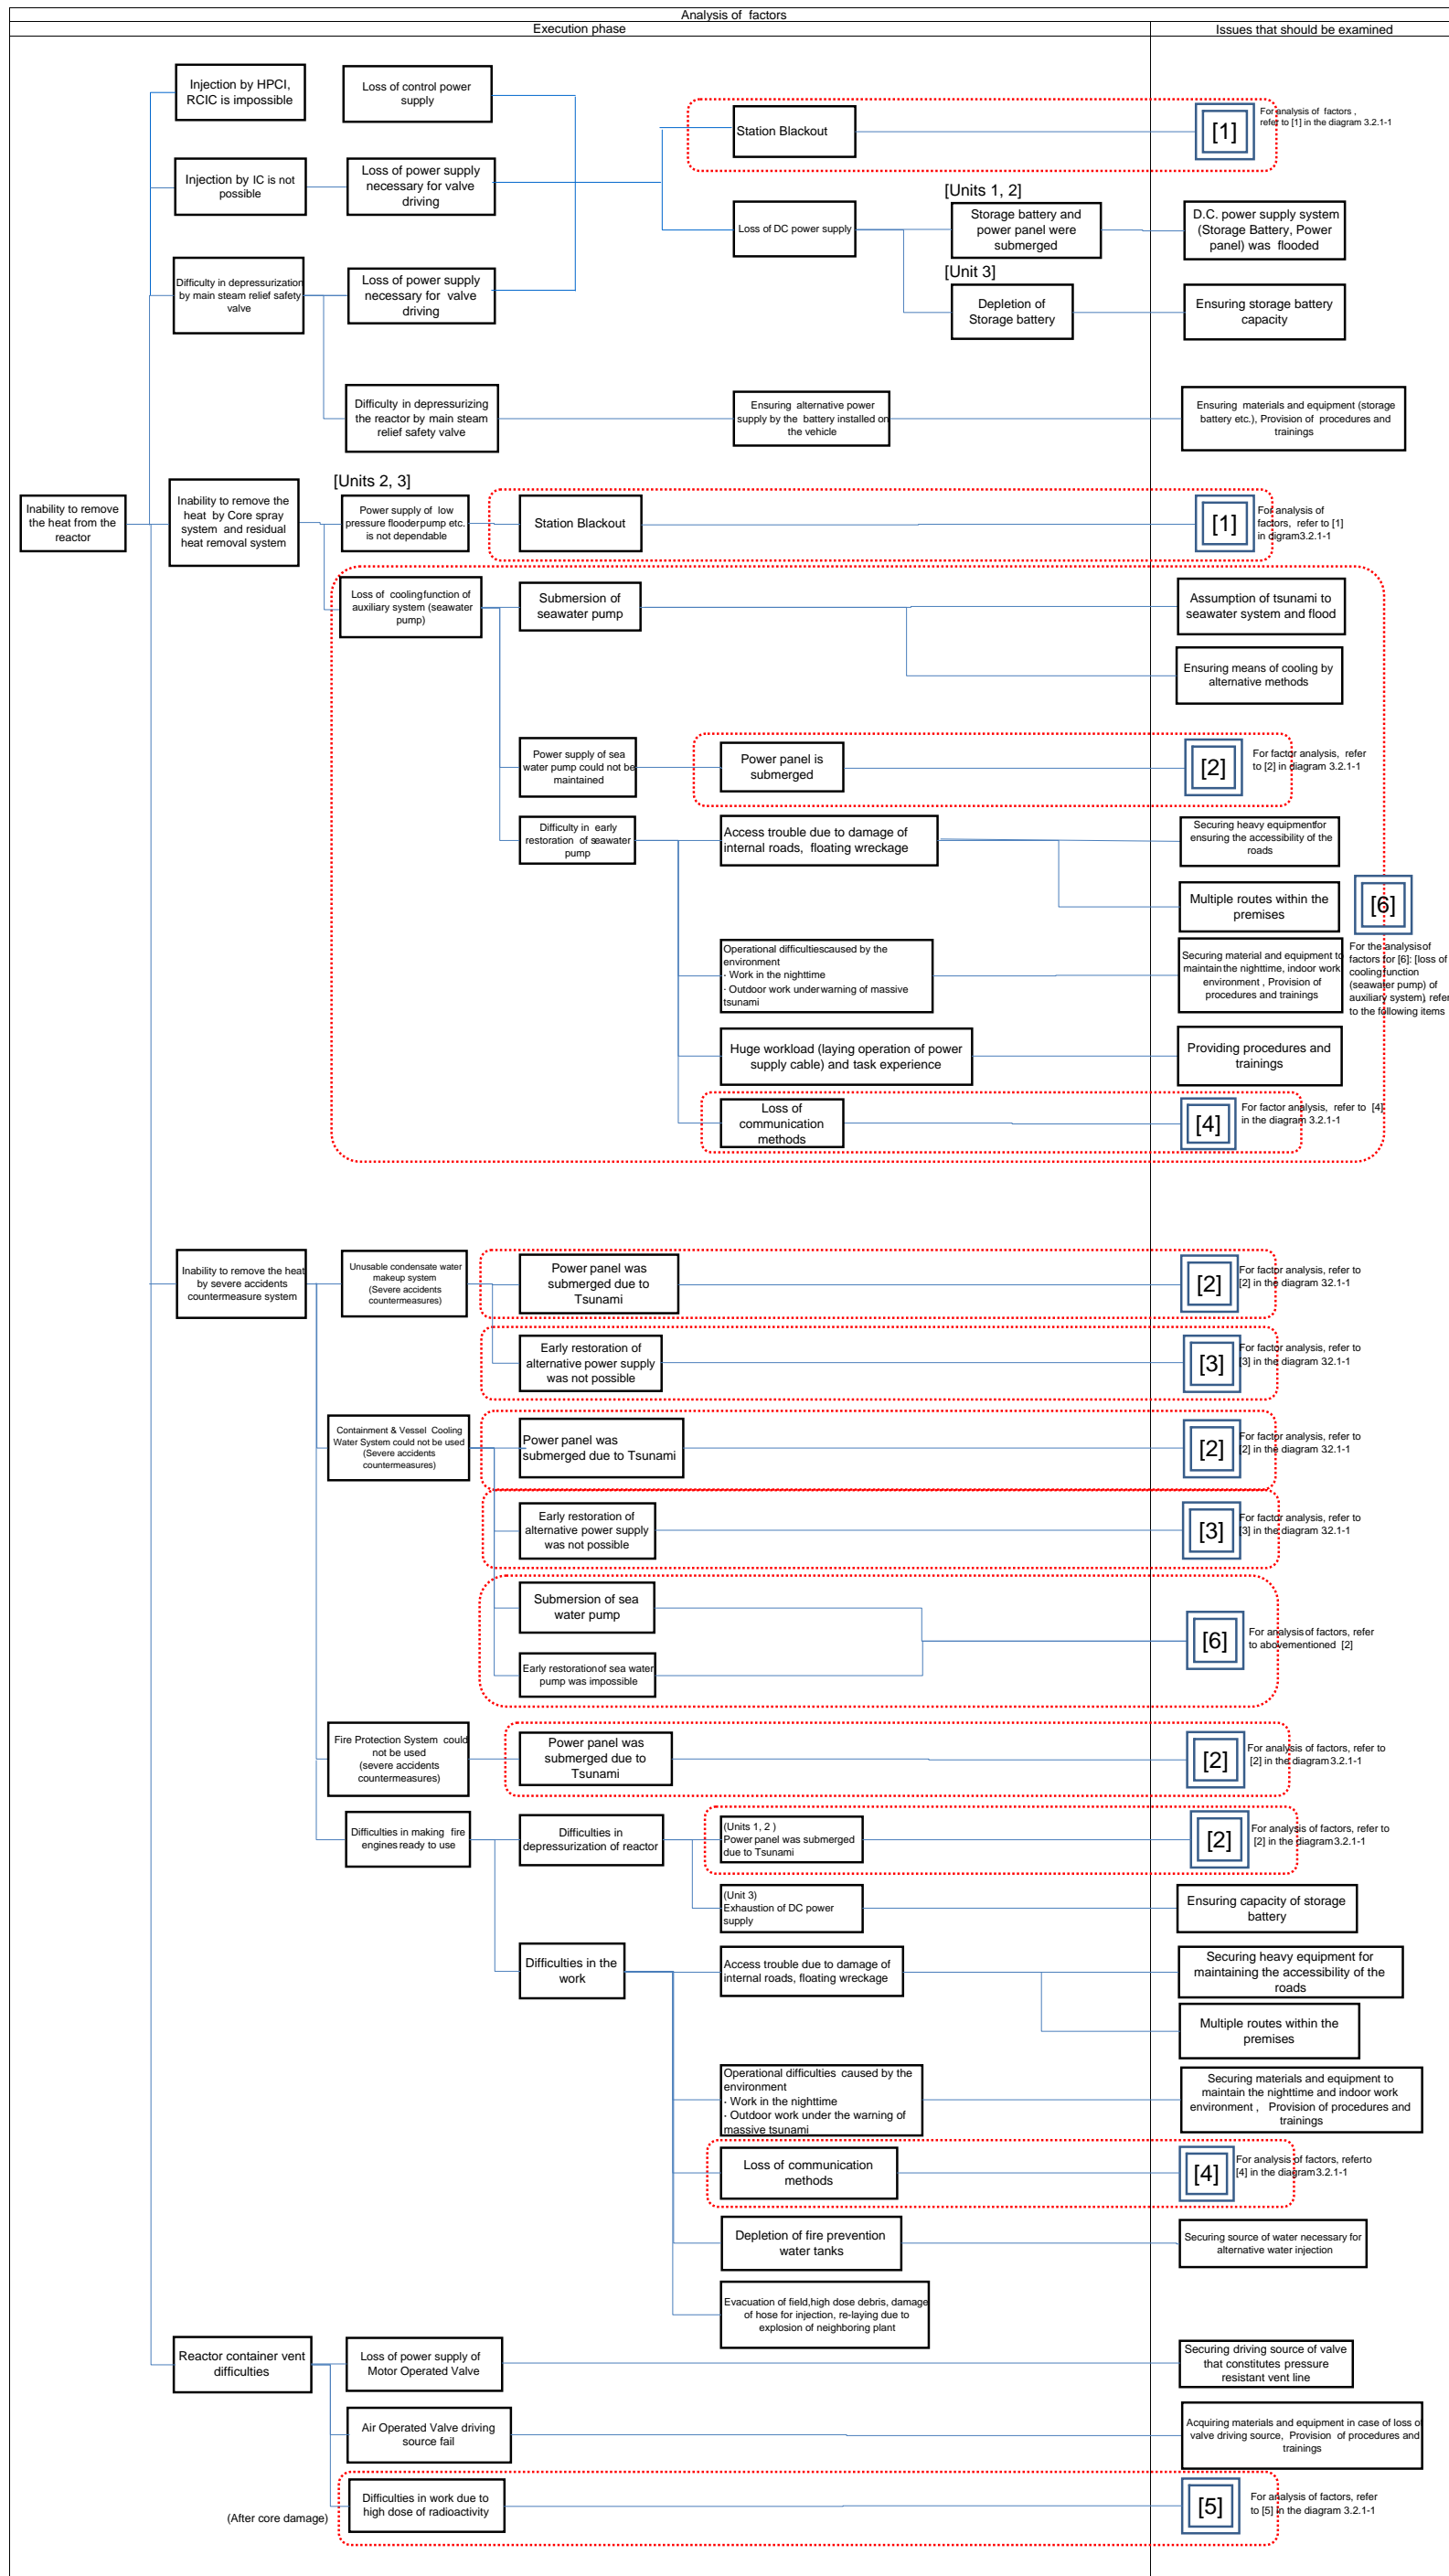
Figure 3.2.1-2 Analysis of causes of inability to remove heat from the reactor

It was impossible to remove heat from the nuclear reactor from the view of the equipment and operation for the following reasons: inability to conduct decompression with SRV, inability to remove heat with CS and RHR, inability to remove heat with severe accident measure equipment (alternative water filling), and difficulty in venting containment vessel.

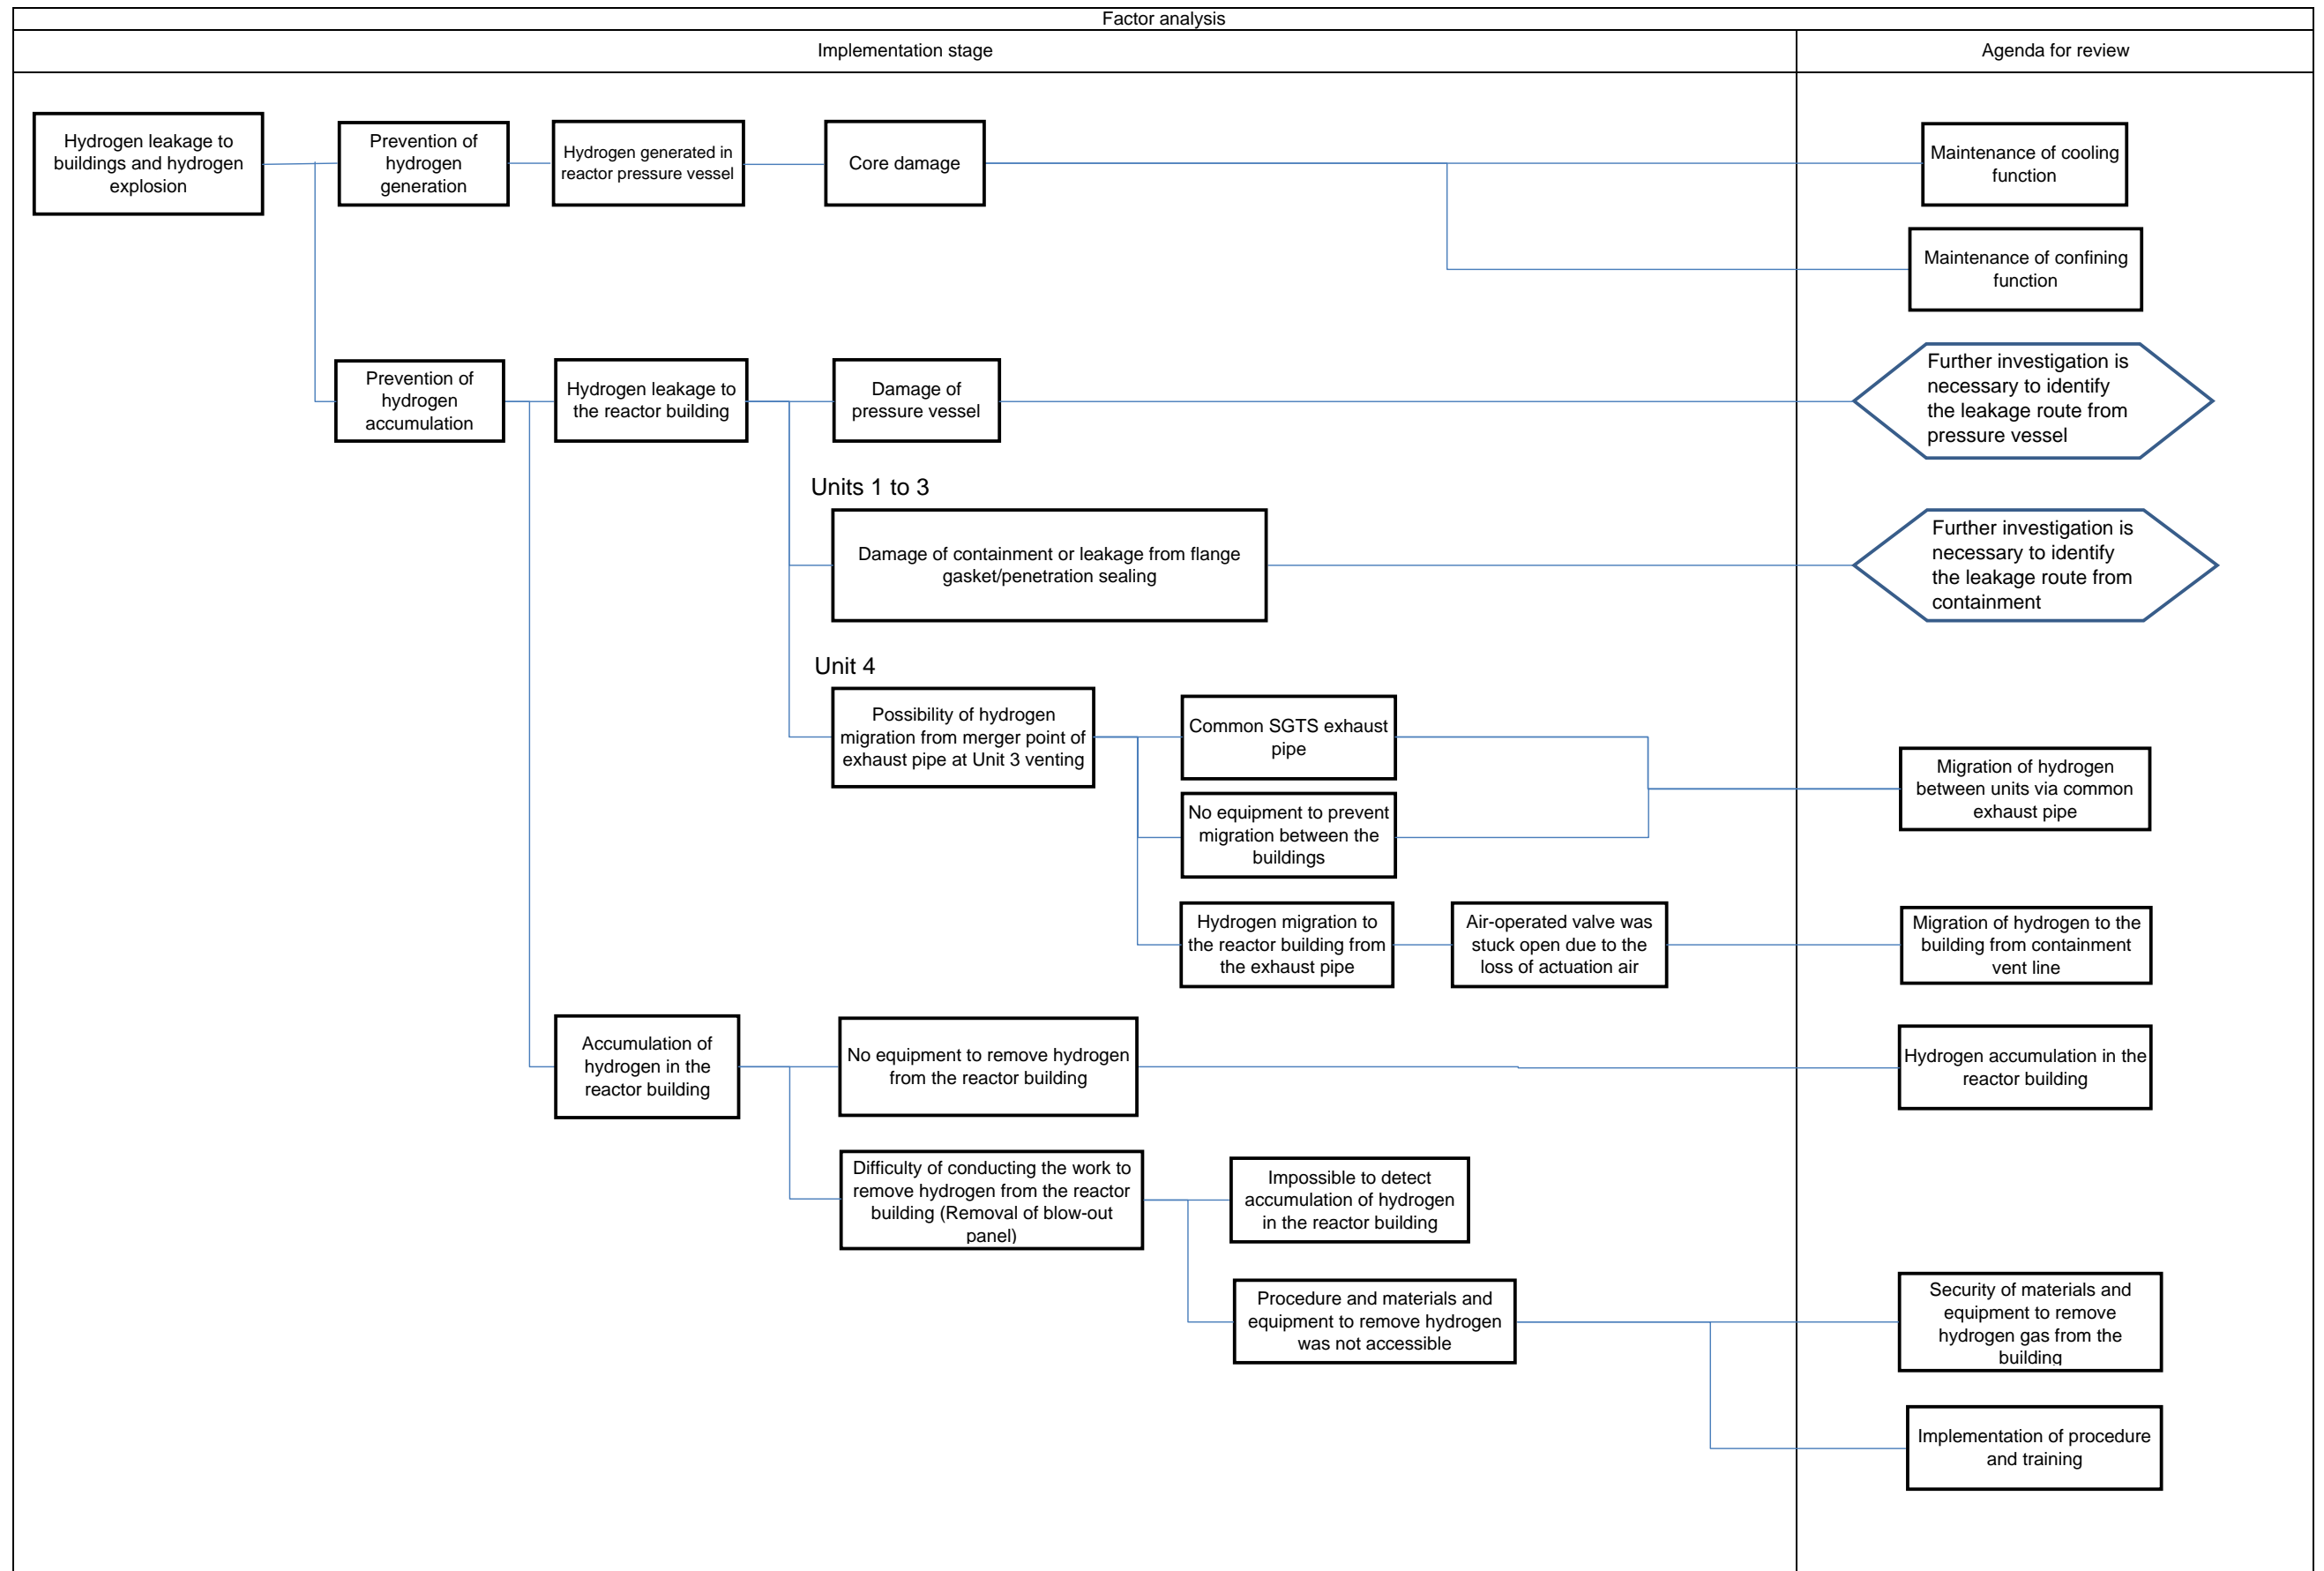
Figure 3.2.1-3: Hydrogen leakage to buildings and hydrogen explosion: Cause analysis

- Hydrogen migration among the Units connected via common stack
- Migration of hydrogen from containment vent line to the reactor building
- Accumulation of hydrogen in the reactor building
- Security of materials and equipment to remove hydrogen gas from the building
- Improvement of procedures and training
