# **Examination of Accident at Tokyo Electric Power Co., Inc.'s Fukushima Daiichi Nuclear Power Station and Proposal of Countermeasures**

**October 2011**

**Japan Nuclear Technology Institute**

**Examination Committee on Accident at Fukushima Daiichi Nuclear  
Power Station**

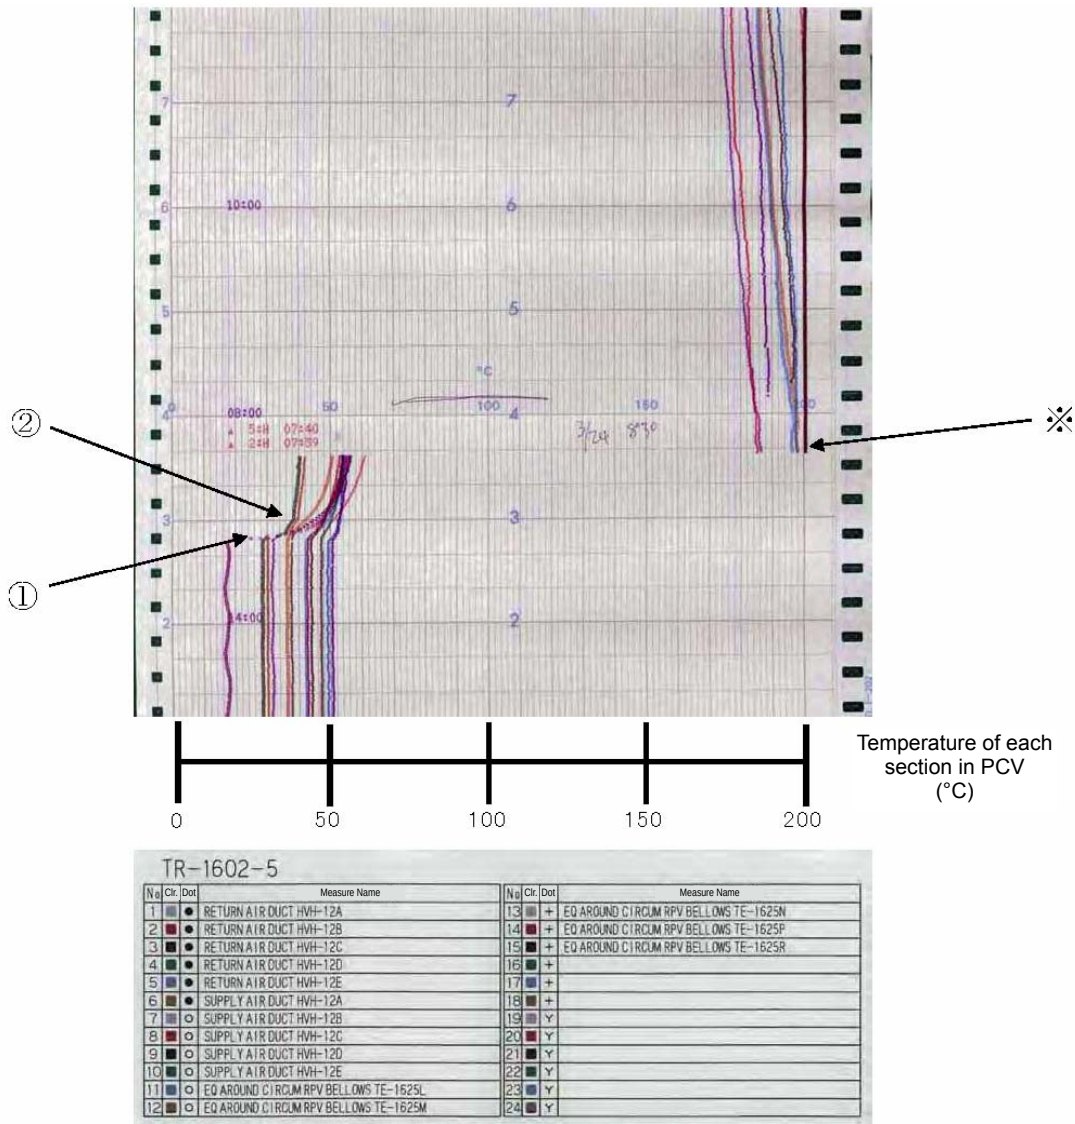
Fig. 2.1-4-1 Temperature of each section in Unit 1's primary containment vessel

- (1) 14:46 Scram due to the earthquake  
 (2) Temperature rise of the PCV because the containment air handling system stopped due to loss of power (no excessive rise in temperature attributable to piping rupture, and such like was observed).  
 \* After 15:30, the recorder power was lost due to arrival of the tsunami and the recorder once stopped. Recording was resumed after the recorder power was restored on March

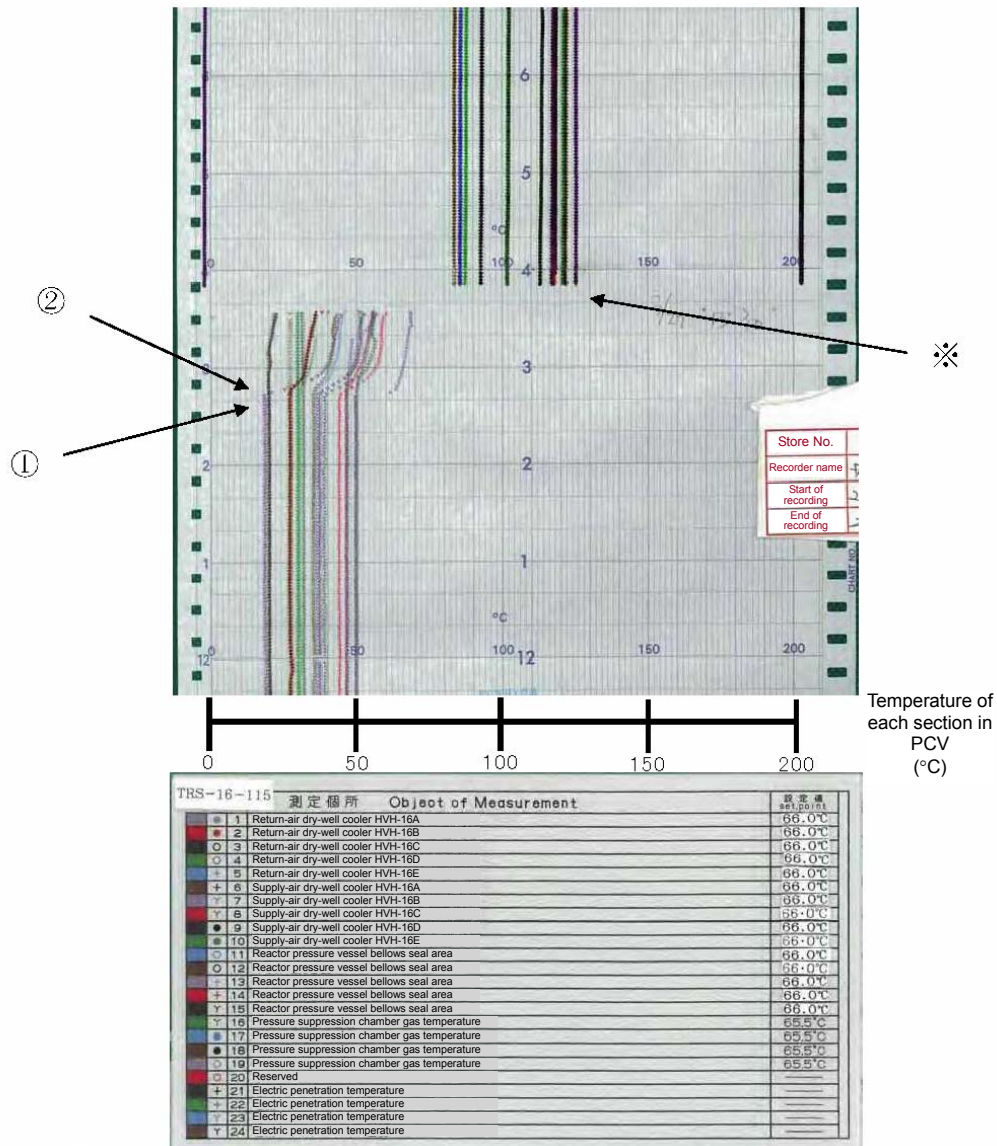
Fig. 2.1-4-2 Temperature of each section in Unit 2's primary containment vessel

- (1) 14:47 Scram due to the earthquake  
 (2) Temperature rise of the PCV because the containment air handling system stopped due to loss of power (no excessive rise in temperature attributable to piping rupture, and such like was observed).  
 \*It is assumed that the tsunami arrived after 15:30. It is also assumed that an accurate indication was not shown due to the effect of the tsunami. However, the recorder continued recording for a while after that because there was a DC power supply.

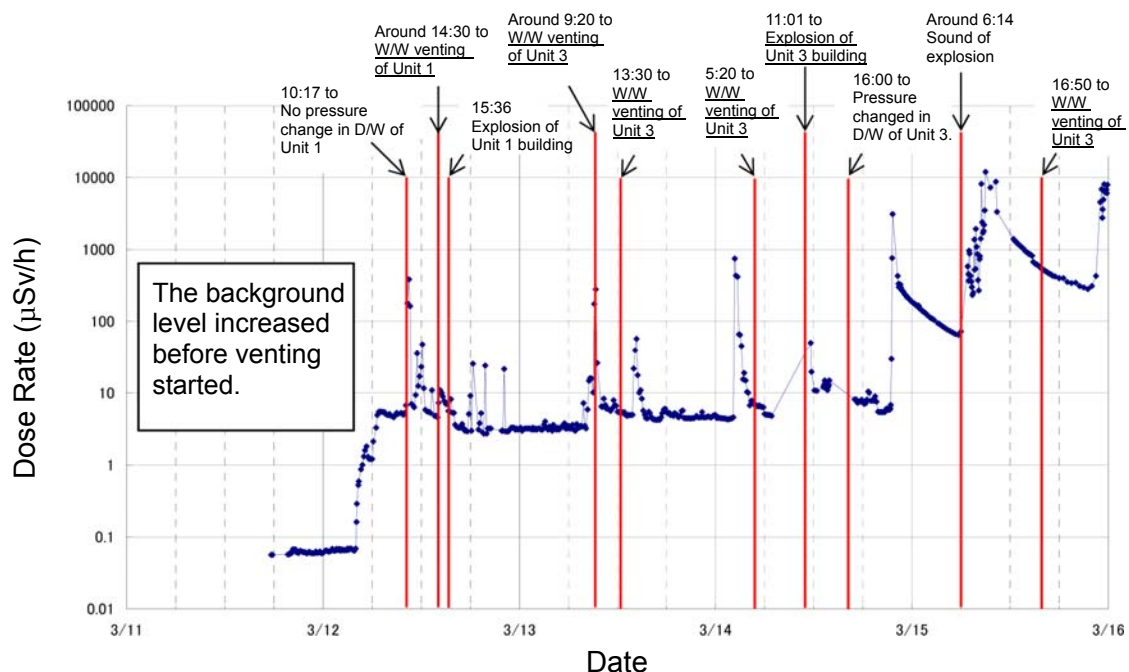
**Fig. 2.8-1 Fukushima Daiichi Nuclear Power Station Fukushima Daiichi Nuclear Power Station Nuclear Power Plant Dose Rate in the Vicinity of Main Gate**

For the dose rate, no big change in the background level before and after these vent operations was observed. However, from 4:00 to 7:00 on March 12, the dose rate increased. In addition, around 6:14 on March 15, the sound of an explosion was confirmed, and the background level of the dose rate increased before and after it.

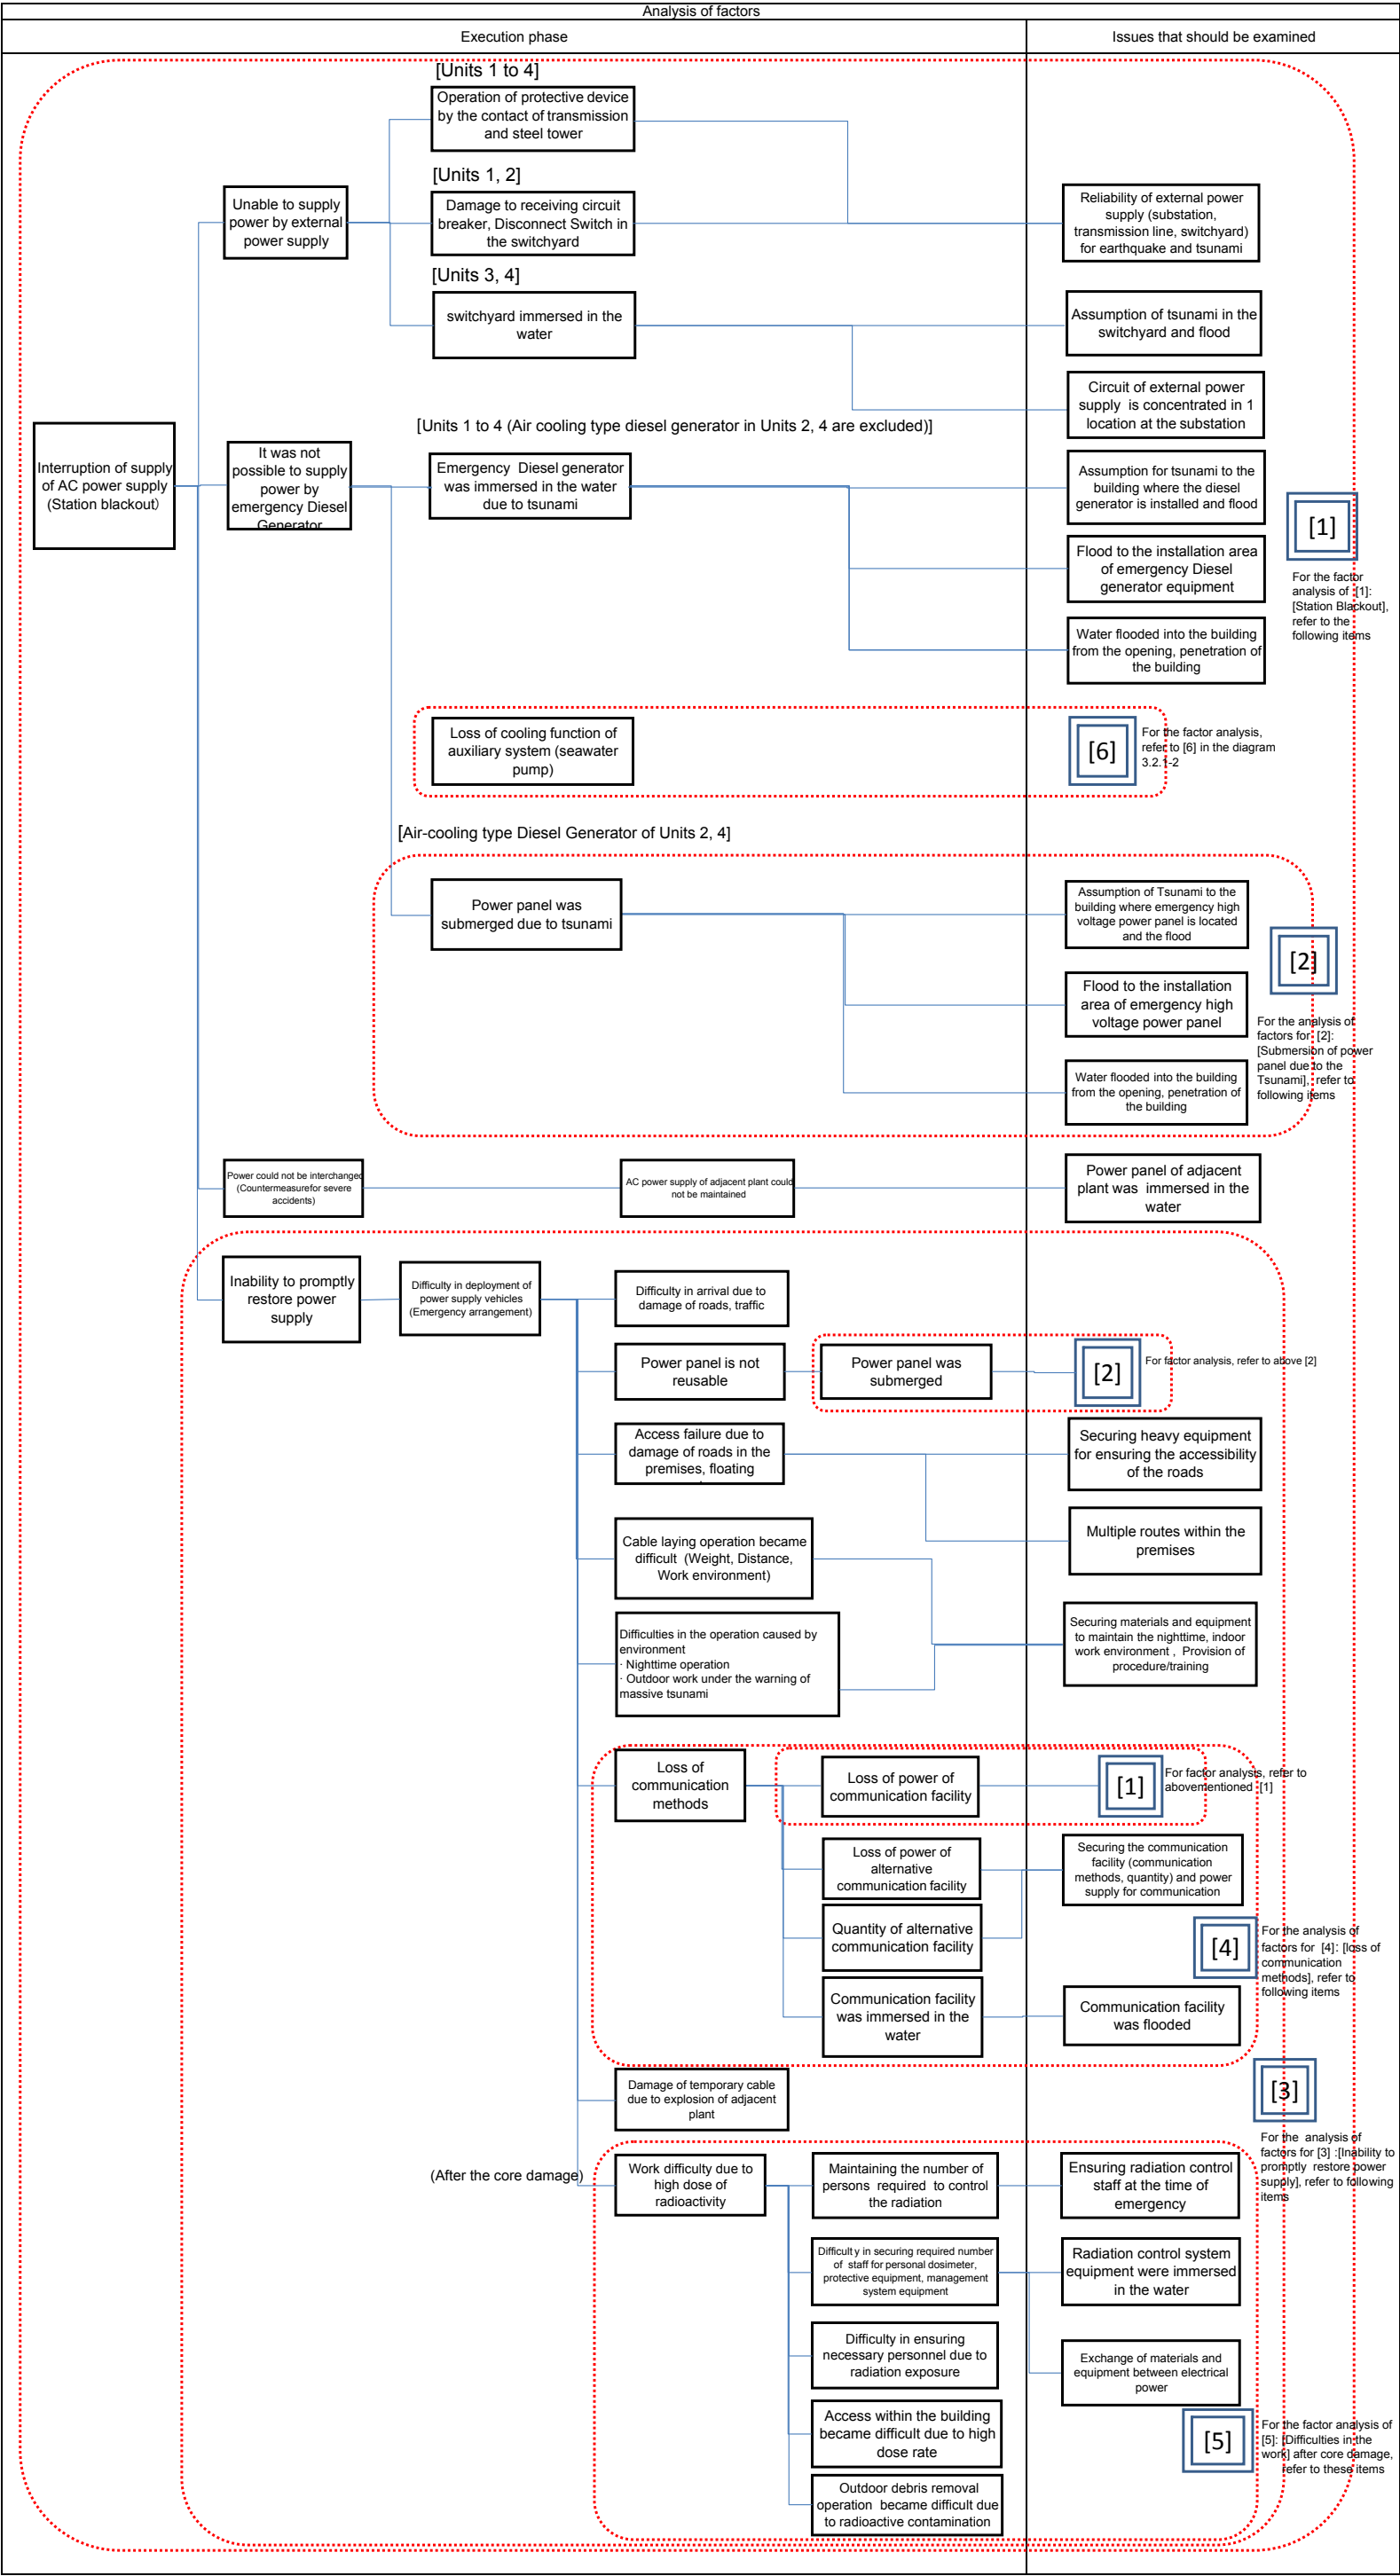
Figure 3.2.1-1 Analysis of causes for interruption of AC power supply

The AC power could not be supplied to the equipment and for operation for reasons including the inability to supply power from the external source, inability to supply power with an emergency DG, inability to jointly use power supply and inability to restore power supply at early stage.

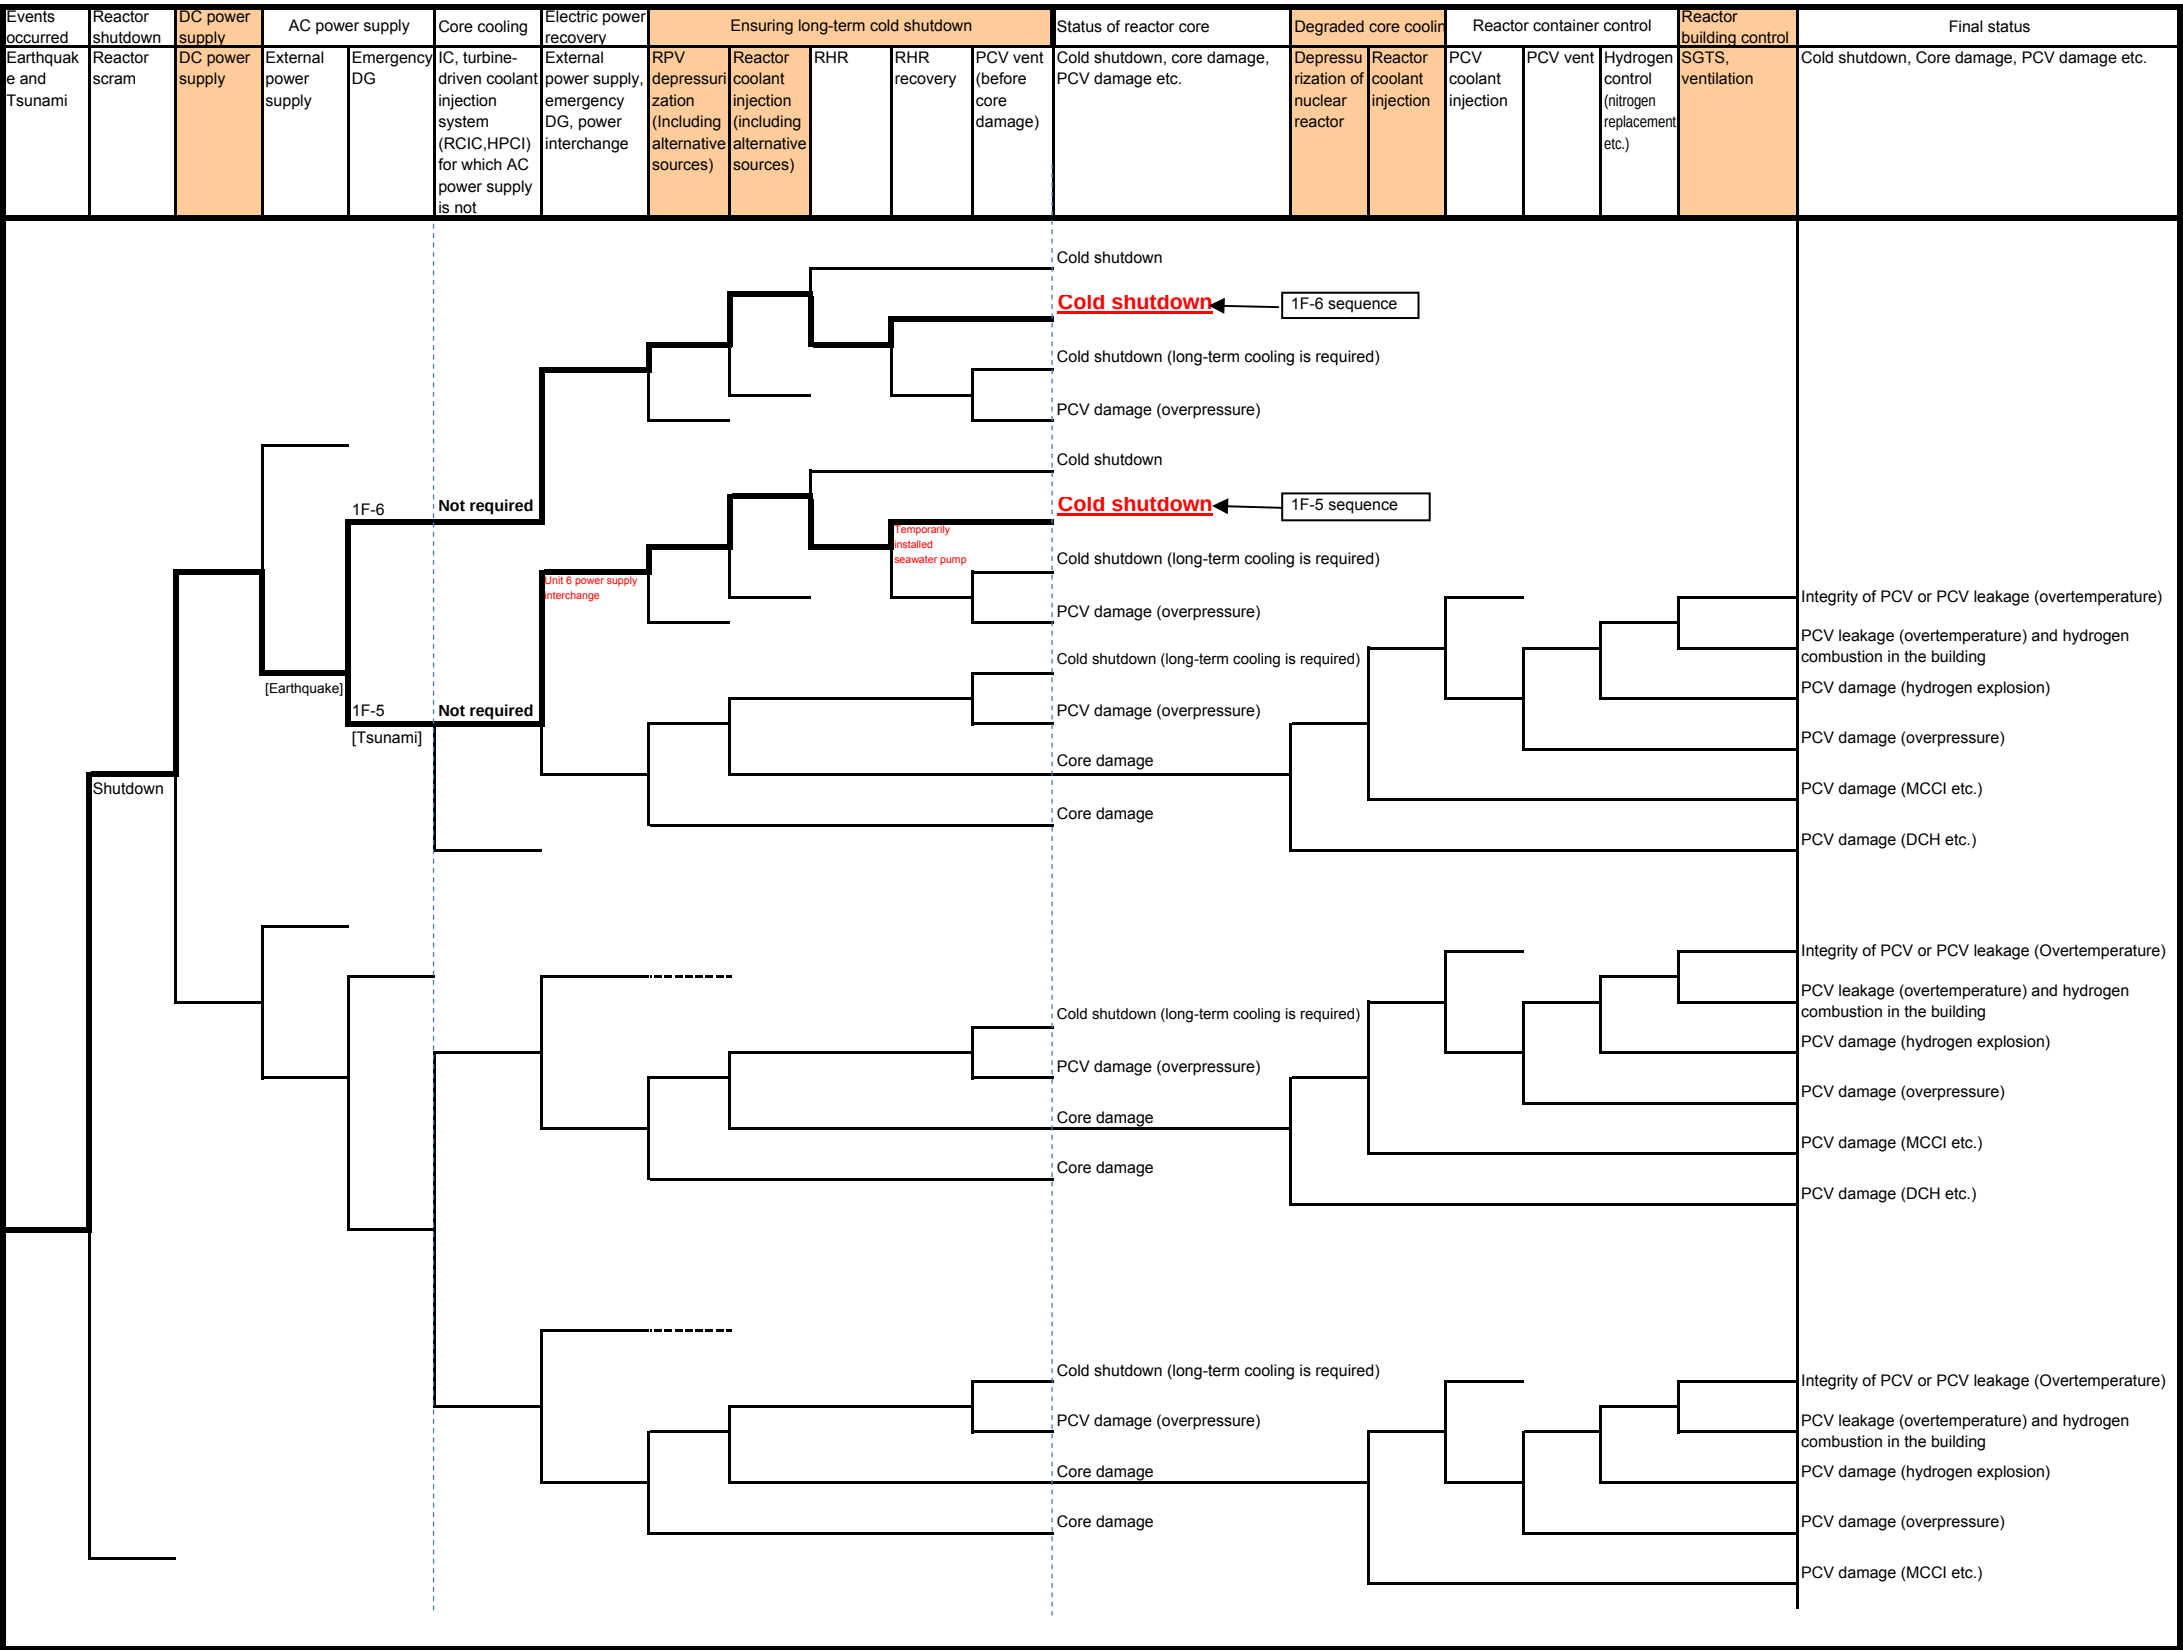
Figure 3.5-1 Disaster identification events tree in Fukushima Daiichi Nuclear Power Station Units 5, 6

However, it should be kept in mind that there was a need to supply power by directly drawing a cable from a bus of the emergency DG to the safety component because the power panel was affected by the tsunami. Because the distribution of electricity to multiple safety components will be simultaneously lost when the power panel is submerged, it is necessary to investigate a plan for supplying power to the necessary components from the available power supplies even when soaking occurs, while ensuring soaking countermeasures in order to increase the security of the dependable power supply.
