# **Examination of Accident at Tokyo Electric Power Co., Inc.'s Fukushima Daiichi Nuclear Power Station and Proposal of Countermeasures**

**October 2011**

**Japan Nuclear Technology Institute**

**Examination Committee on Accident at Fukushima Daiichi Nuclear  
Power Station**

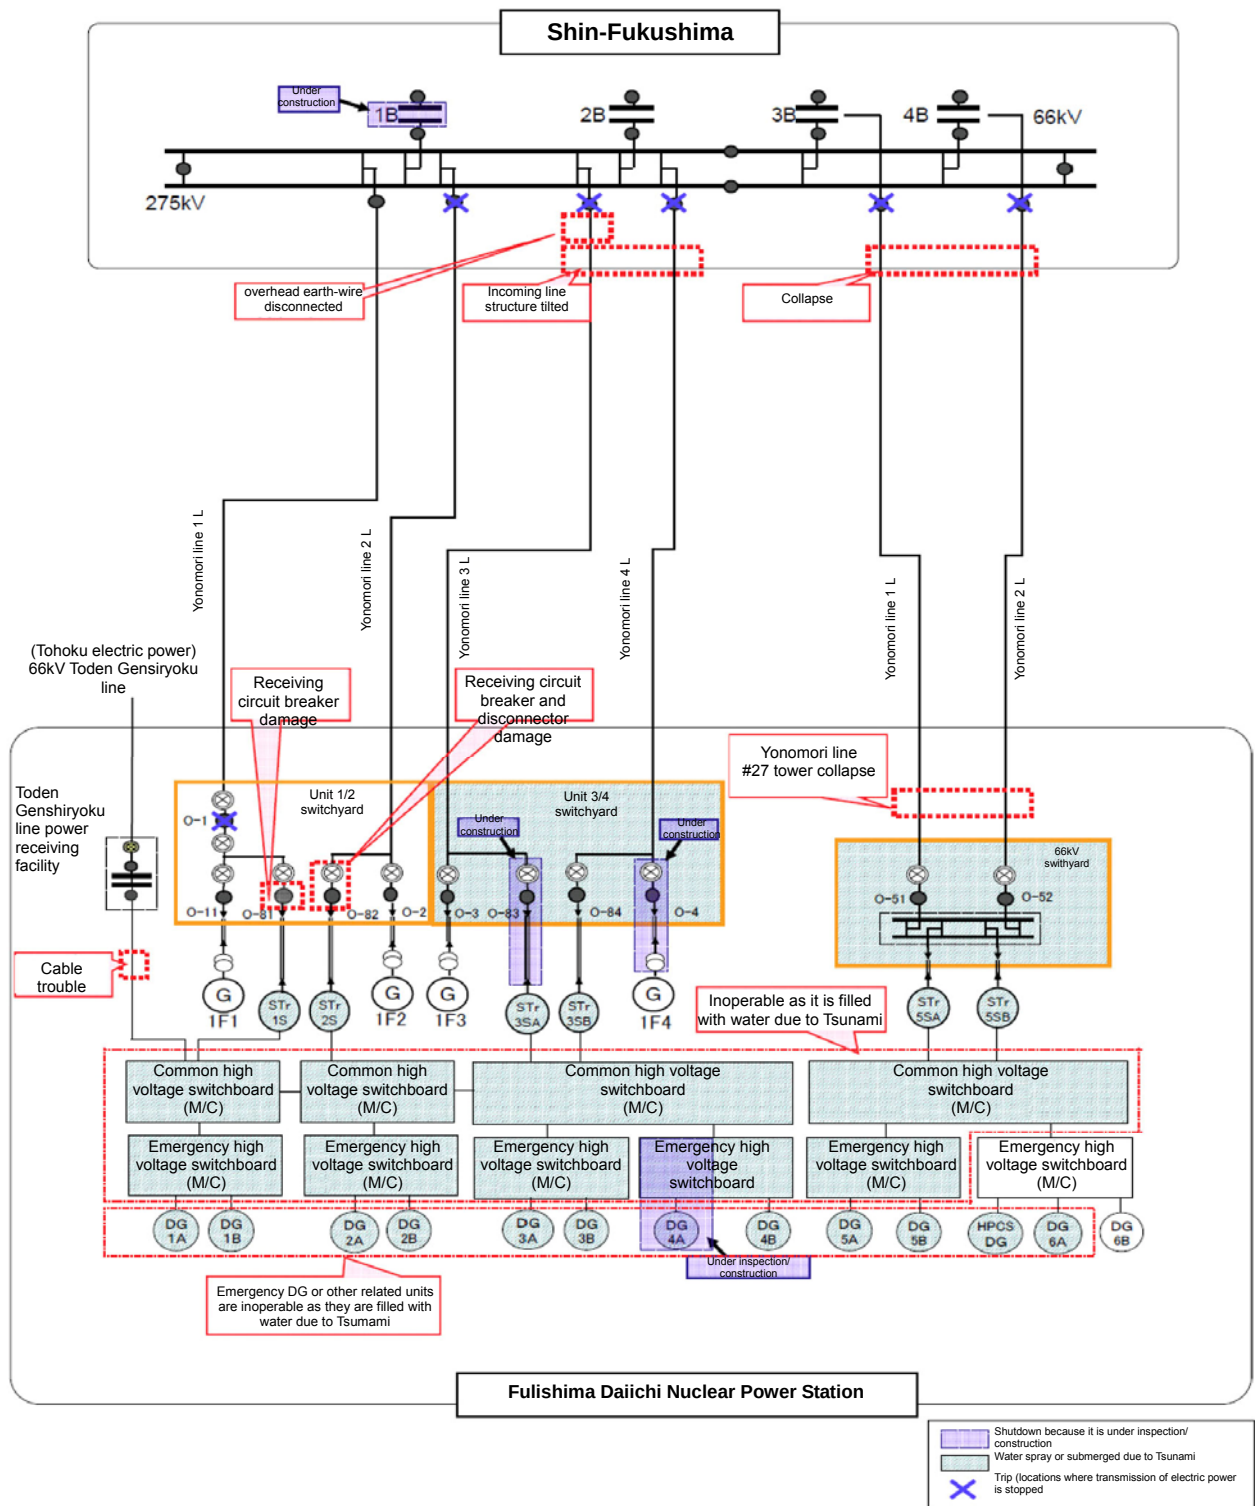
Figure 2.1-2 Outline figure of external power supply control system (after earthquake, before tsunami)

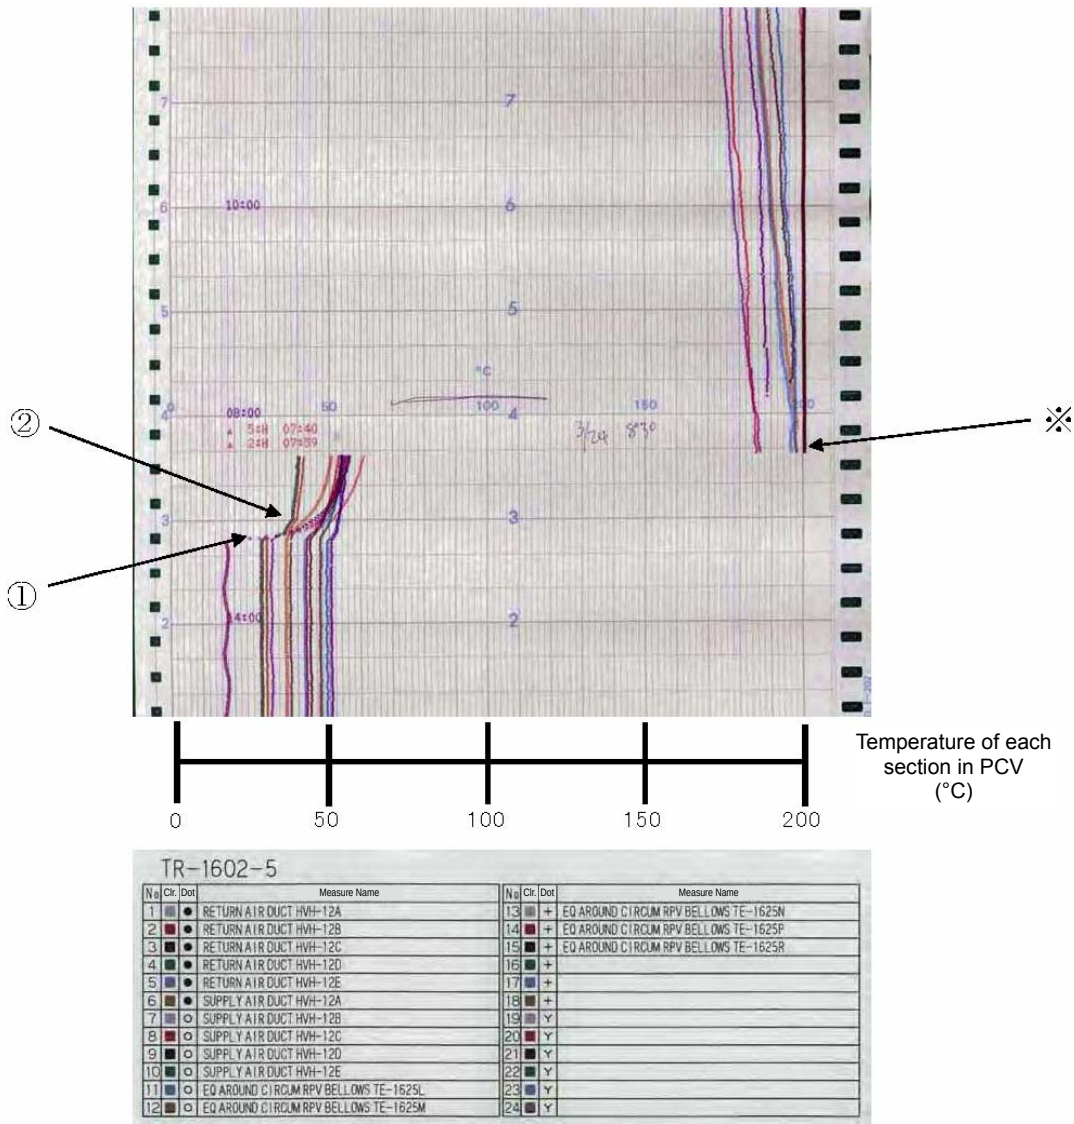
Fig. 2.1-4-1 Temperature of each section in Unit 1's primary containment vessel

- (1) 14:46 Scram due to the earthquake  
 (2) Temperature rise of the PCV because the containment air handling system stopped due to loss of power (no excessive rise in temperature attributable to piping rupture, and such like was observed).  
 \* After 15:30, the recorder power was lost due to arrival of the tsunami and the recorder once stopped. Recording was resumed after the recorder power was restored on March

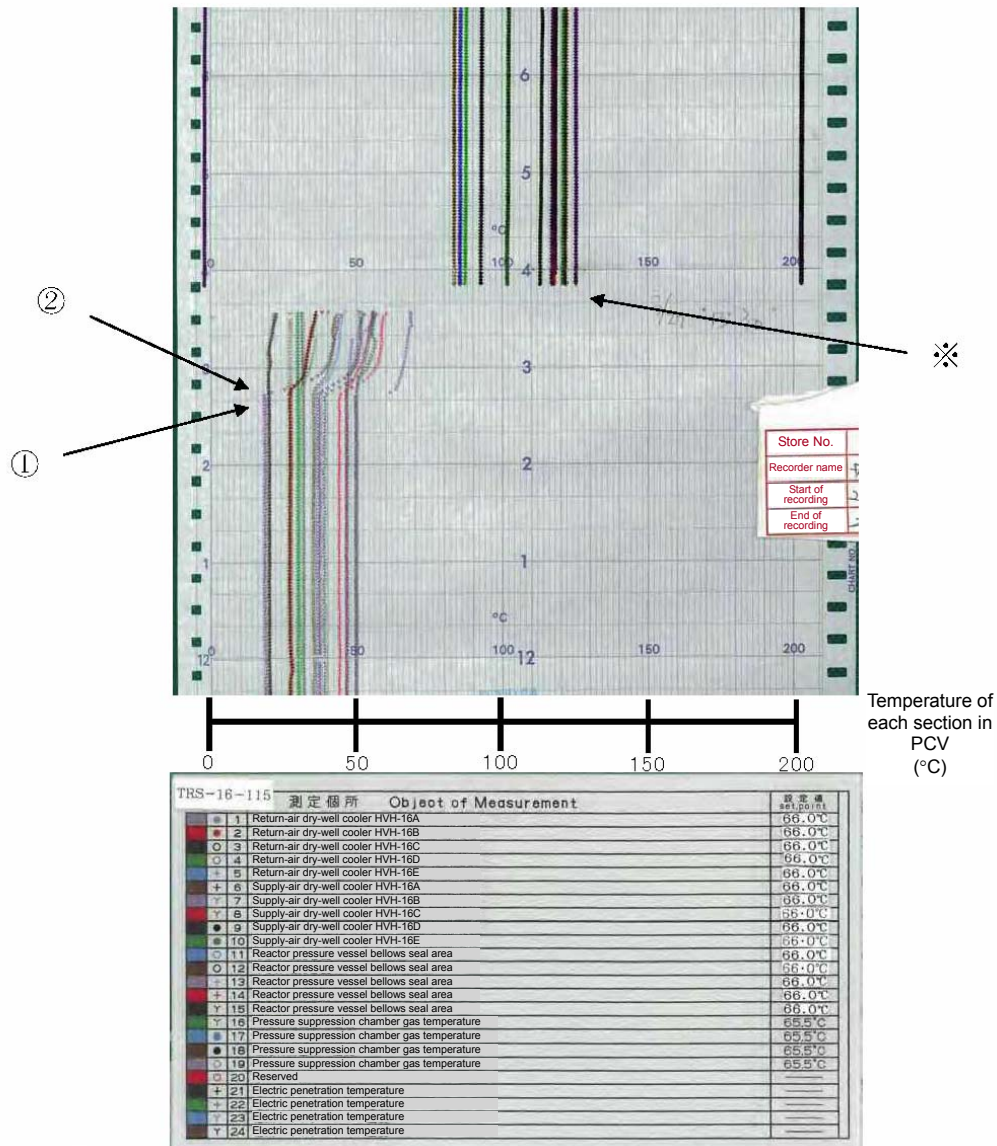
Fig. 2.1-4-2 Temperature of each section in Unit 2's primary containment vessel

- (1) 14:47 Scram due to the earthquake  
 (2) Temperature rise of the PCV because the containment air handling system stopped due to loss of power (no excessive rise in temperature attributable to piping rupture, and such like was observed).  
 \*It is assumed that the tsunami arrived after 15:30. It is also assumed that an accurate indication was not shown due to the effect of the tsunami. However, the recorder continued recording for a while after that because there was a DC power supply.

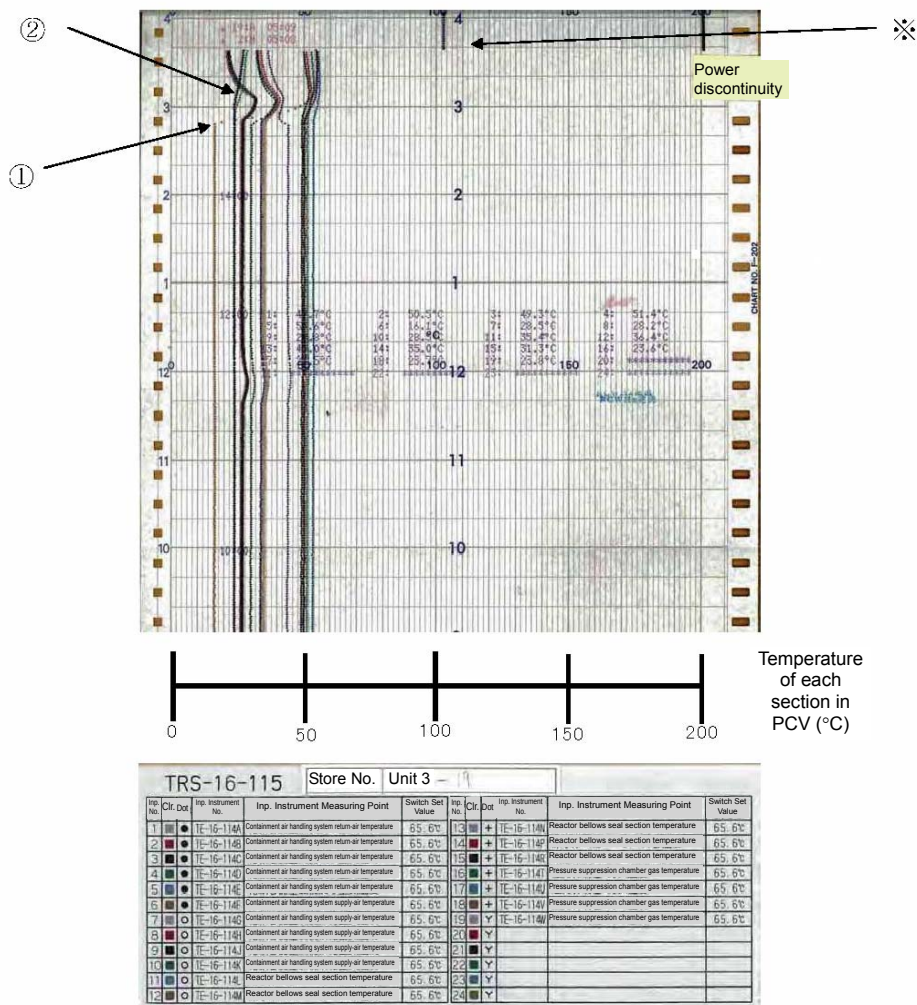
Fig. 2.1-4-3 Temperature of each section in Unit 3's primary containment vessel

- (1) 14:47 Scram due to the earthquake
- (2) Temperature change in the containment vessel because the containment air handling system stopped due to loss of power and the power decreased due to a scram (no excessive rise in temperature attributable to piping rupture, and such like was observed).
- \* After 15:30, it is considered that the recorder power was lost due to arrival of the tsunami and the recorder once stopped.

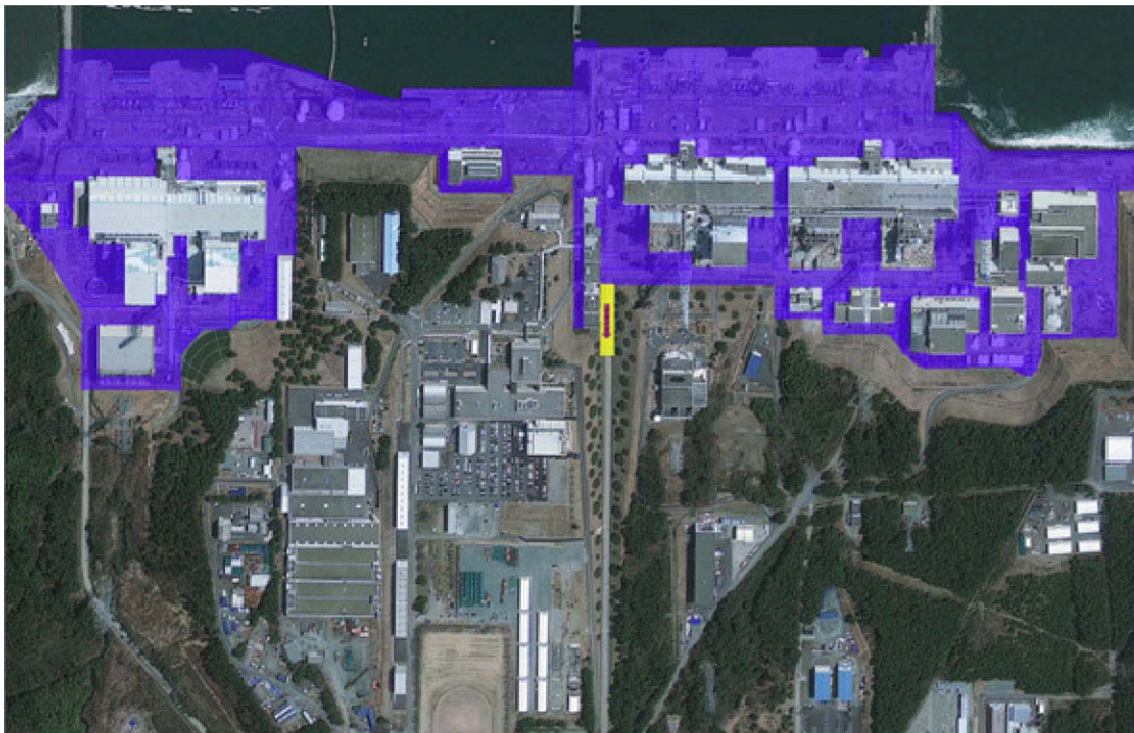
Figure 2.1-4 Extent of flooding within the power plant

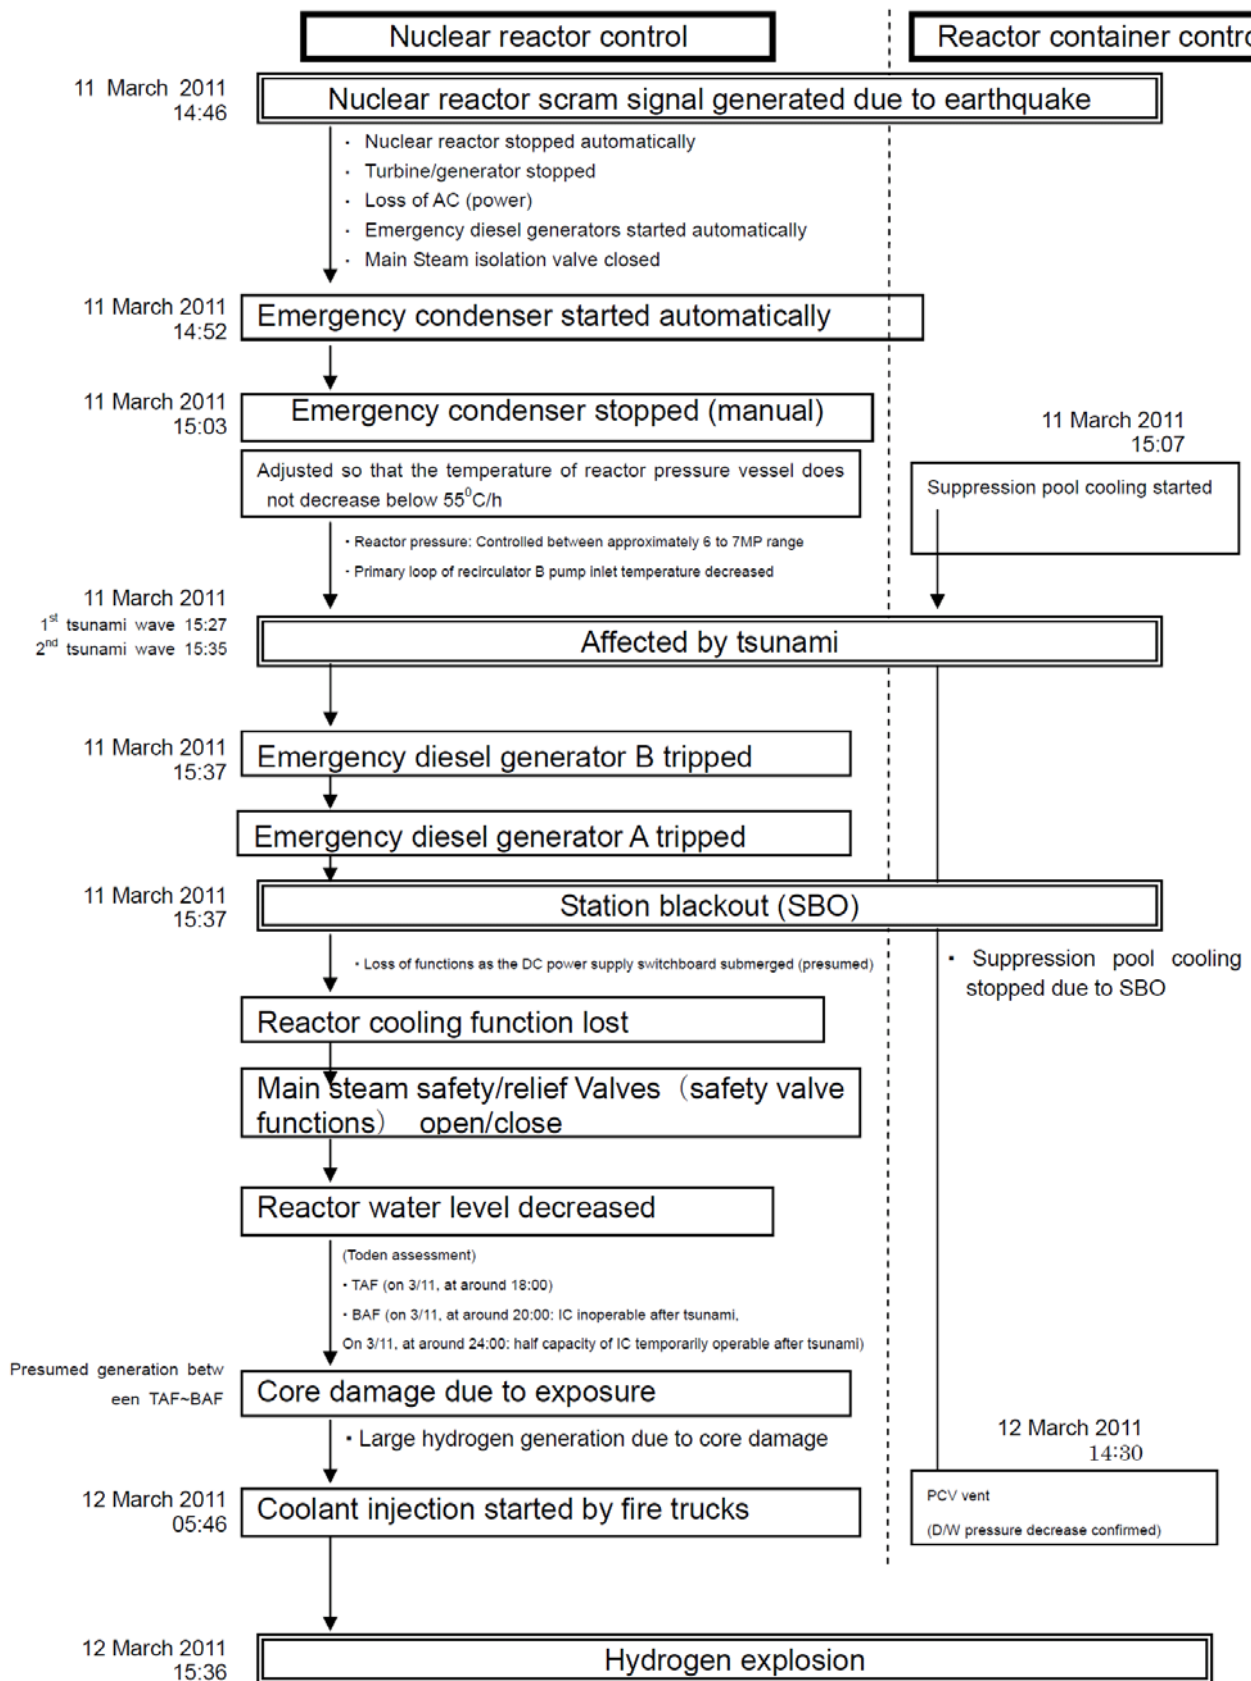
**Figure 2.2-1 Course of accident after earthquake at Unit 1 of the Fukushima Daiichi Nuclear Power Station**

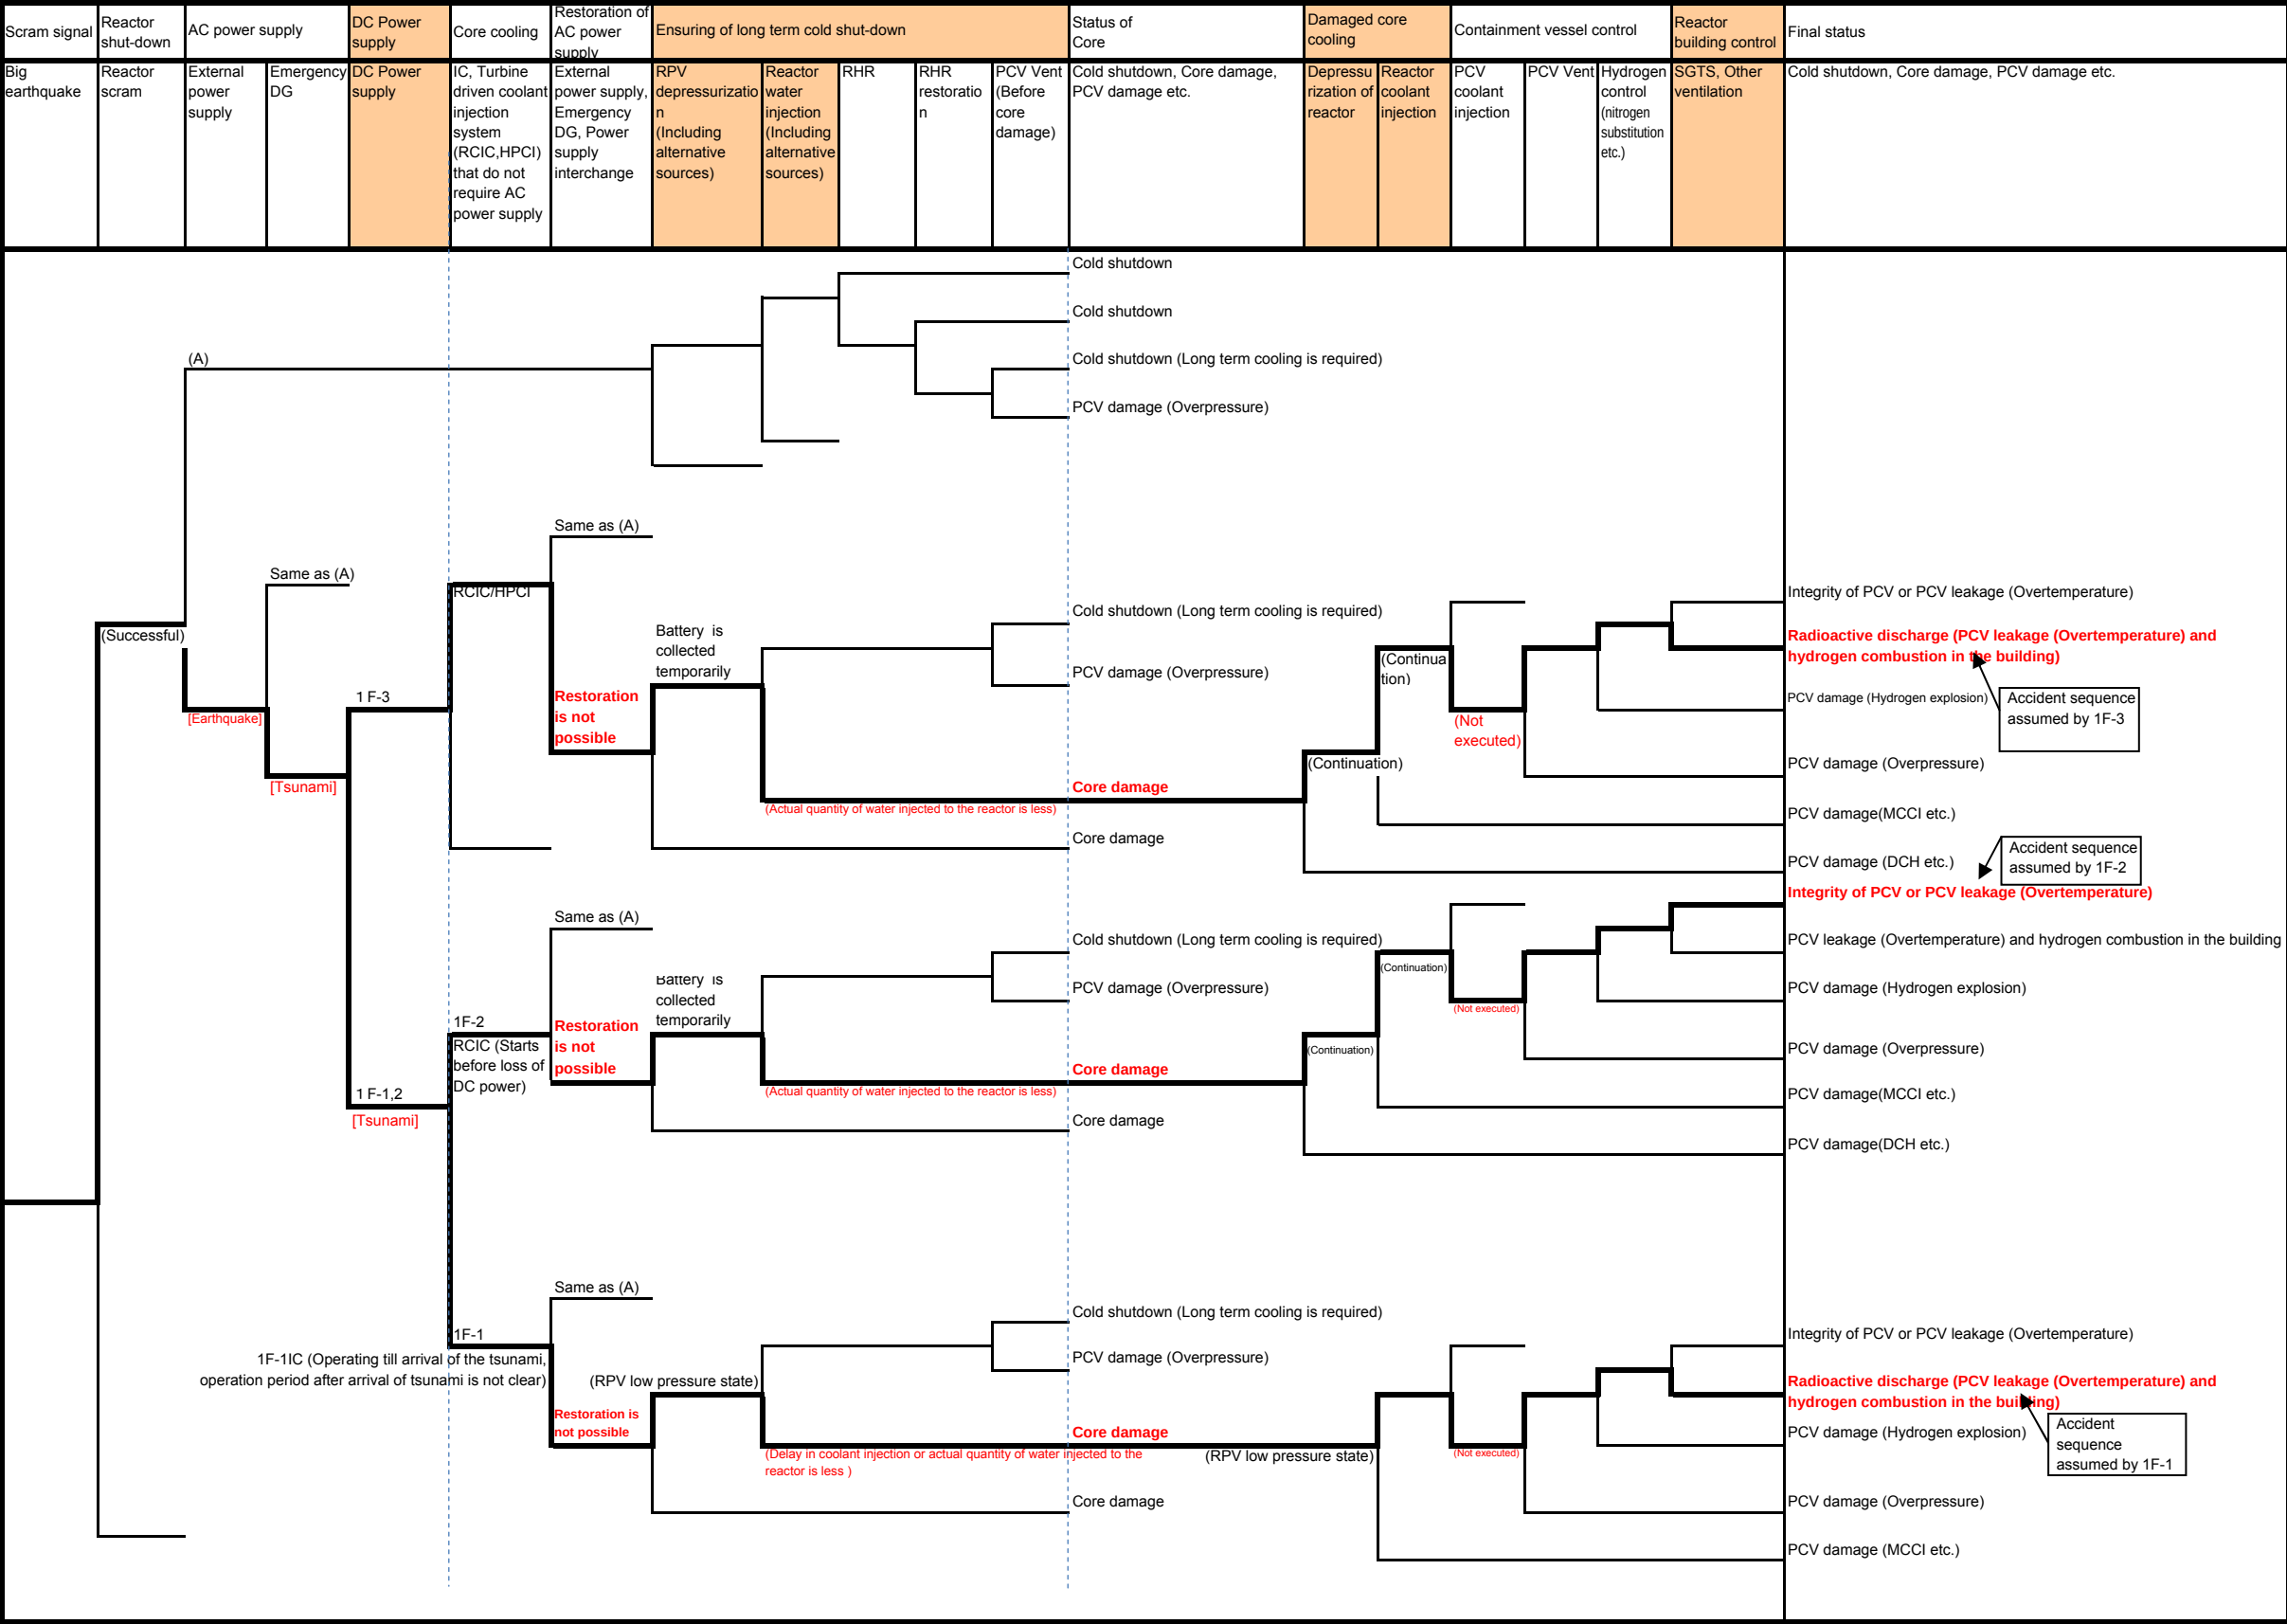
Unit 6 (under suspension for periodical inspection) was in a state of cold shutdown with all fuels being loaded and the upper lid of the RPV being shut. Since external power was lost due to the earthquake three emergency DGs started to work automatically but two Units of them became inoperable because functions of the seawater pump and the power panel were lost due to attack of the tsunami. As AC power was secured with the remaining one Unit (air-cooling type), power supply for Unit 5, cooling the SFP and for the reactor was performed. The seawater pumps in the RHR line were damaged by the tsunami, but the makeshift seawater pumps were used for the RHR and the reactor well was cooled by the RHR line. With this, the reactor returned to the state of cold shutdown.

Figure 3.1-1 Disaster identification events tree in Fukushima Daiichi Nuclear Power Station, Units 1 to 3

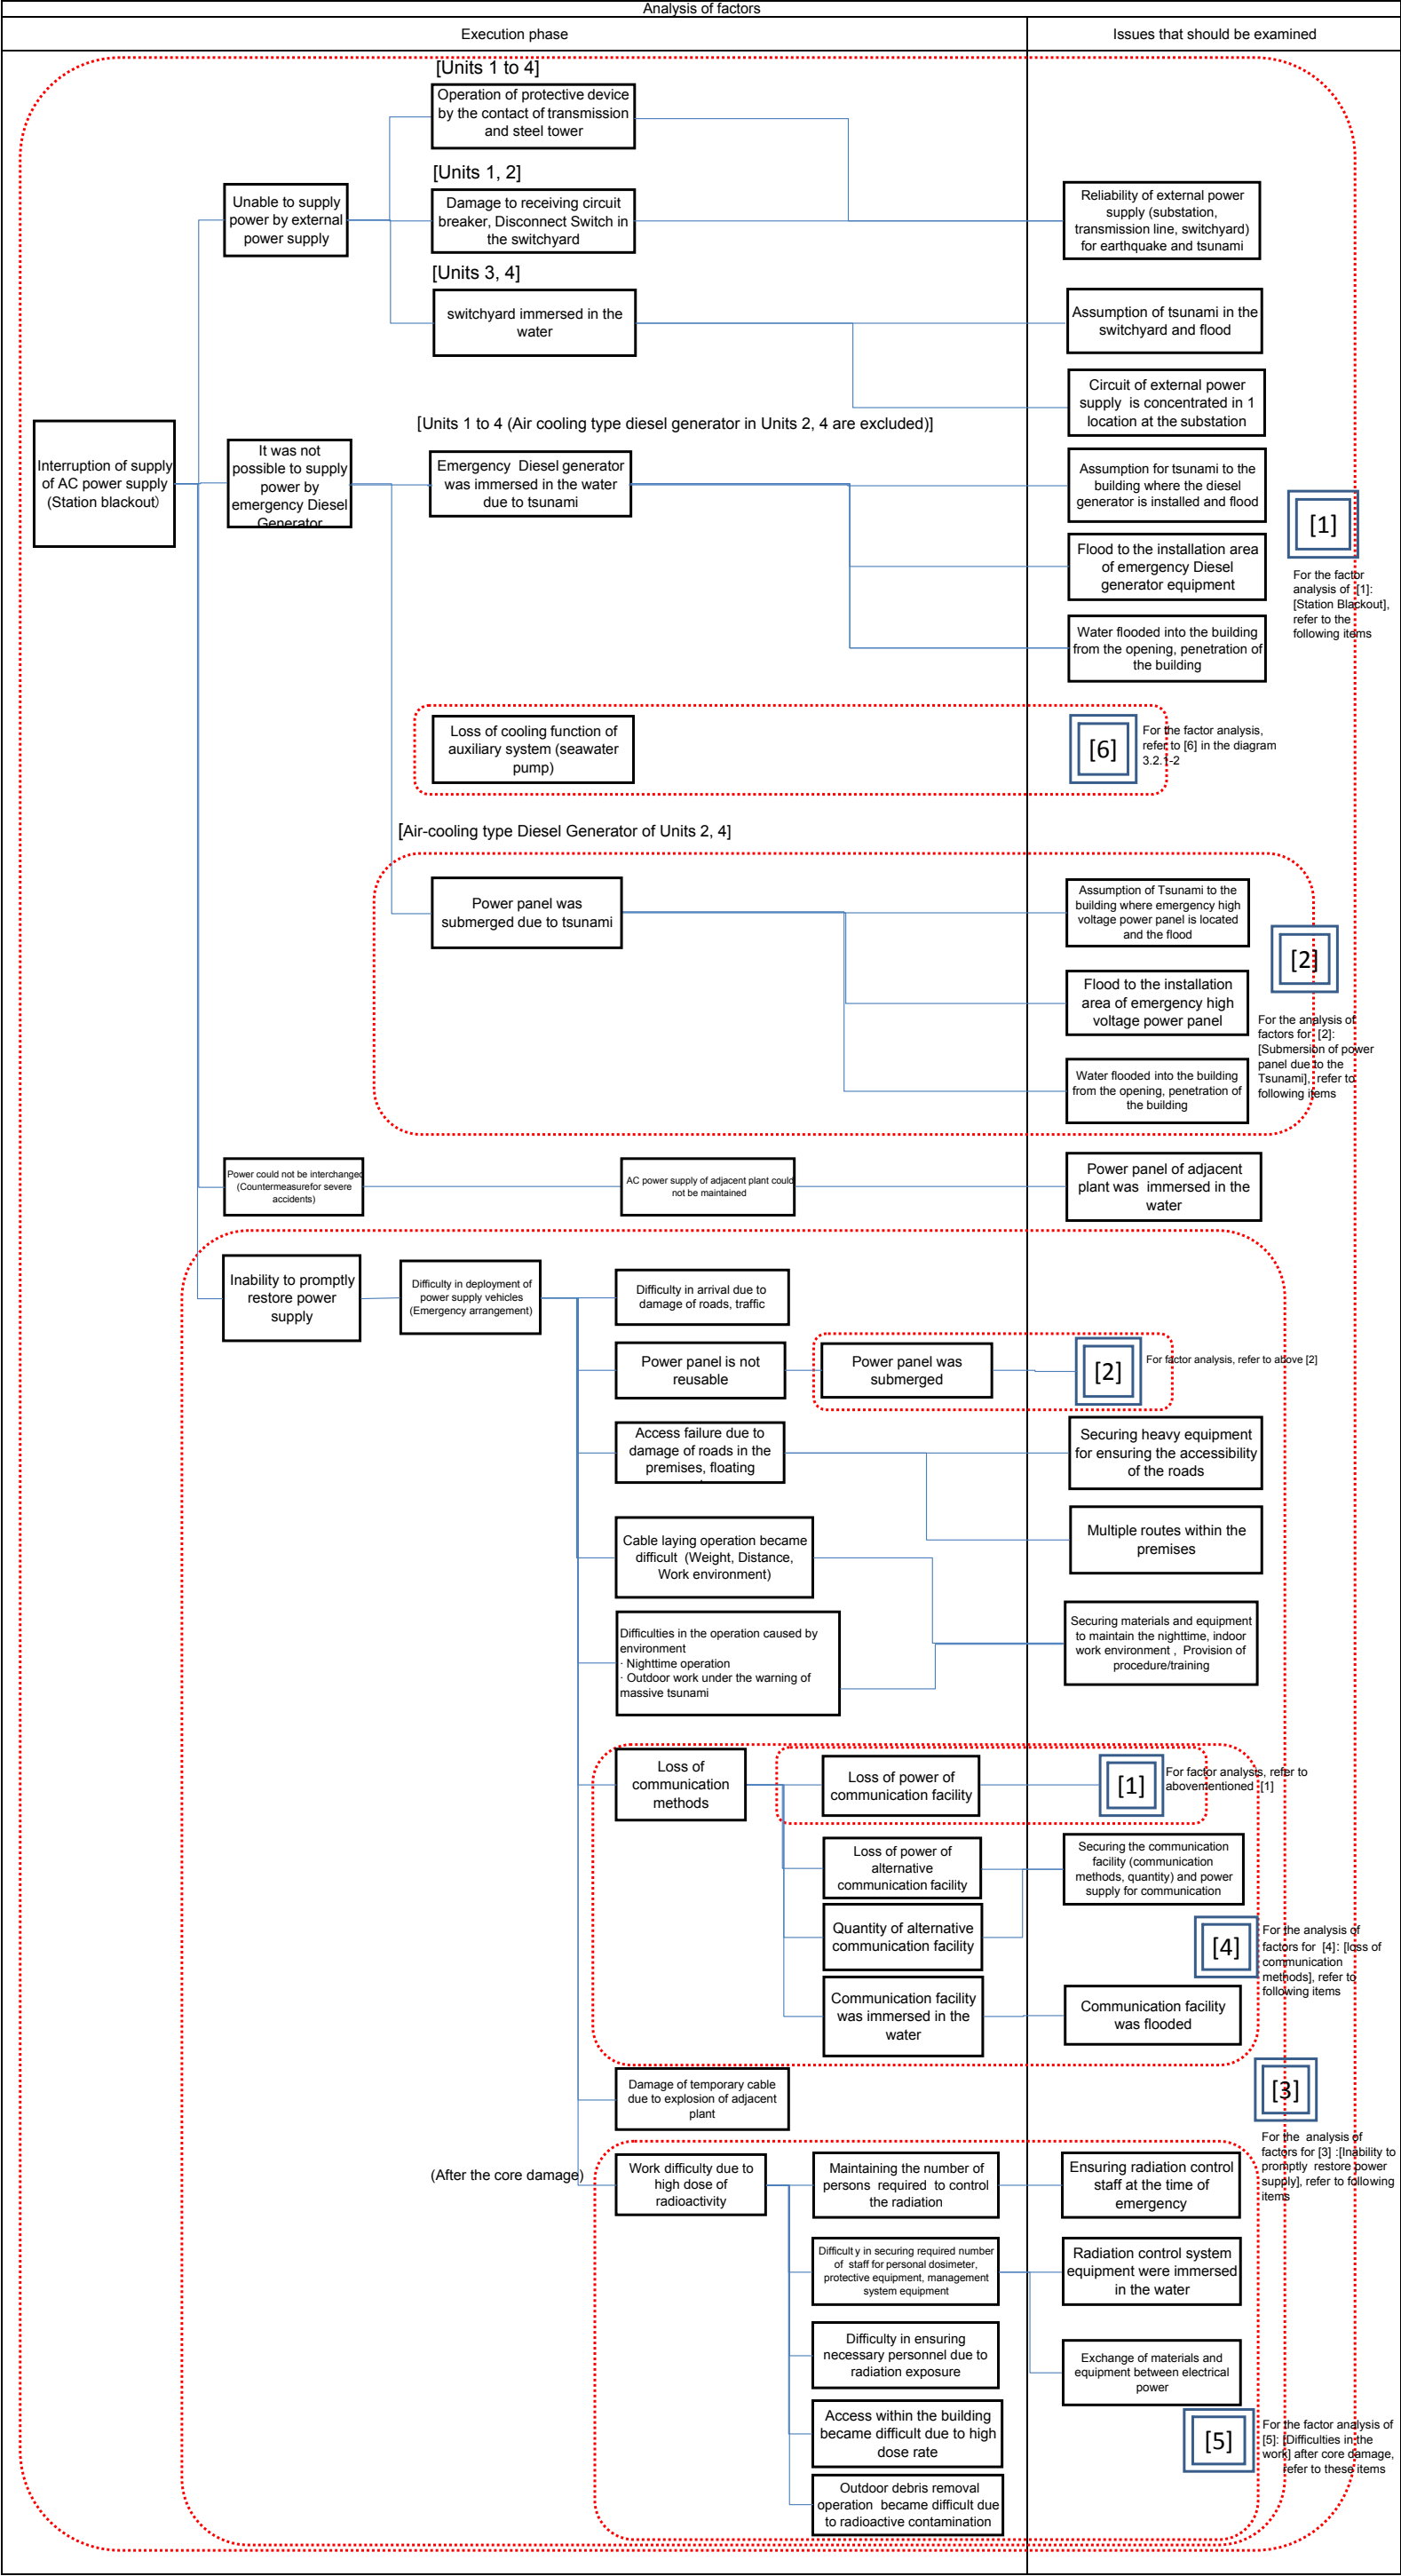
The AC power could not be supplied to the equipment and for operation for reasons including the inability to supply power from the external source, inability to supply power with an emergency DG, inability to jointly use power supply and inability to restore power supply at early stage.

Figure 3.2.1-1 Analysis of causes for interruption of AC power supply

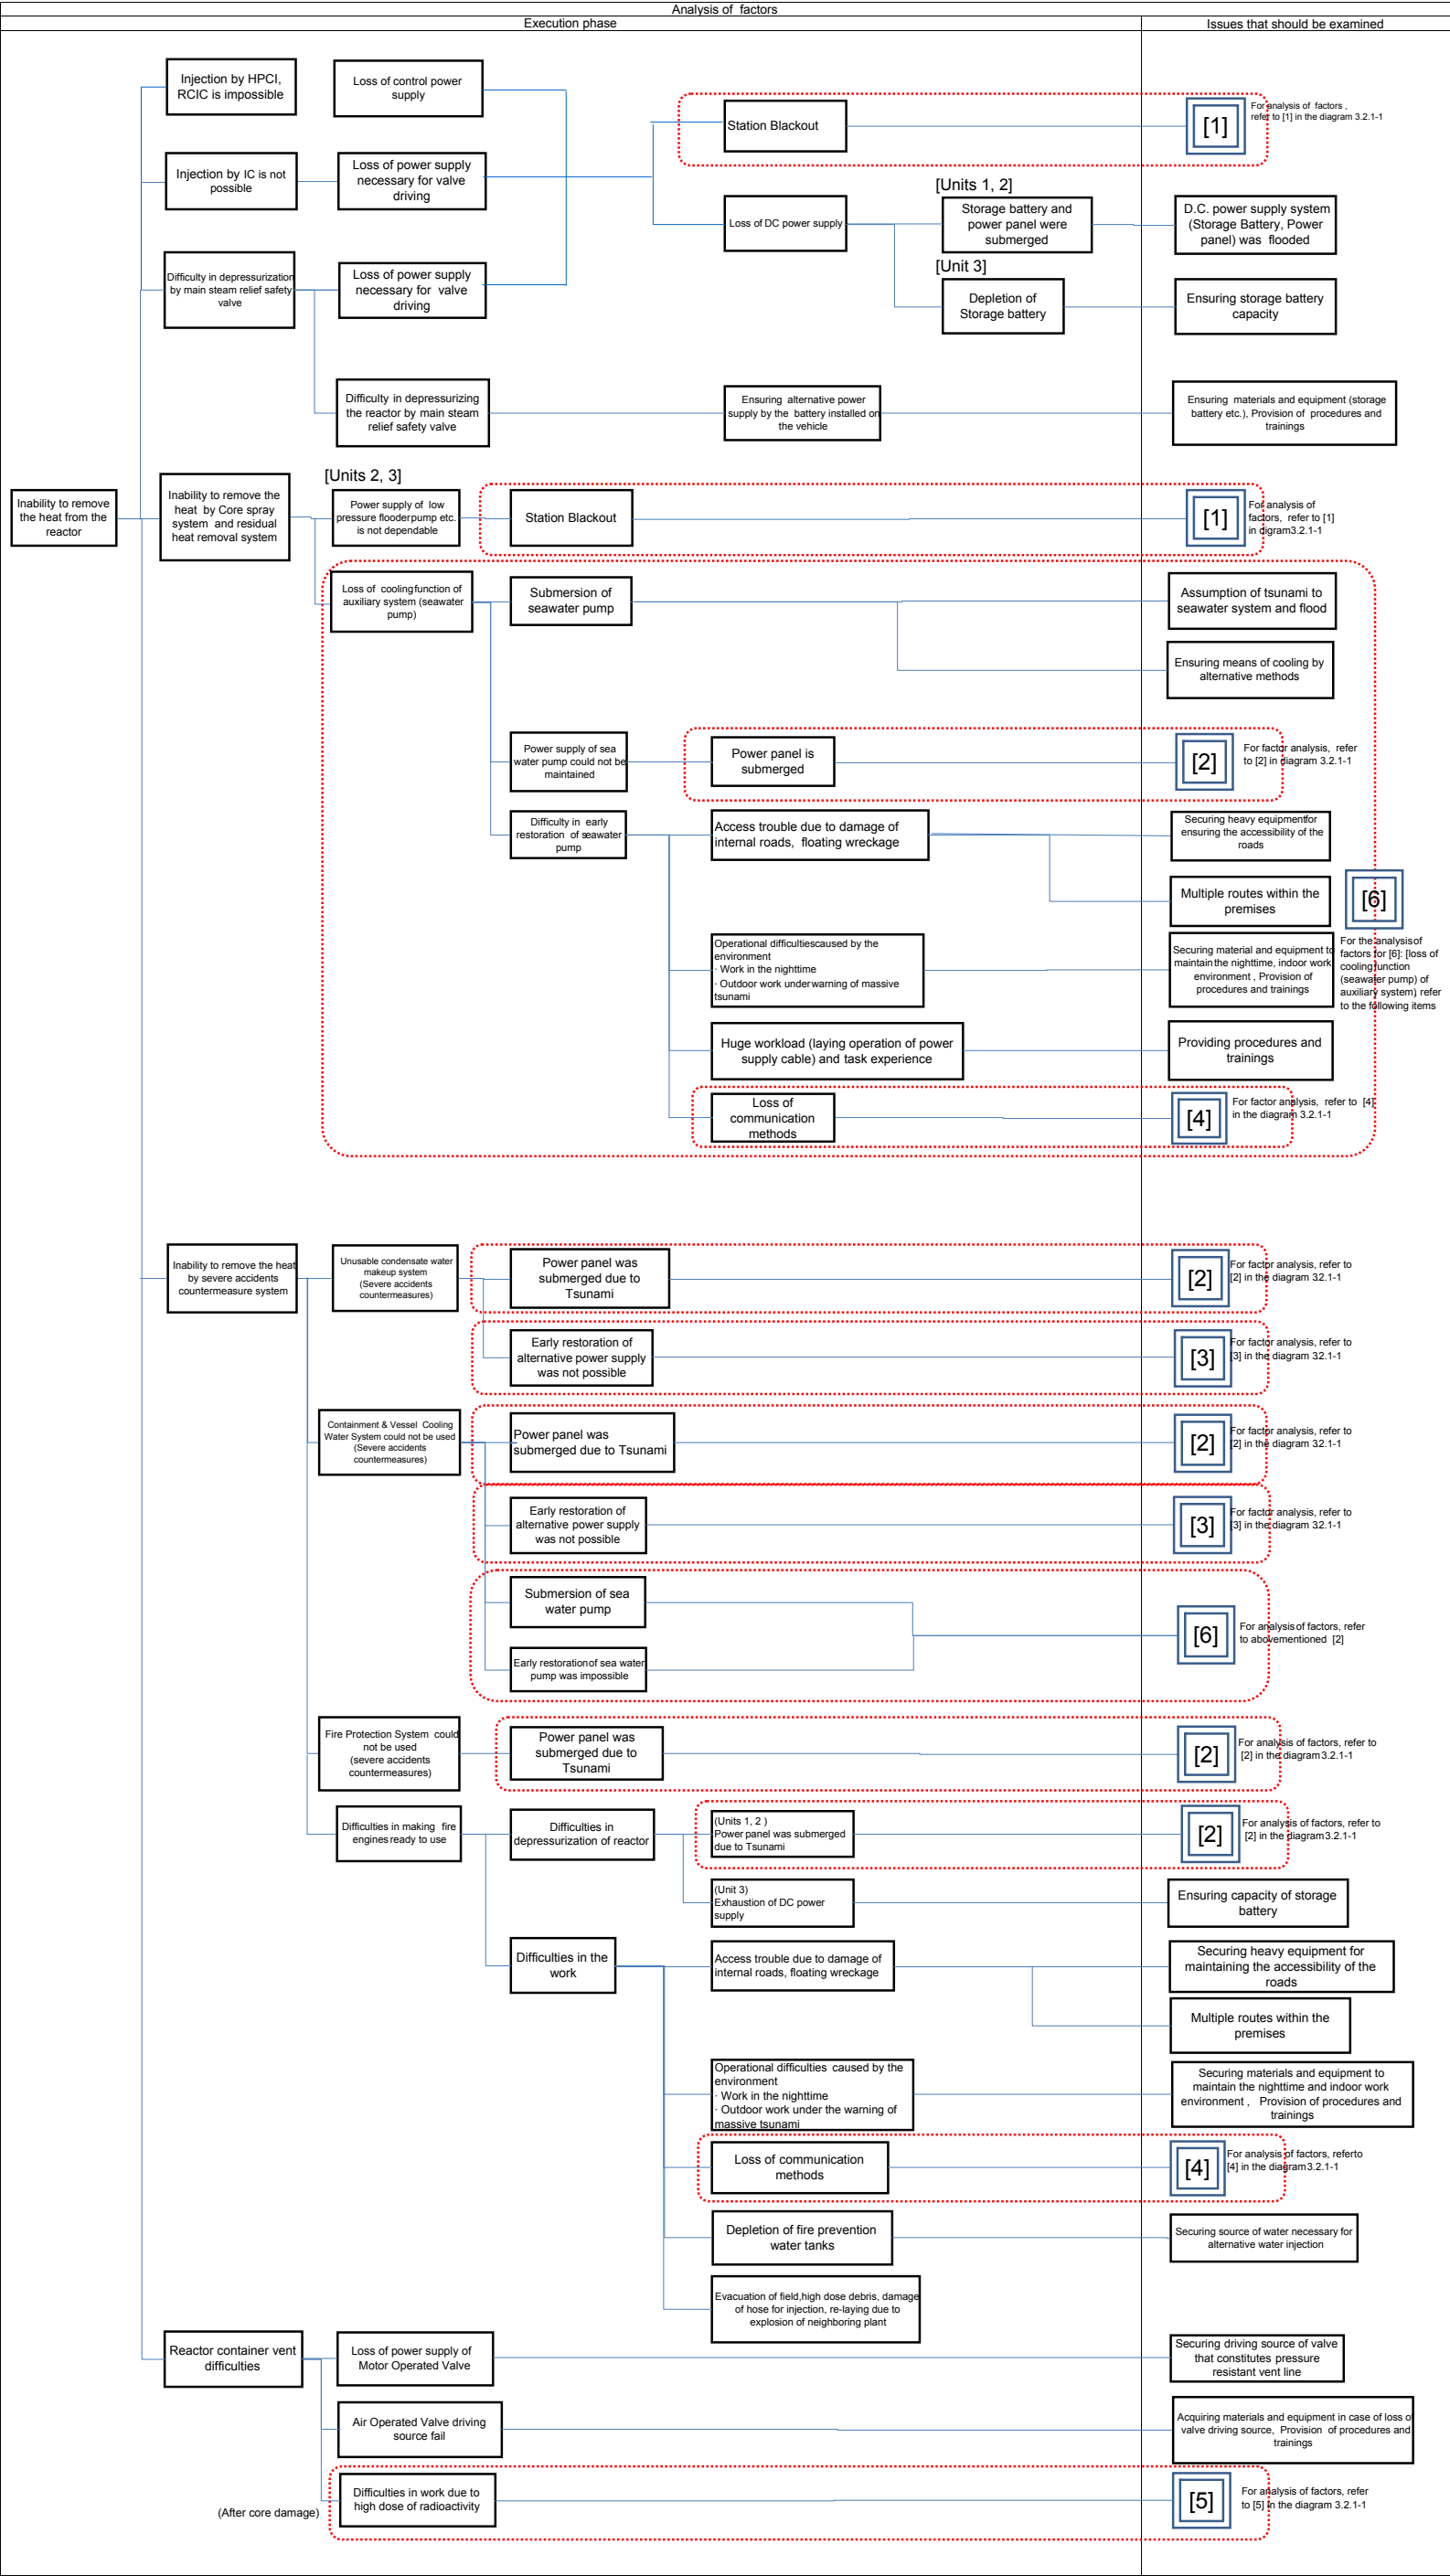
It was impossible to remove heat from the nuclear reactor from the view of the equipment and operation for the following reasons: inability to conduct decompression with SRV, inability to remove heat with CS and RHR, inability to remove heat with severe accident measure equipment (alternative water filling), and difficulty in venting containment vessel.

Figure 3.2.1-2 Analysis of causes of inability to remove heat from the reactor
