# **Examination of Accident at Tokyo Electric Power Co., Inc.'s Fukushima Daiichi Nuclear Power Station and Proposal of Countermeasures**

**October 2011**

**Japan Nuclear Technology Institute**

**Examination Committee on Accident at Fukushima Daiichi Nuclear  
Power Station**

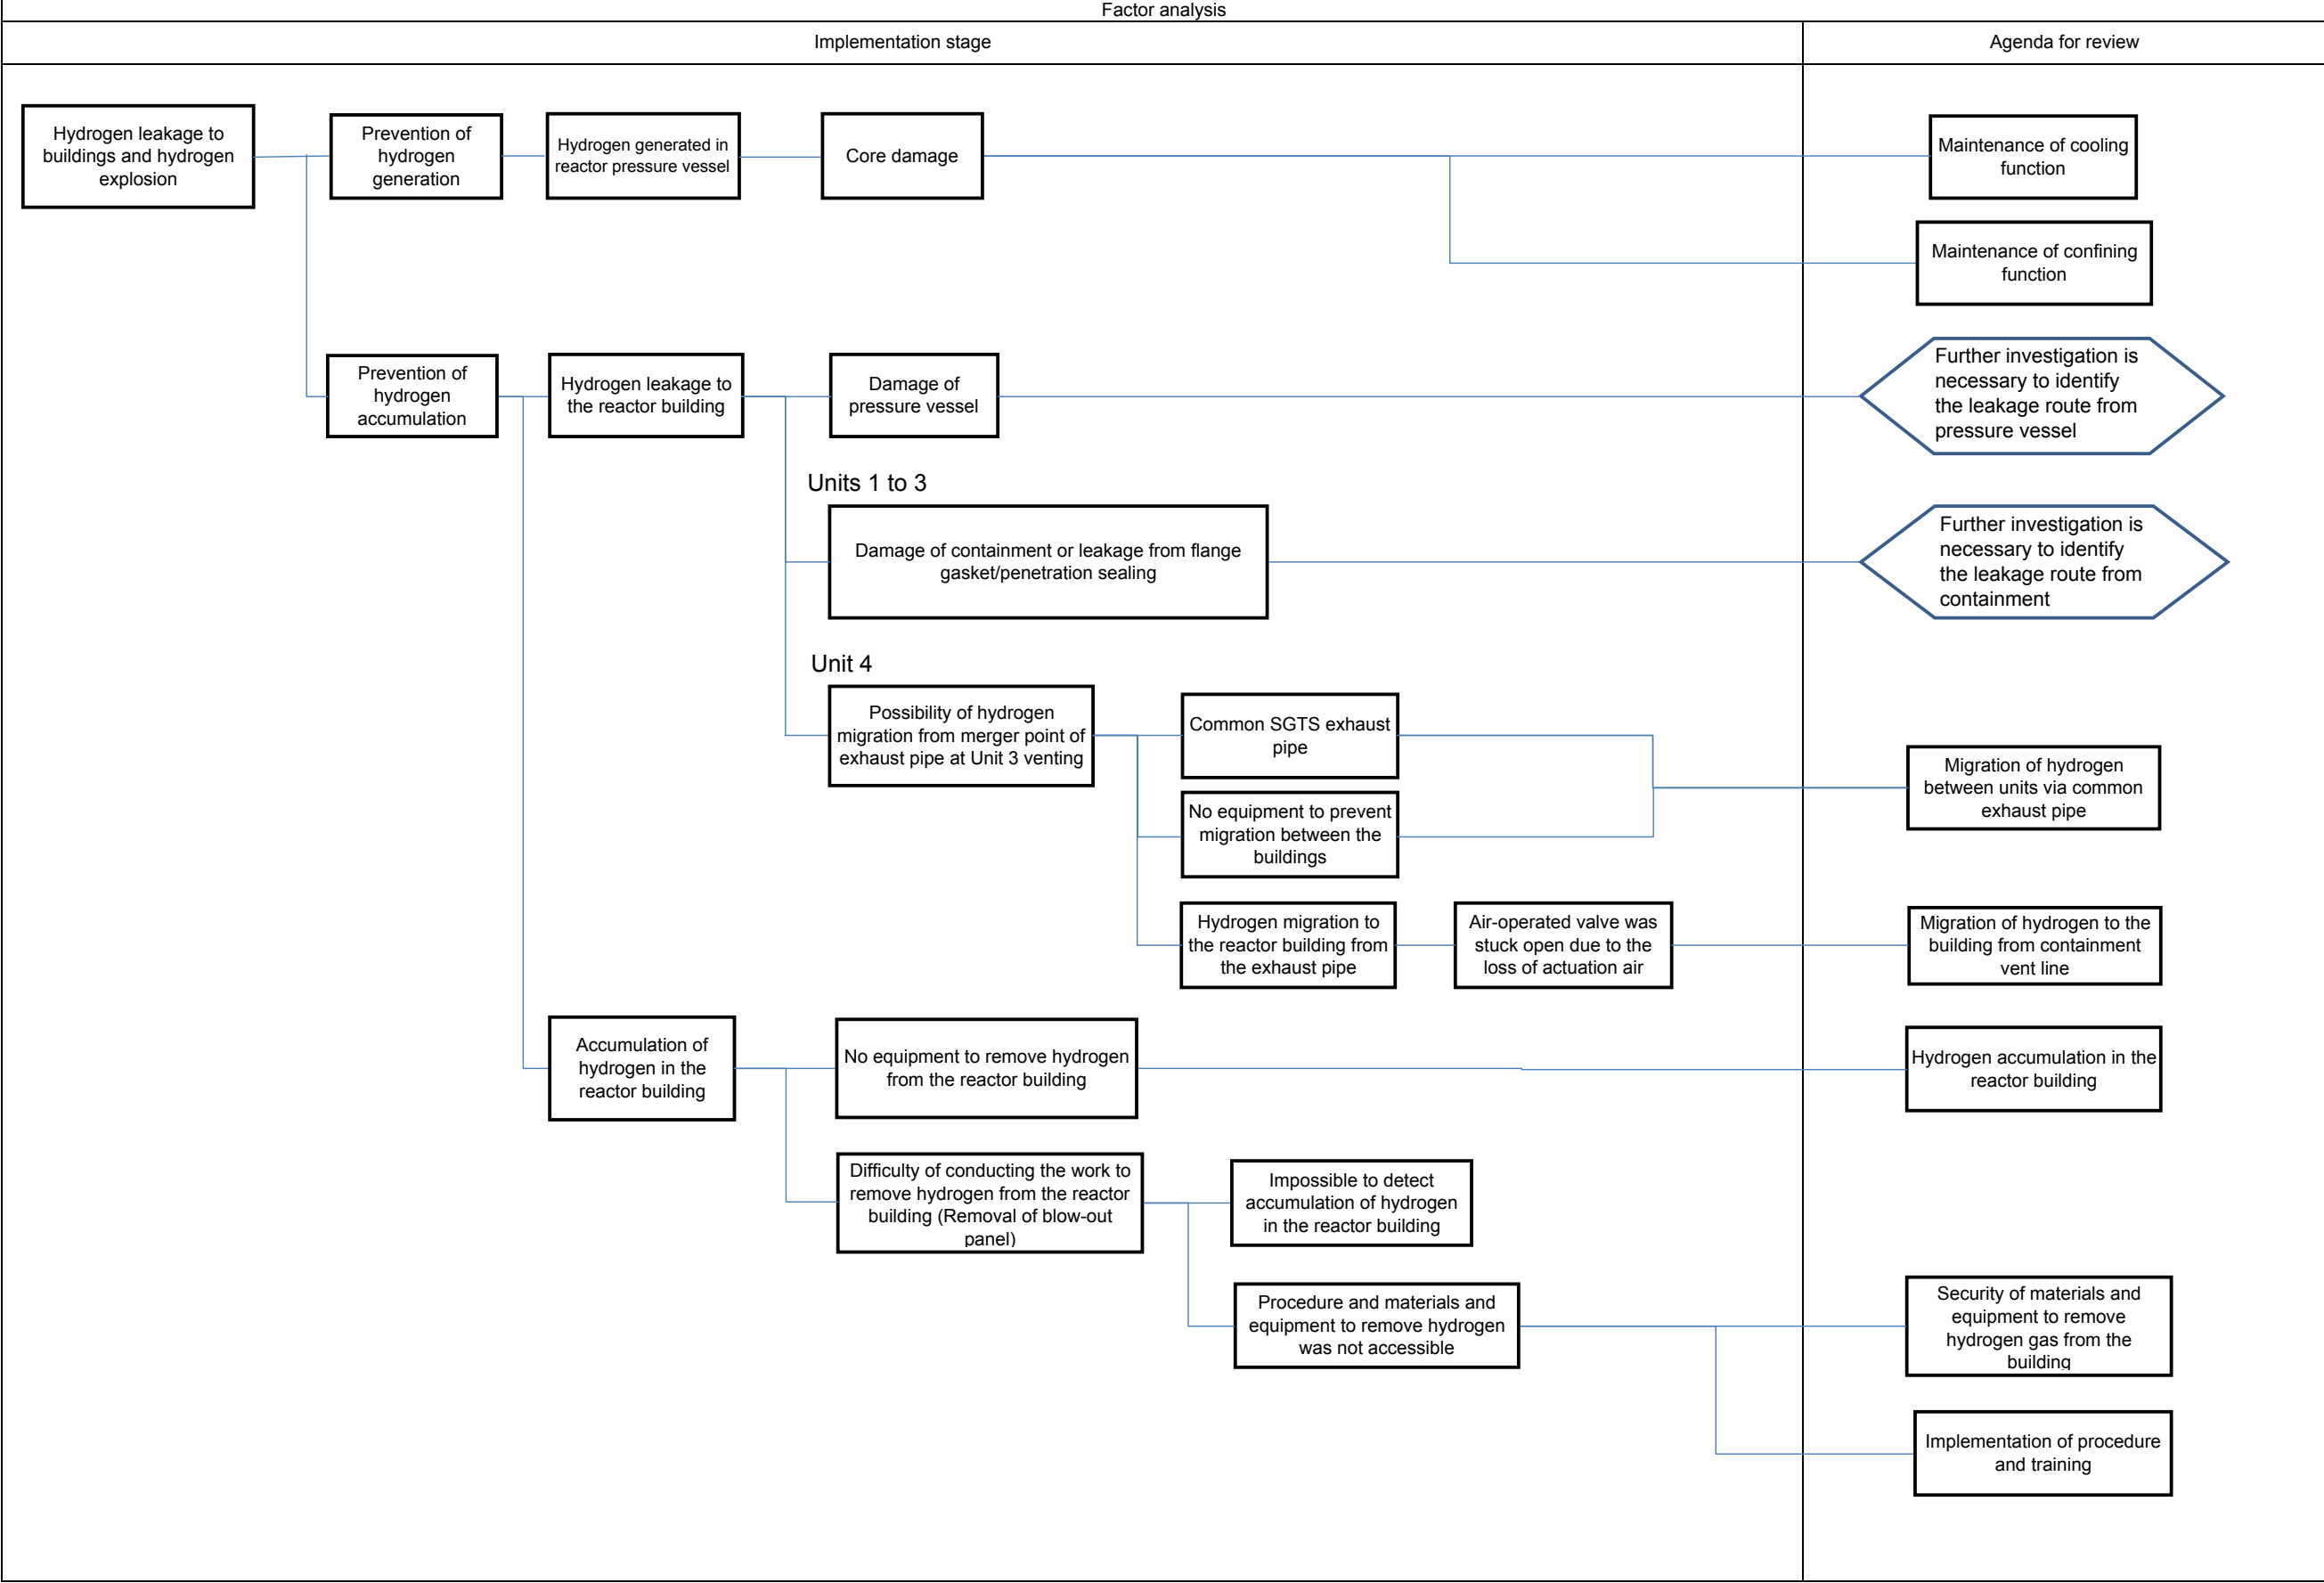
- Hydrogen migration among the Units connected via common stack
- Migration of hydrogen from containment vent line to the reactor building
- Accumulation of hydrogen in the reactor building
- Security of materials and equipment to remove hydrogen gas from the building
- Improvement of procedures and training

Figure 3.2.1-3: Hydrogen leakage to buildings and hydrogen explosion: Cause analysis

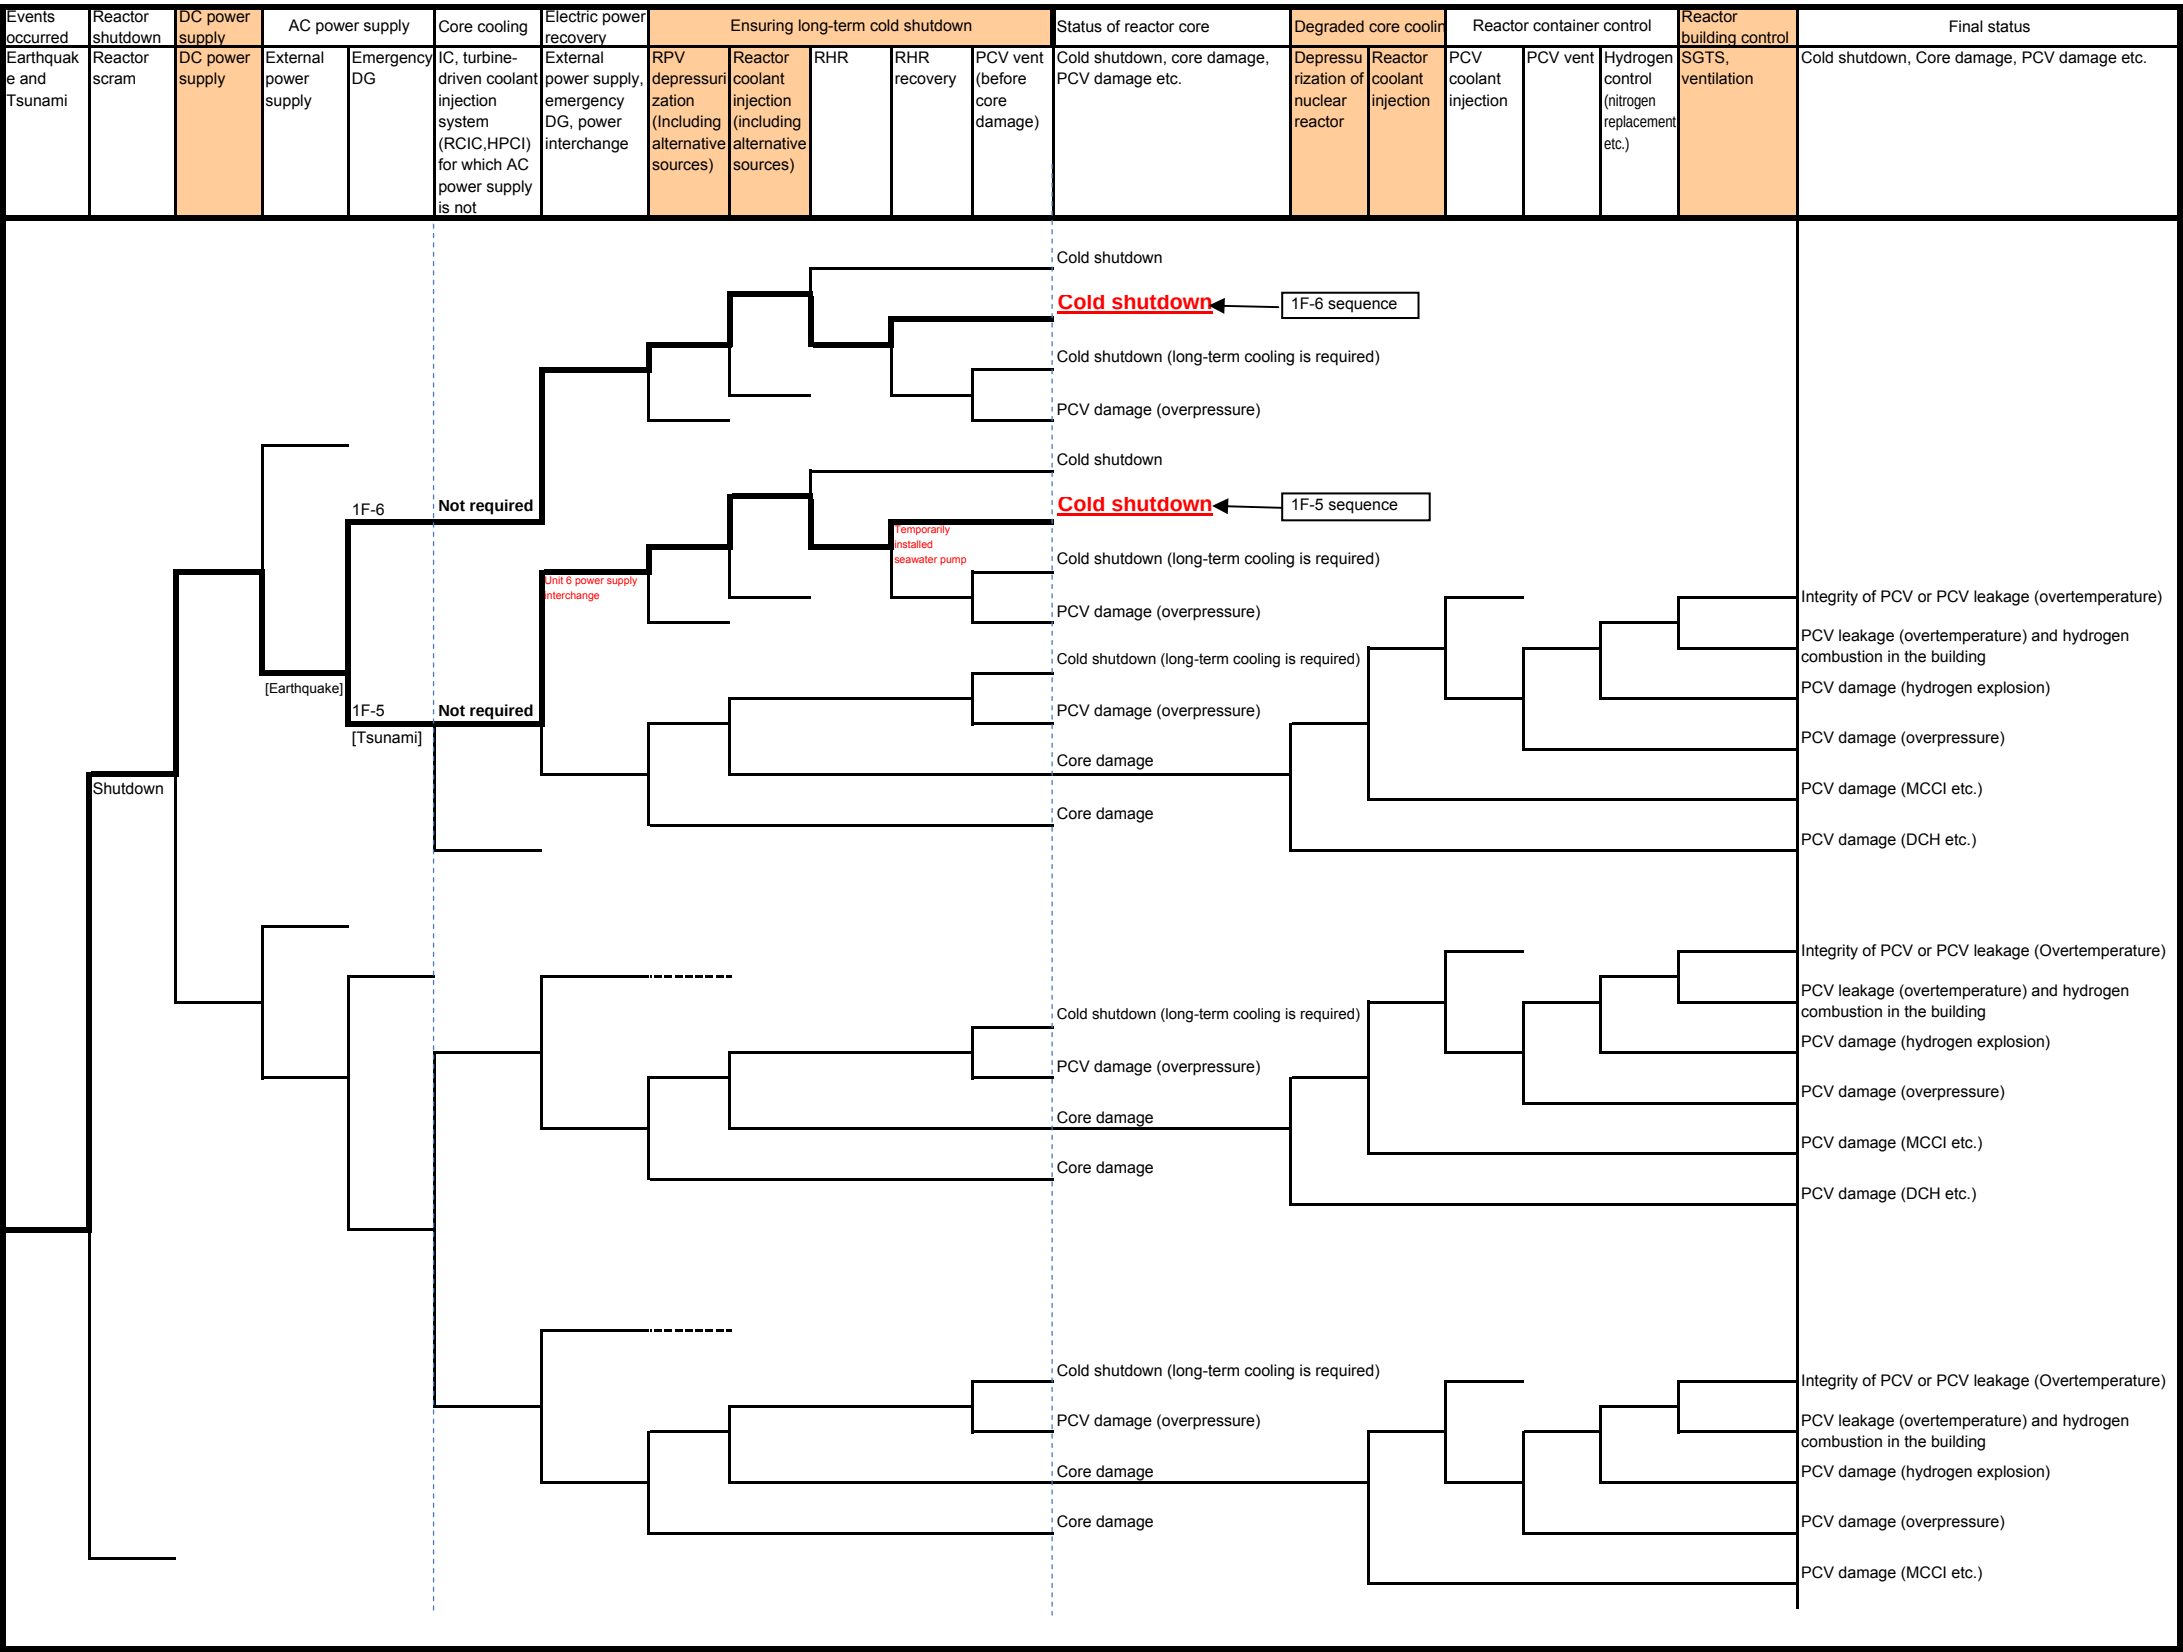
However, it should be kept in mind that there was a need to supply power by directly drawing a cable from a bus of the emergency DG to the safety component because the power panel was affected by the tsunami. Because the distribution of electricity to multiple safety components will be simultaneously lost when the power panel is submerged, it is necessary to investigate a plan for supplying power to the necessary components from the available power supplies even when soaking occurs, while ensuring soaking countermeasures in order to increase the security of the dependable power supply.

Figure 3.5-1 Disaster identification events tree in Fukushima Daiichi Nuclear Power Station Units 5, 6
