Examination of the Accident of the Tokyo Electric Power Co., Inc.'s Fukushima Daiichi Nuclear Power Station and Proposal of Countermeasures (Draft)

October, 2011

Japan Nuclear Technology Institute

Examination Committee on the Accident of Fukushima Daiichi Nuclear Power Station

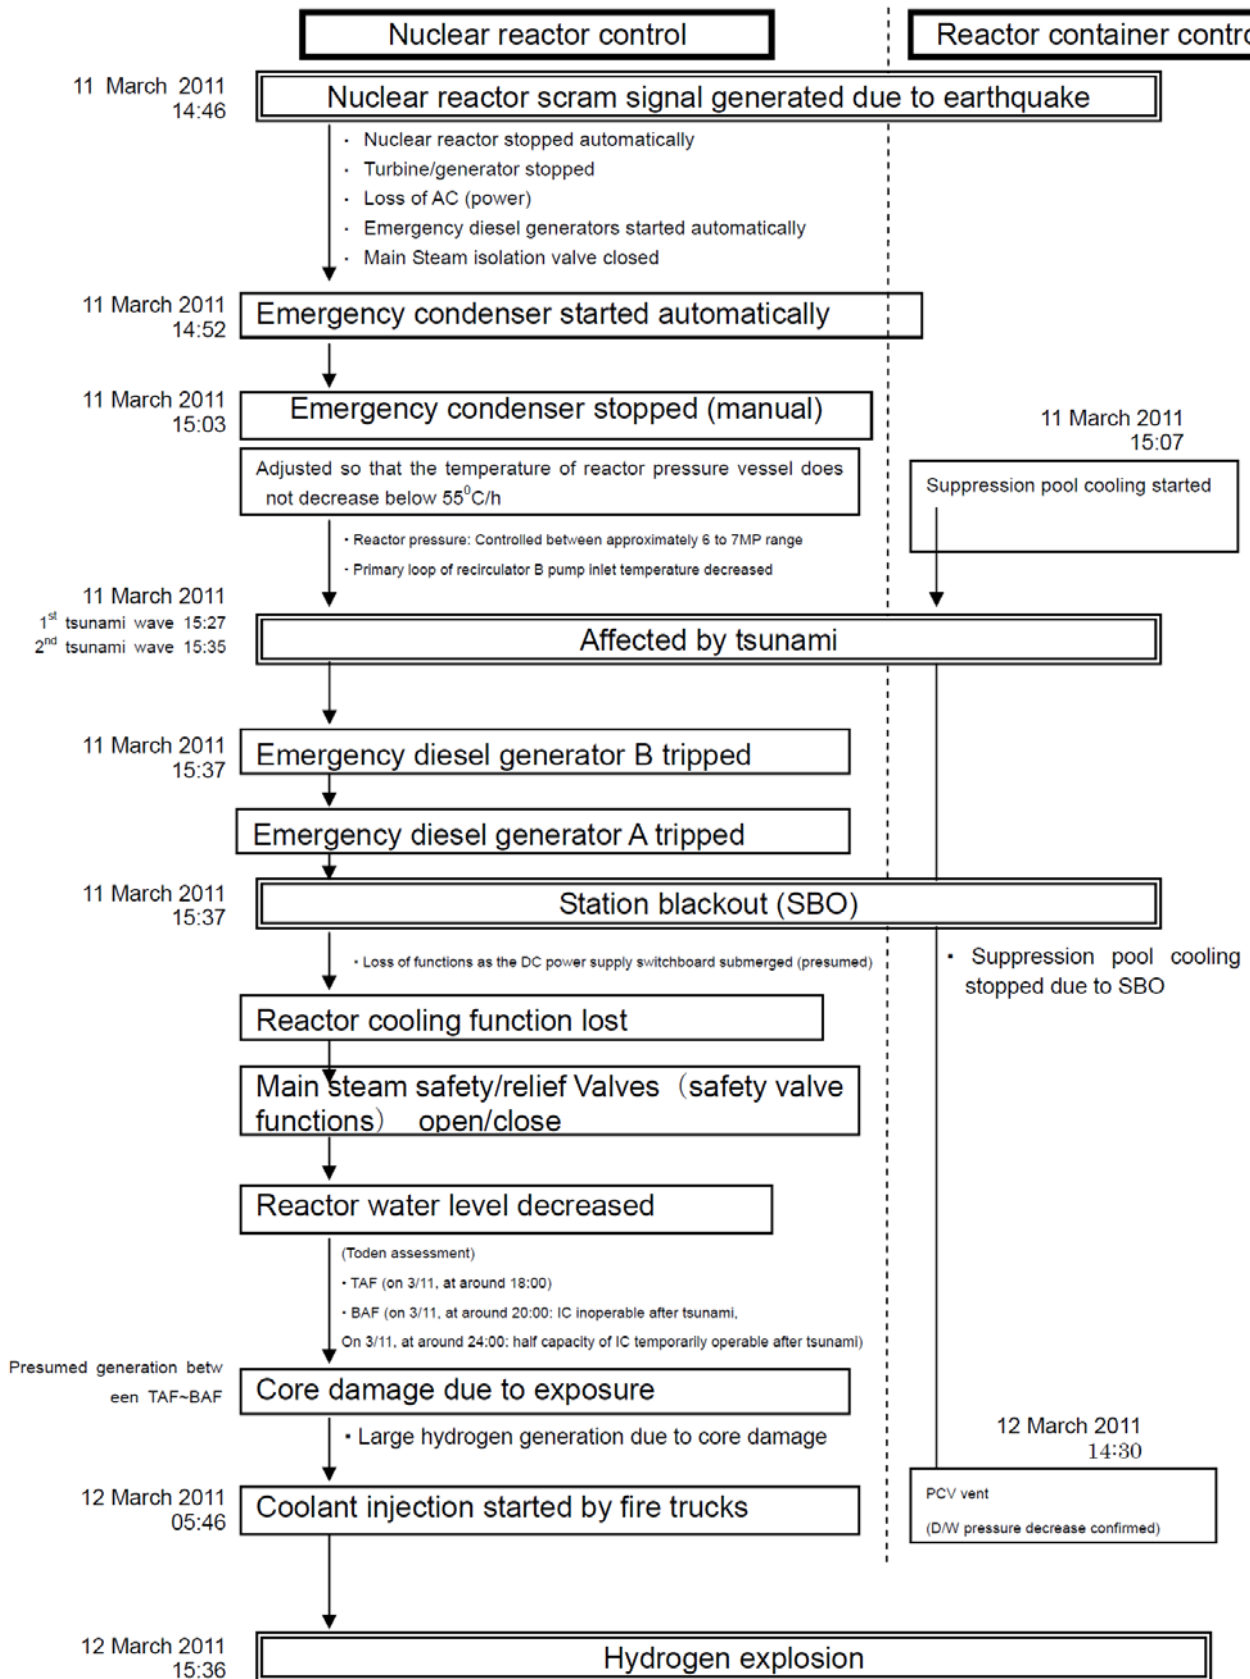
Figure 2.2-1 Development of accident after earthquake of unit 1 of Fukushima Daiichi nuclear power plant

(Note)As per the meter indication, it is such that the water level of the reactor core is maintained, but thinking about the period of reactor damage etc, it was possible that the meter was not showing proper reading.

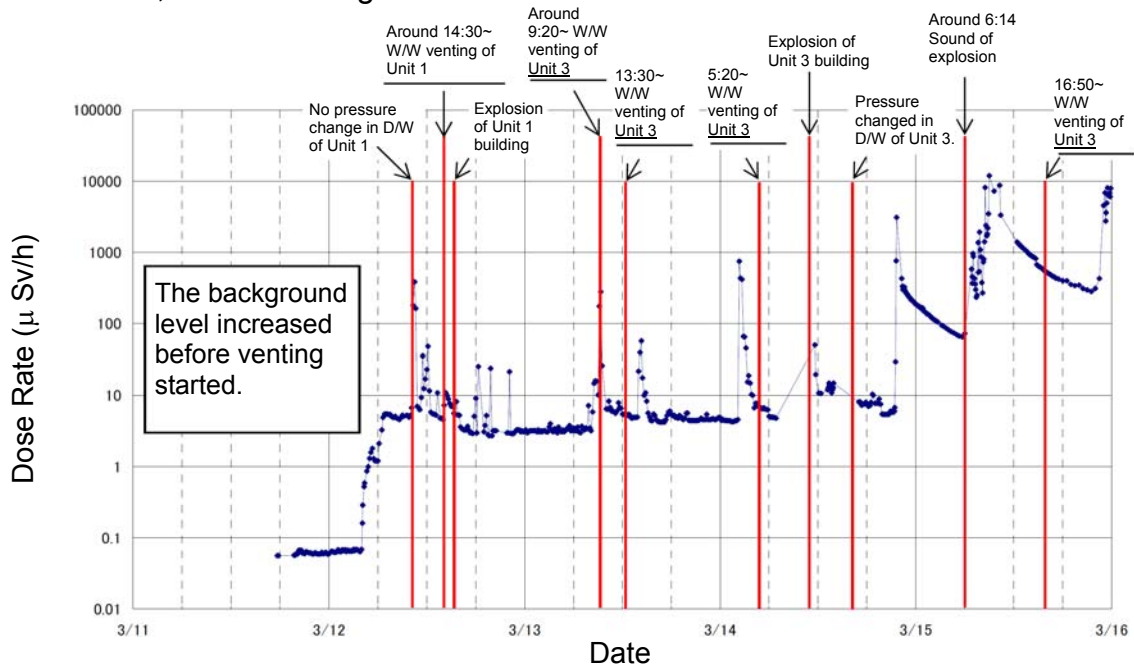
**Fig. 2.8-1 Fukushima Daiichi Nuclear Power Station
Dose Rate in the Vicinity of Main Gate**

For the dose rate, no big change in the background level before and after these vent operations was observed. However, from 4:00 to 7:00 on March 12, the dose rate increased. In addition, around 6:14 on March 15, the sound of explosion was confirmed, and the background level of the dose rate increased before and after it.

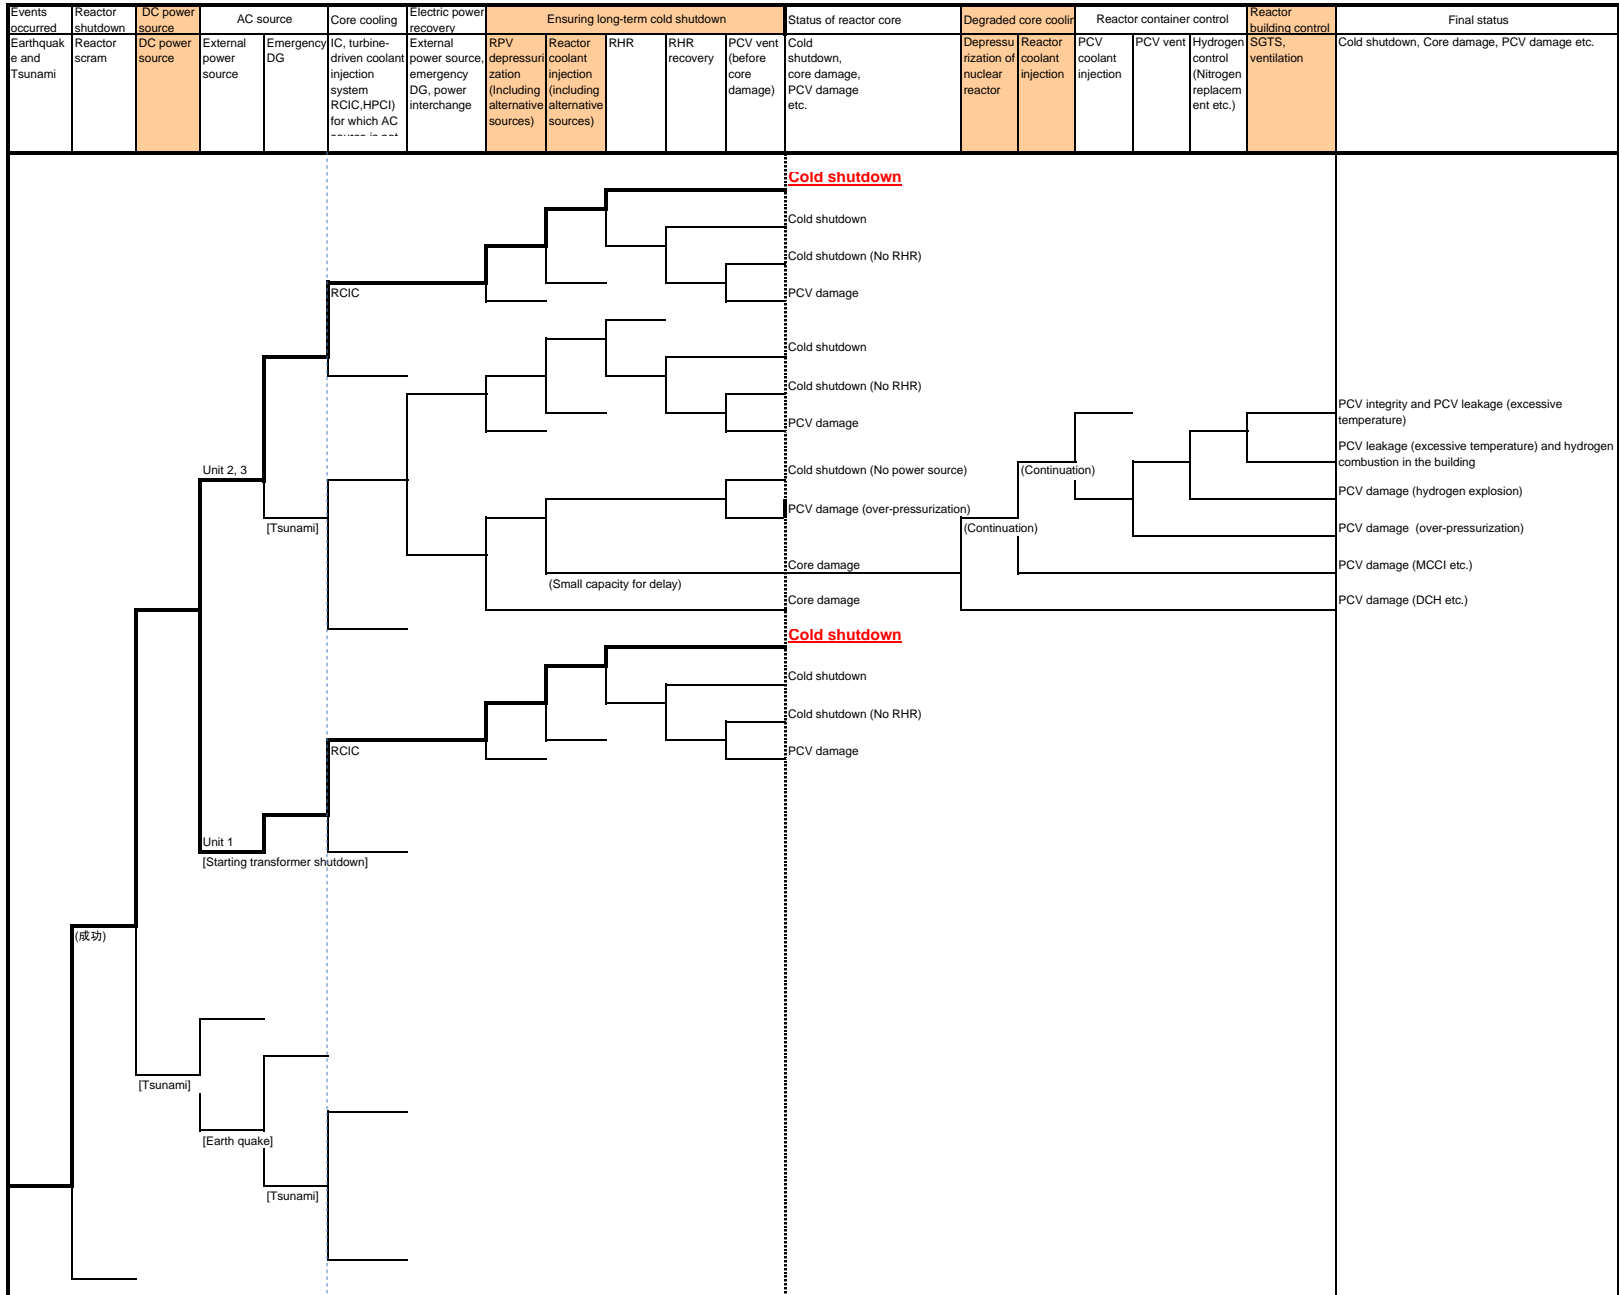
Diagram Appendix 1-2 Onagawa Nuclear Power plant disaster identification events tree

The series of events on Onagawa are shown in Figure Appendix 1-2 with the event tree.
