# **Examination of Accident at Tokyo Electric Power Co., Inc.'s Fukushima Daiichi Nuclear Power Station and Proposal of Countermeasures (Draft)**

**October 2011**

**Japan Nuclear Technology Institute**

**Examination Committee on Accident at Fukushima Daiichi Nuclear Power Station**

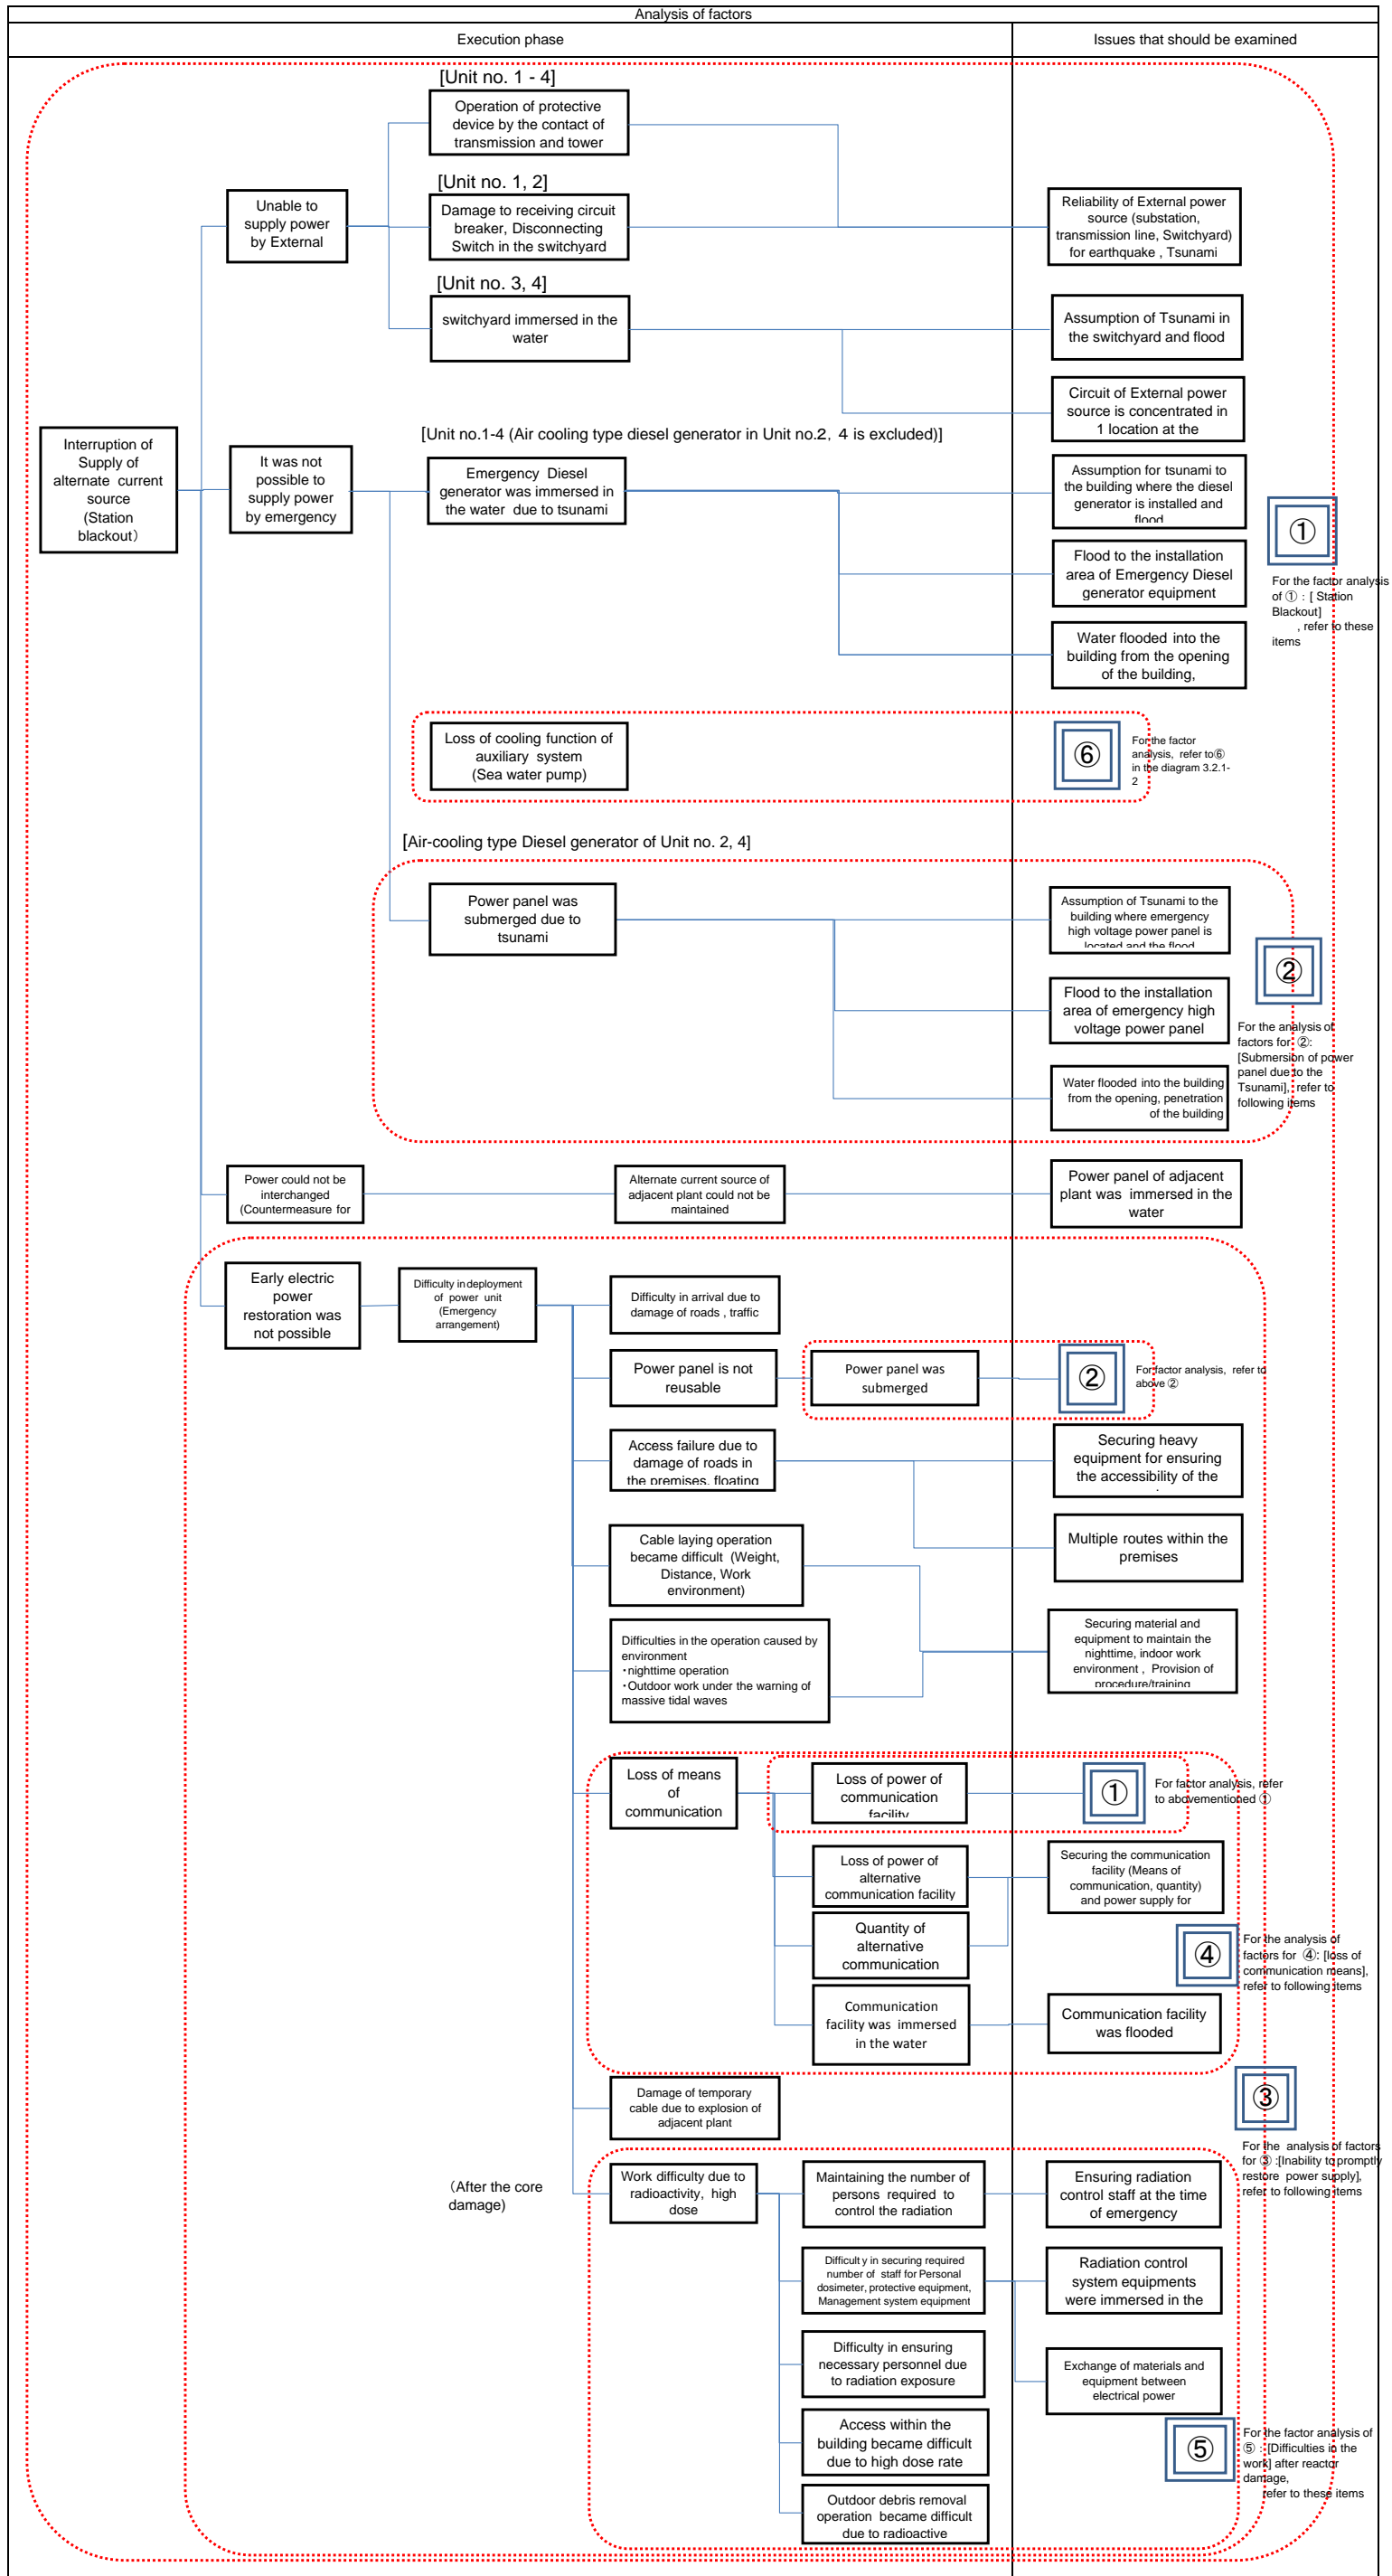
Diagram 3.2.1-1 Analysis of causes for interruption of supply of alternate current power

The cause where AC power could not be supplied from the view of the equipment and operation includes inability of power supply from the external source, inability of power supply by emergency DG, inability of joint use of power supply and inability of power supply restoration at early stage.

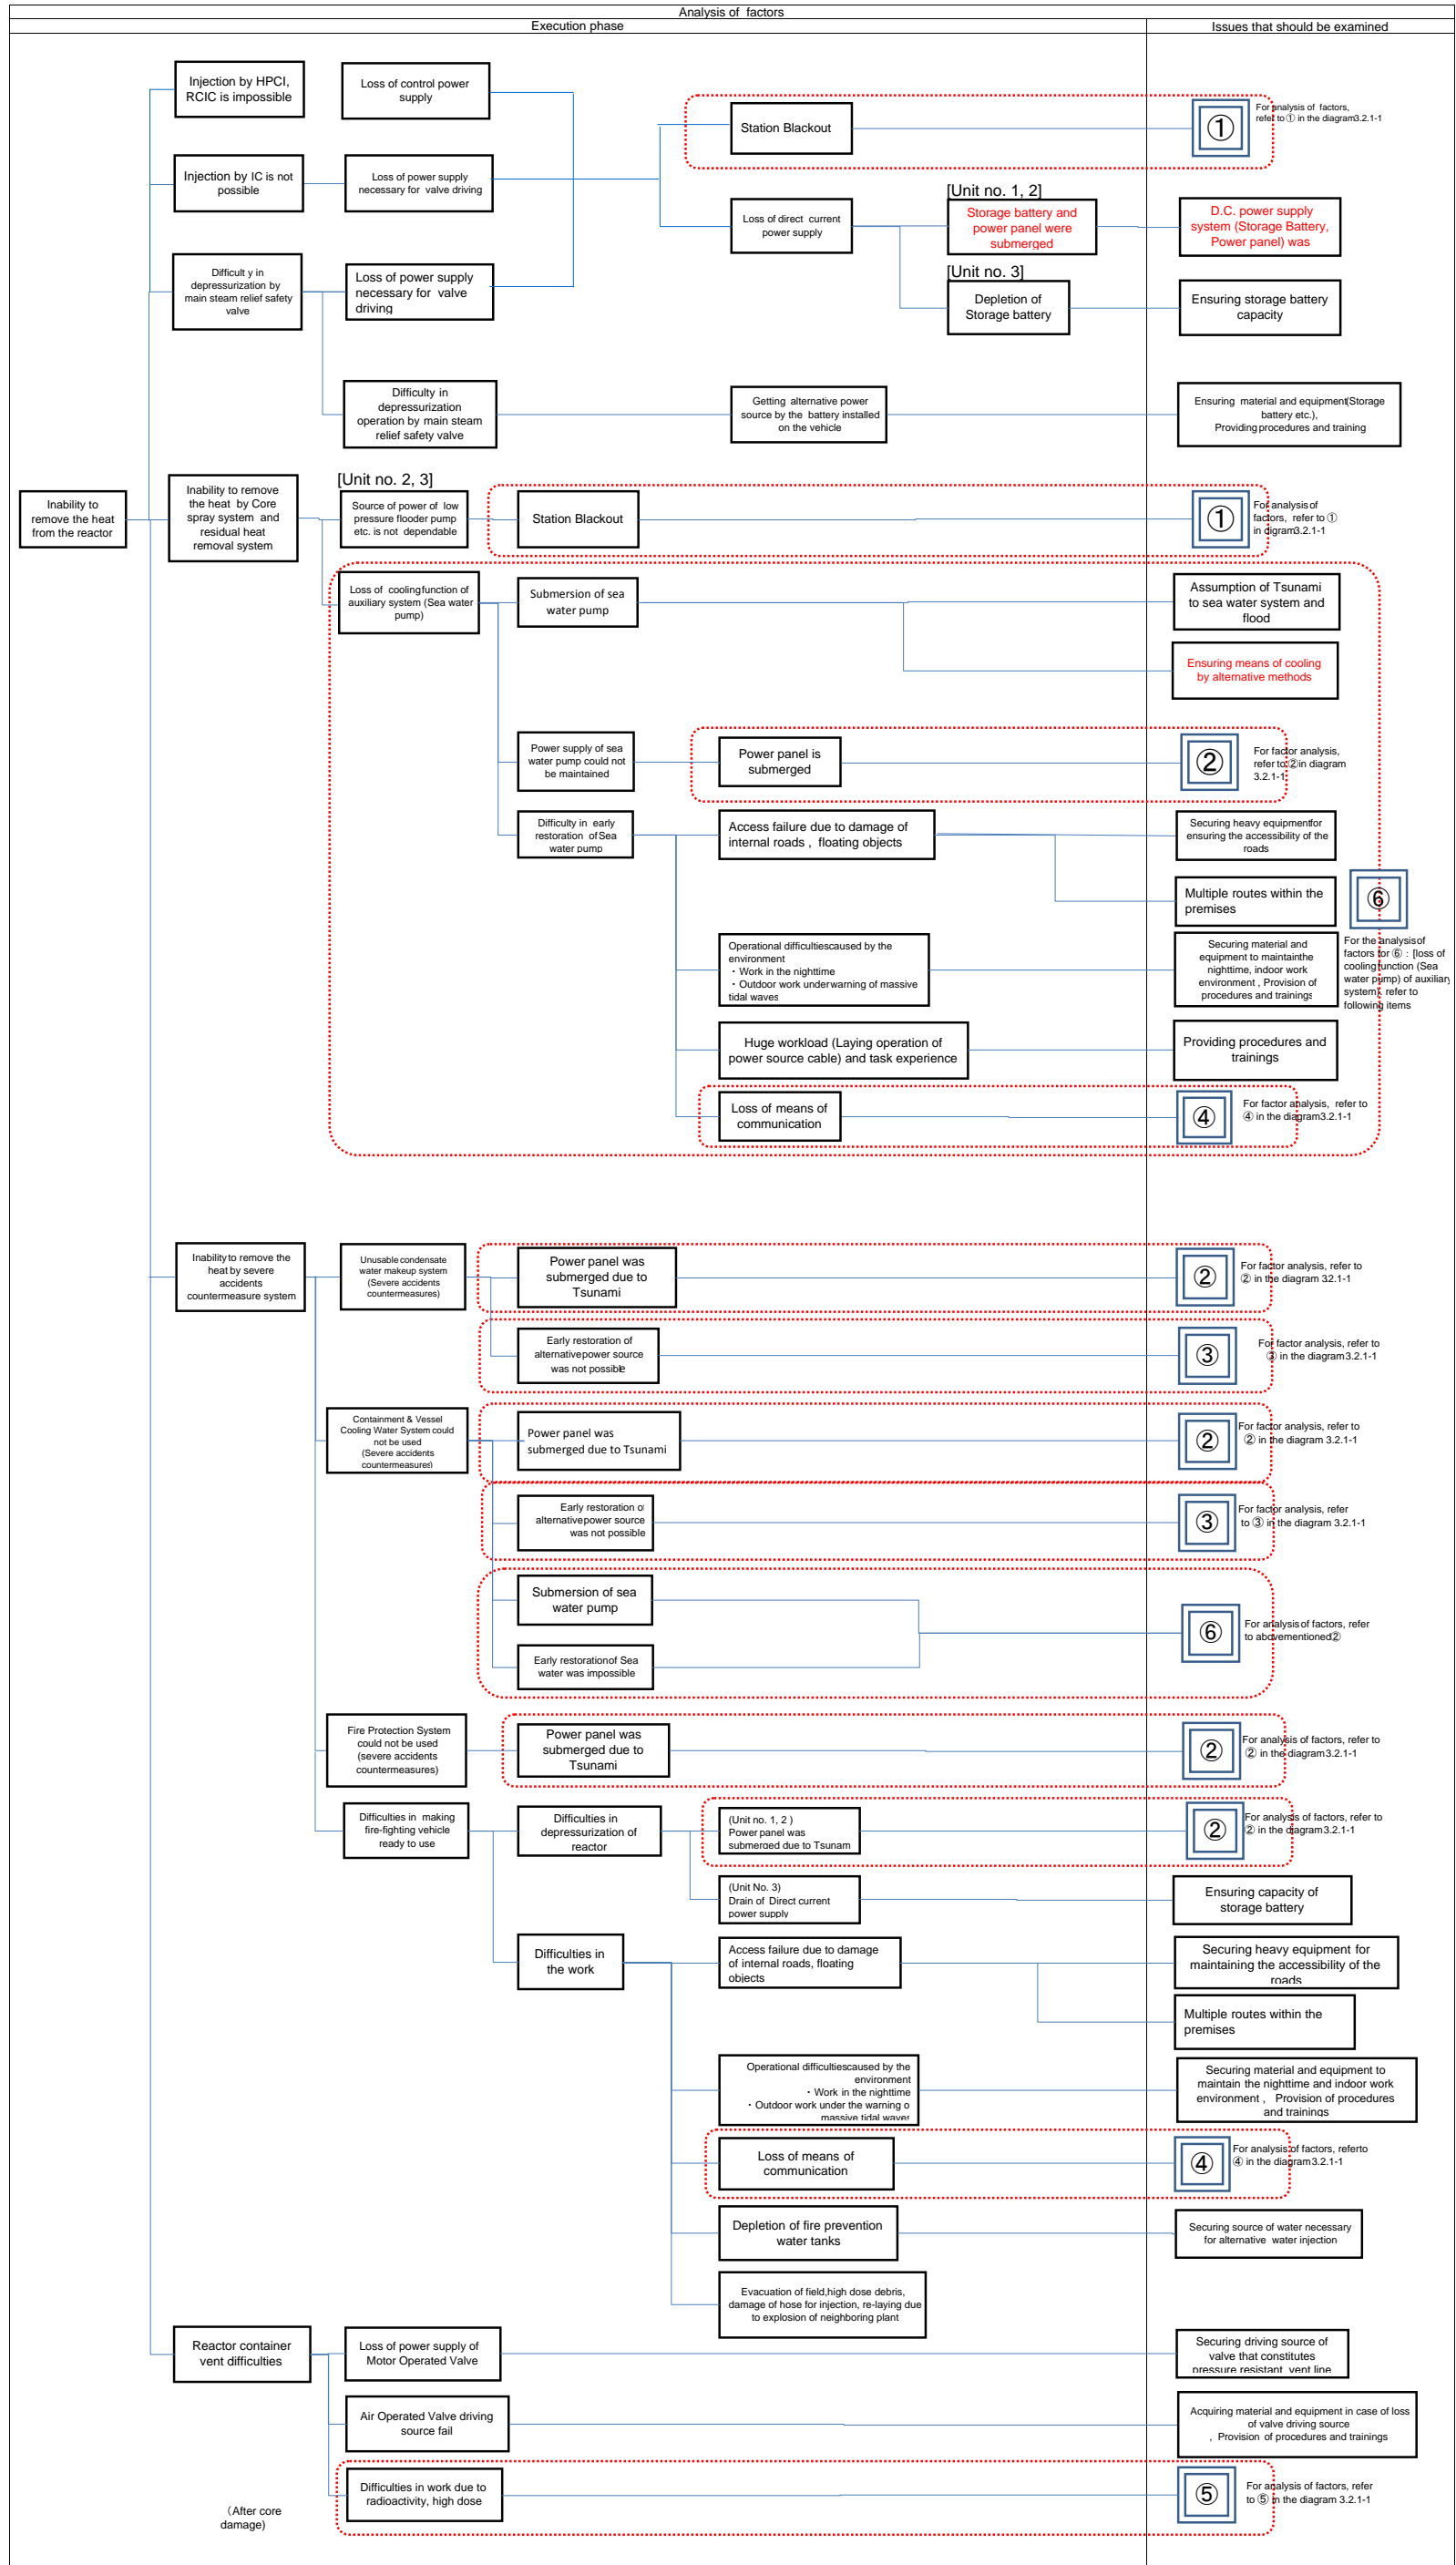
Diagram 3.2.1-2 Analysis of causes of inability to remove heat from the reactor

The cause of heat removing impossible from nuclear reactor from the view of the equipment and operation includes inability of decompression by SRV, inability of heat removing by CS and RHR, inability of heat removing by severe accident measure equipment (alternative water filling), and difficulty in containment vessel vent.

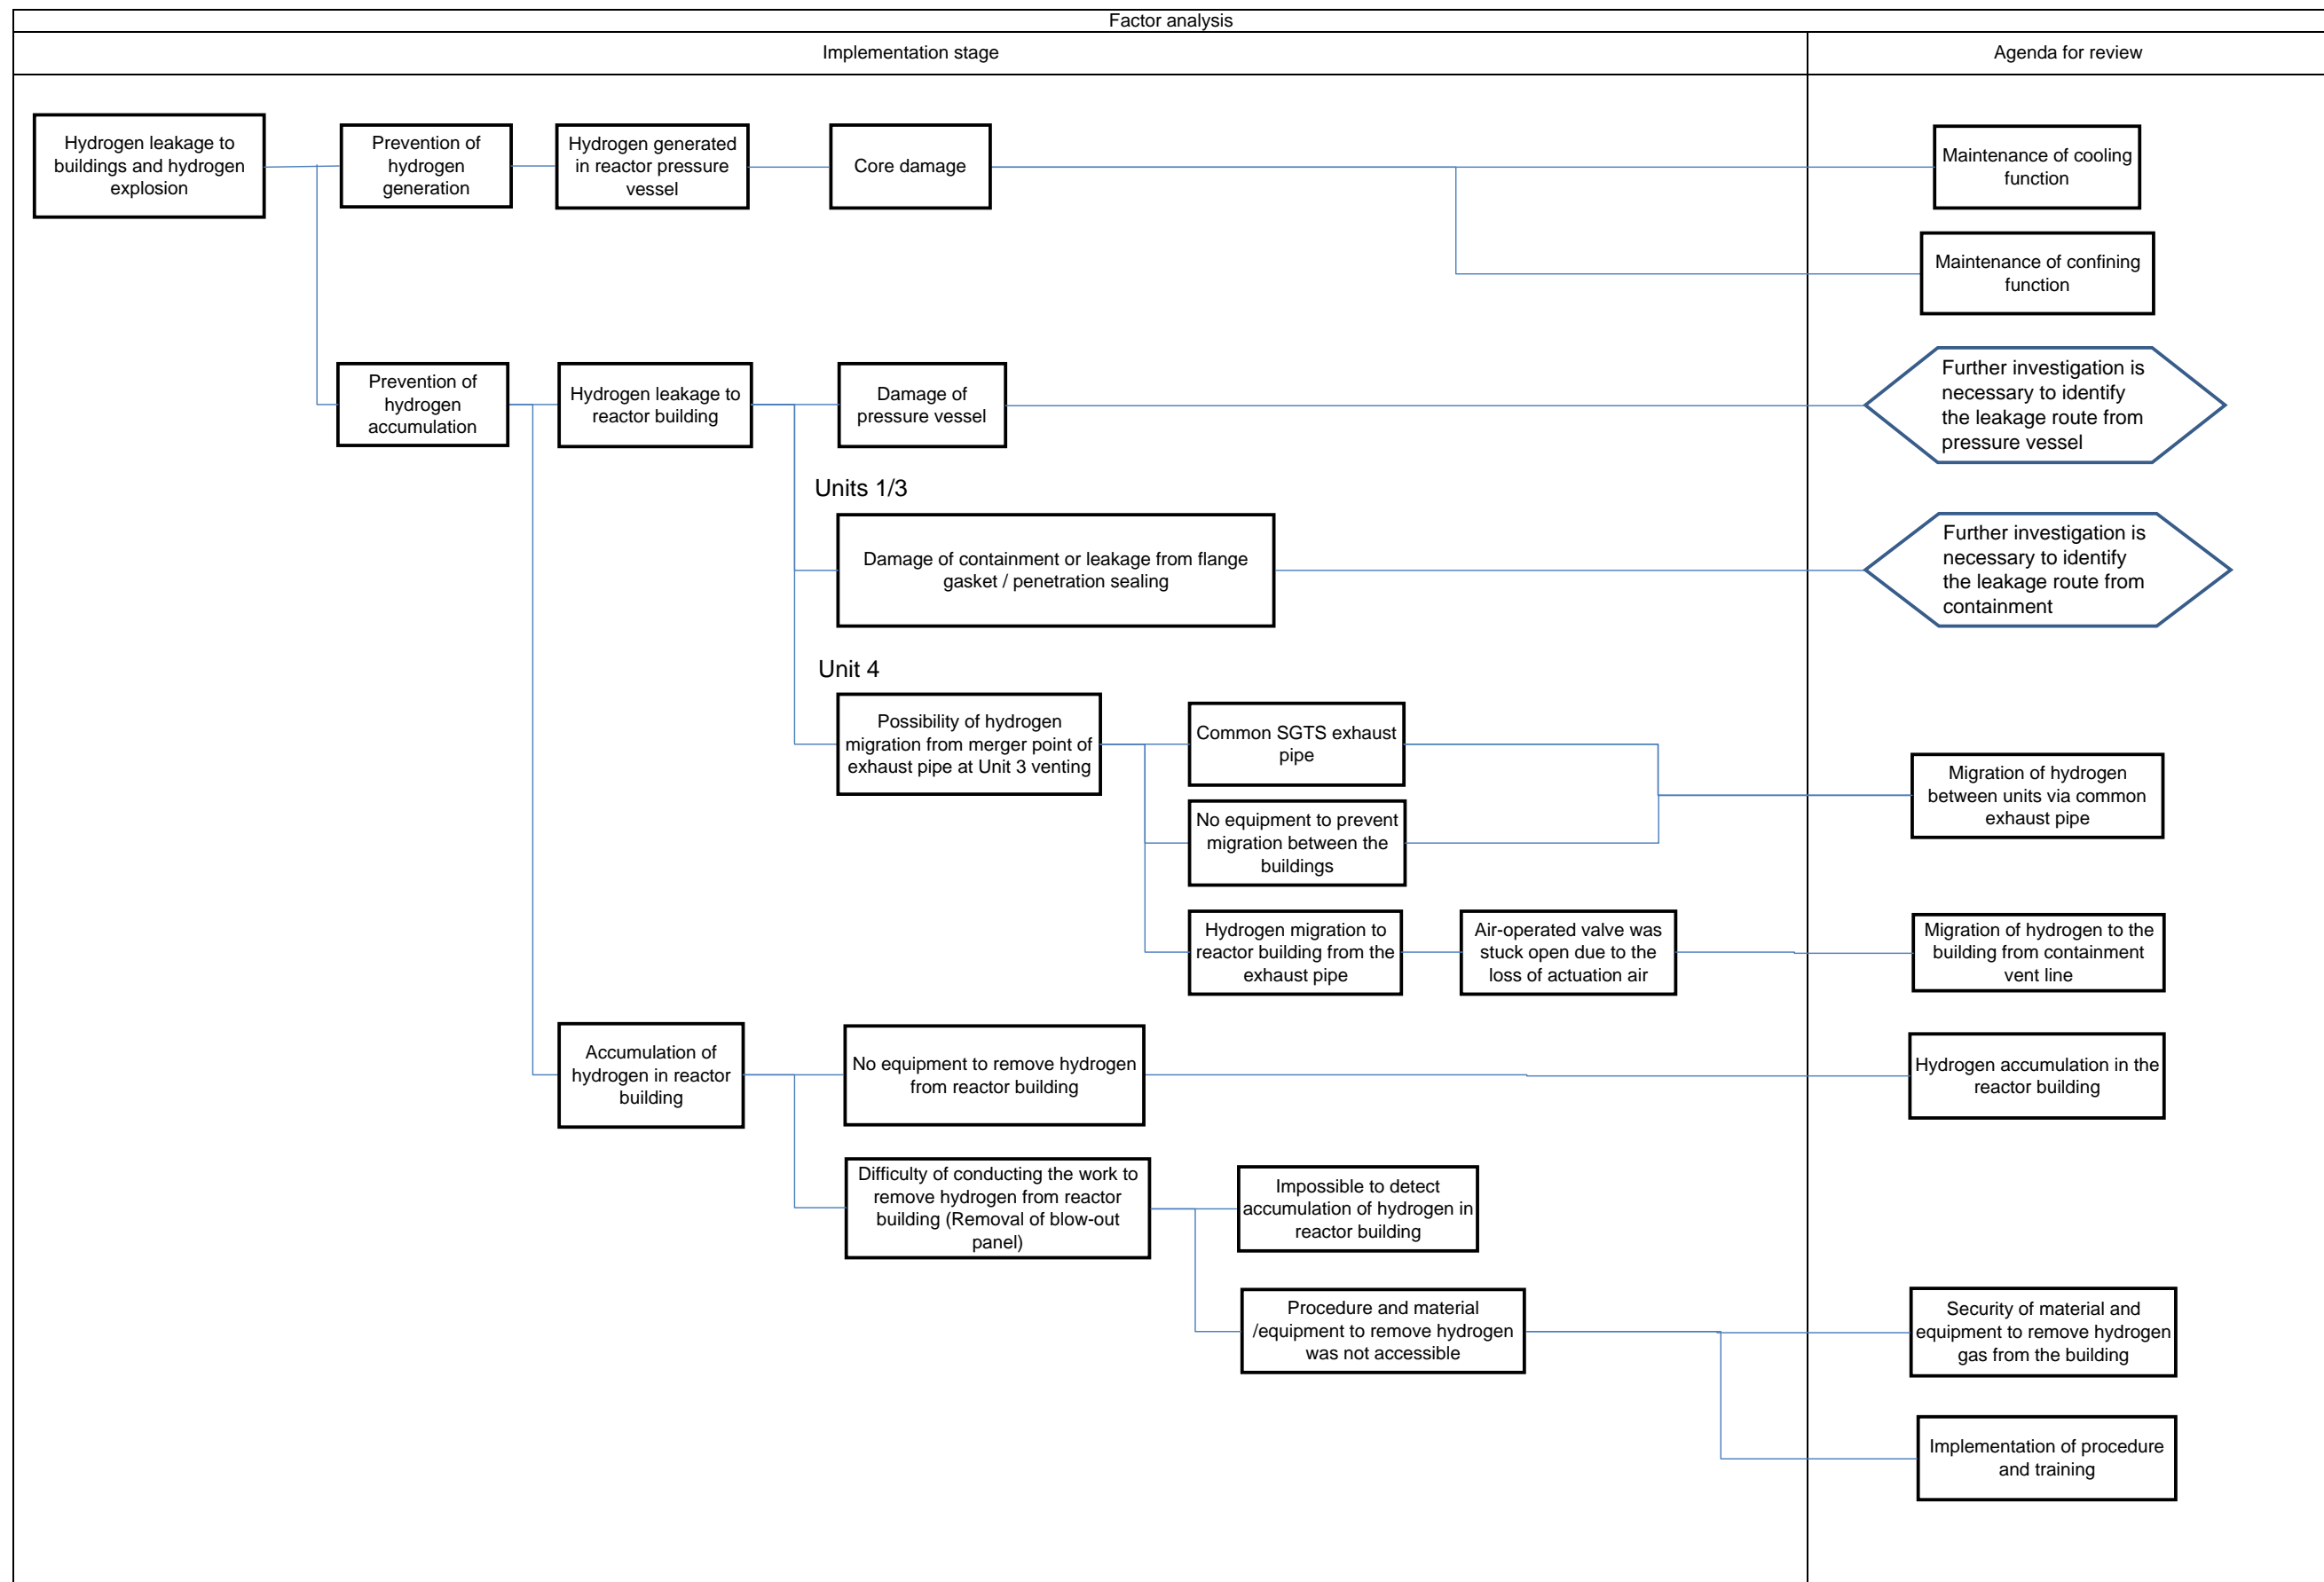
Figure 3.2.1-3: Hydrogen leakage to buildings and hydrogen explosion: Cause analysis

- Hydrogen migration among the units connected via common stack
- Migration of hydrogen from containment vent line to the reactor building
- Accumulation of hydrogen in the reactor building
- Security of materials and equipment to remove hydrogen gas from the building
- Improvement of procedures and trainings

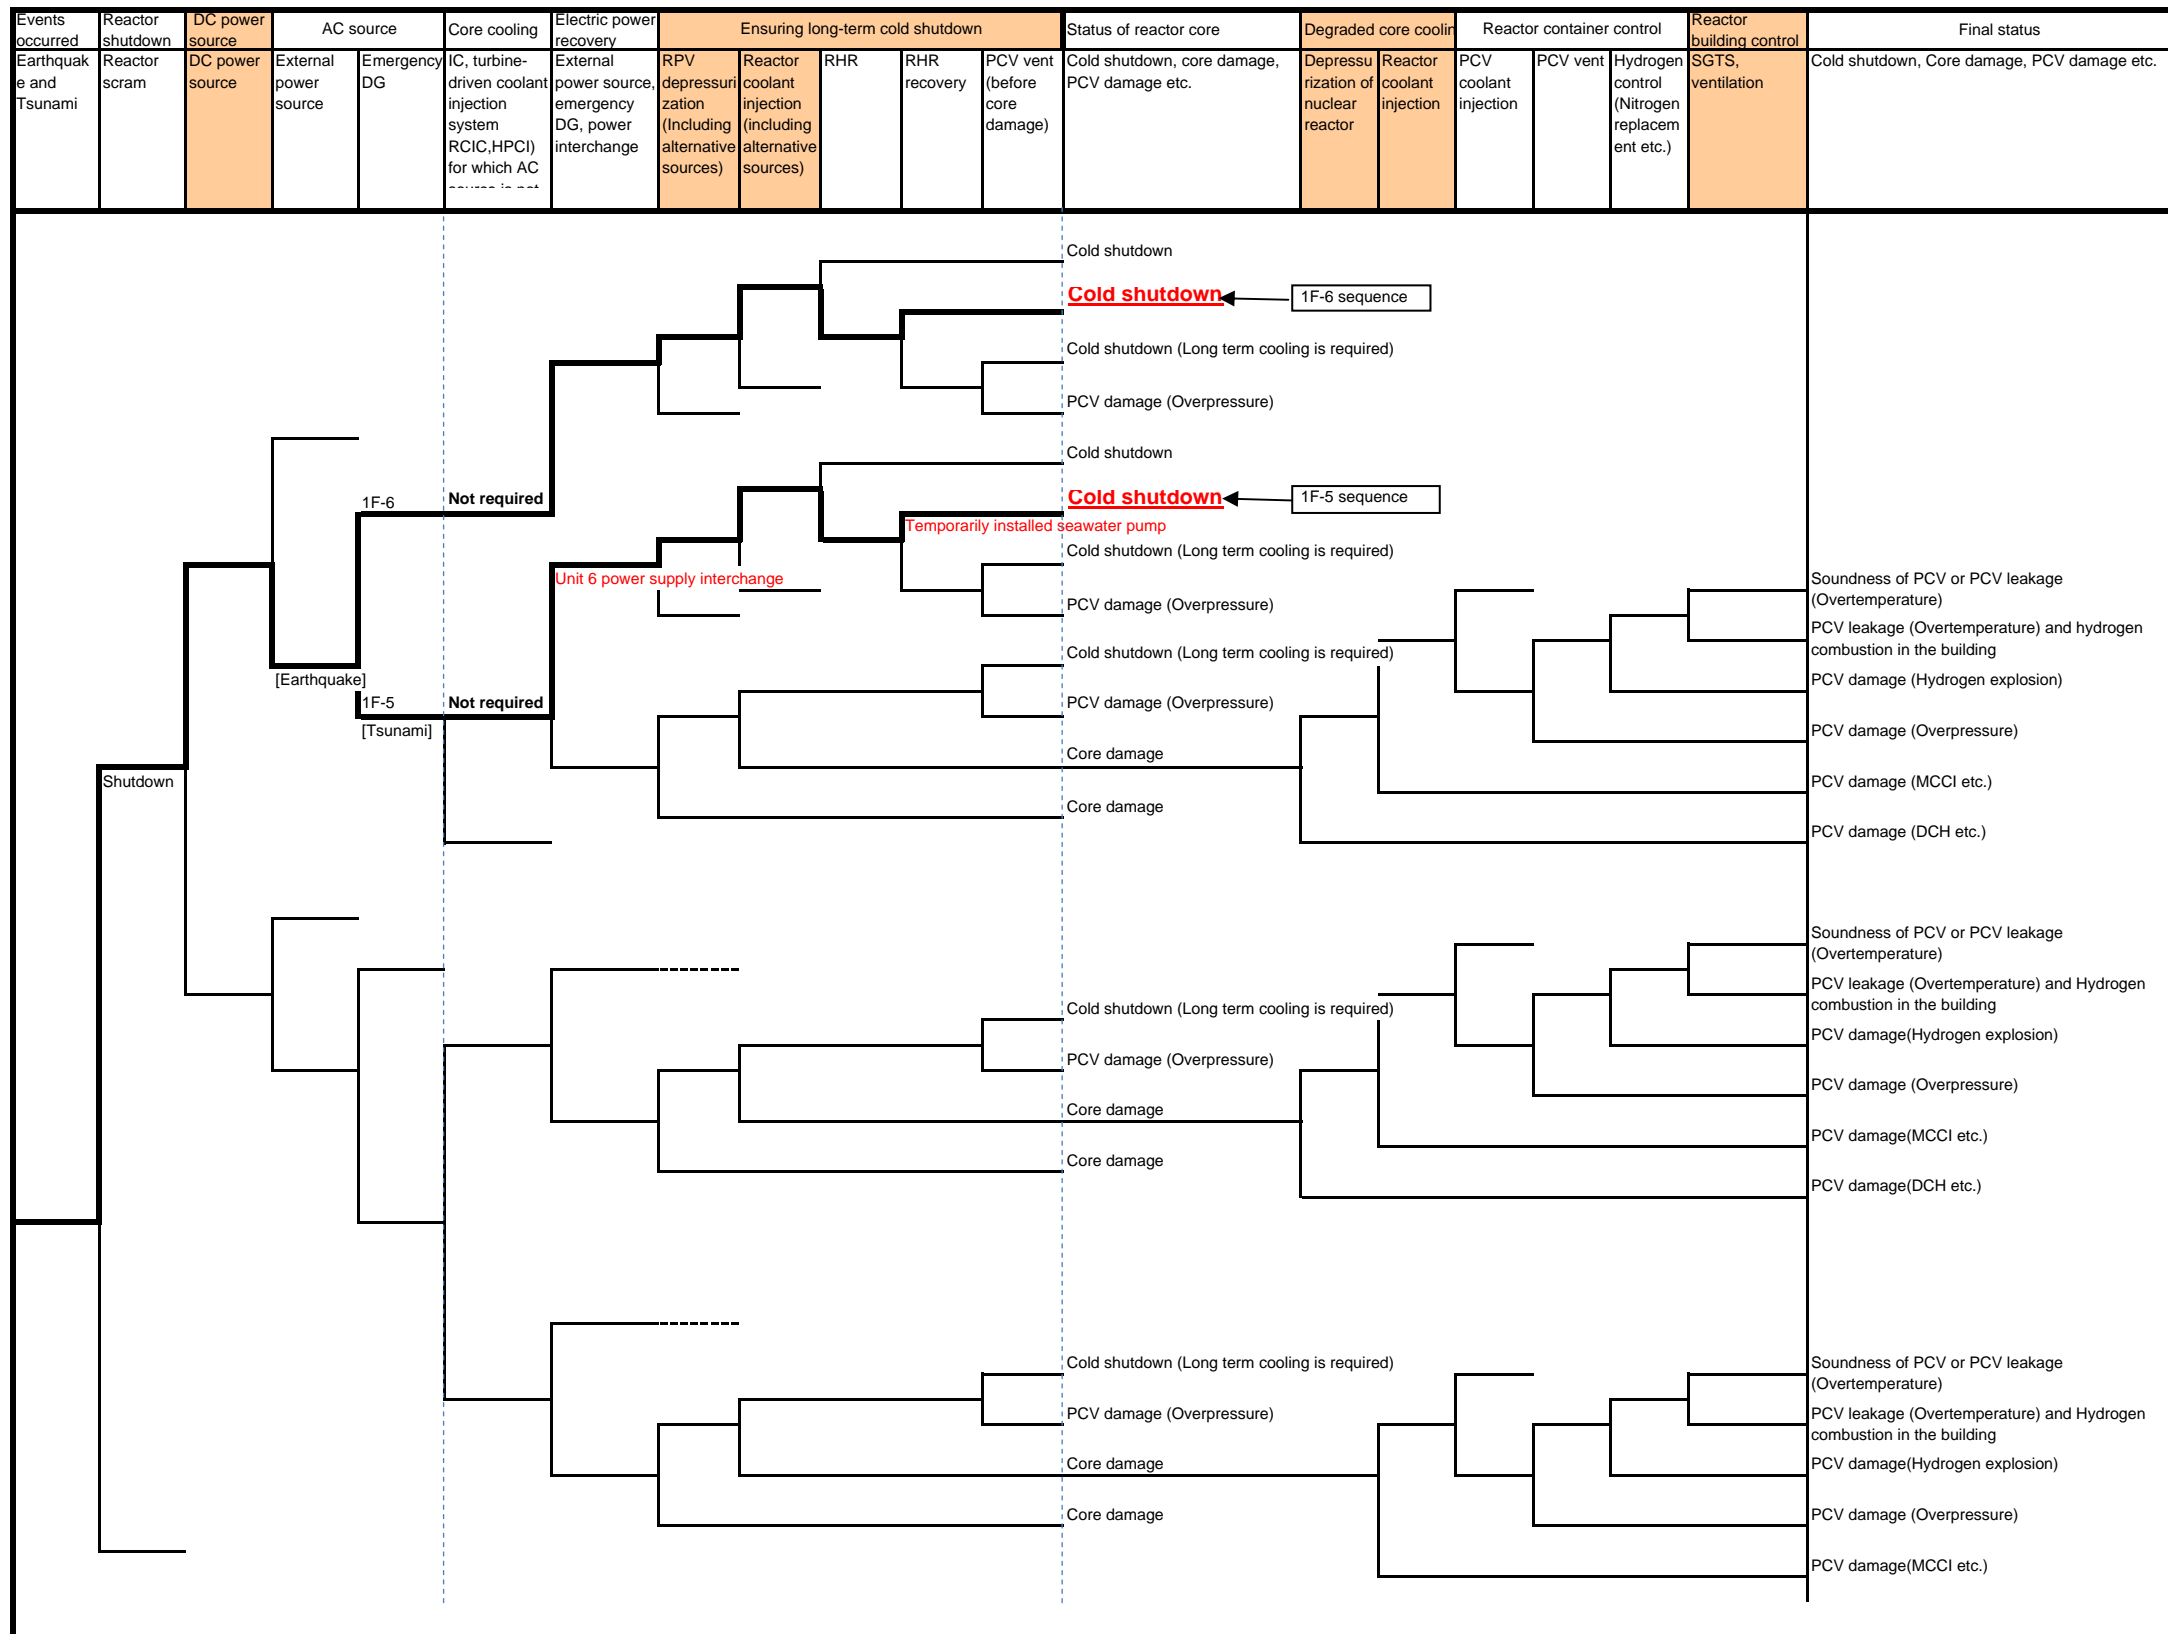
Figure 3.5-1 Event tree of event progress in Fukushima Daiichi Nuclear Reactor Unit 5, 6

However, it should be kept in mind that there was a necessity of supplying power by directly drawing a cable from a bus of the emergency DG to the safety component because the power panel was affected by the tsunami. Because the distribution of electricity to a plurality of the safety components will be simultaneously lost when the power panel is submerged, it is necessary to investigate a plan for supplying power to the necessary components from the available power sources even when soaking occurs while ensuring soaking countermeasures in order to increase the security of the dependable power source.
