Examination of Accident at Tokyo Electric Power Co., Inc.'s Fukushima Daiichi Nuclear Power Station and Proposal of Countermeasures

October 2011

Japan Nuclear Technology Institute

Examination Committee on Accident at Fukushima Daiichi Nuclear Power Station

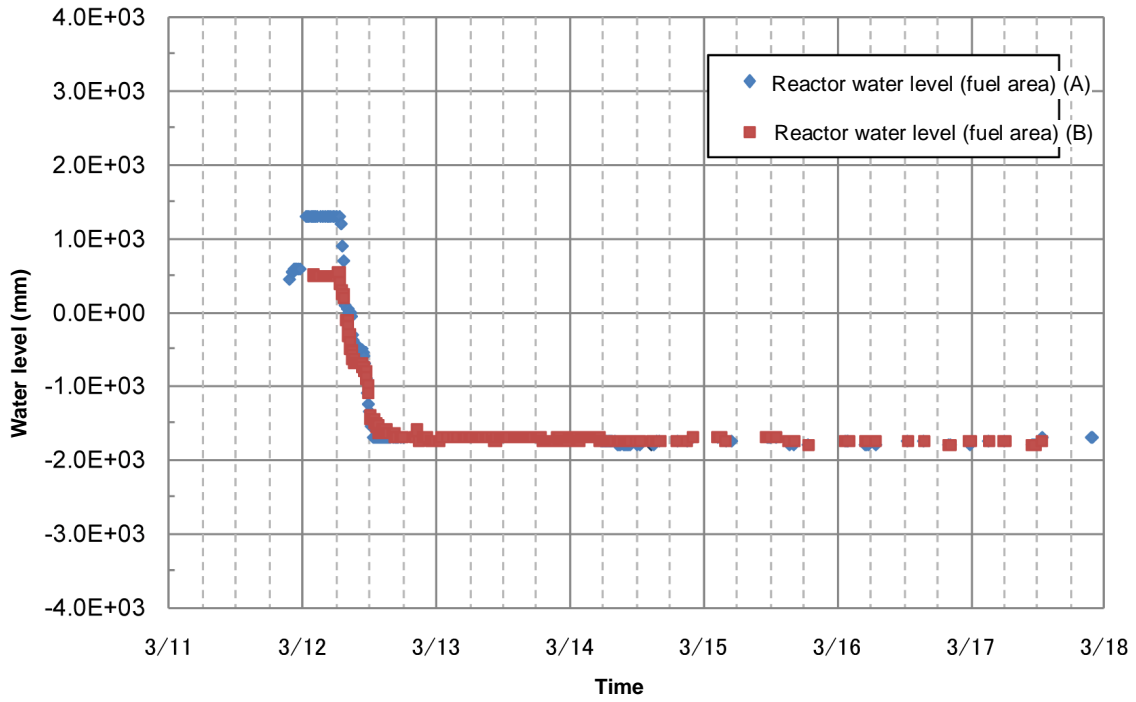
Figure 2.2-2a Change in reactor water level (Unit 1)

Note: The meter indication showed that the water level of the reactor core was being maintained, but thinking about the period of reactor damage and such like, it was possible that the meter was not showing a proper indicated value.
