# **Examination of Accident at Tokyo Electric Power Co., Inc.'s Fukushima Daiichi Nuclear Power Station and Proposal of Countermeasures**

**October 2011**

**Japan Nuclear Technology Institute**

**Examination Committee on Accident at Fukushima Daiichi Nuclear  
Power Station**

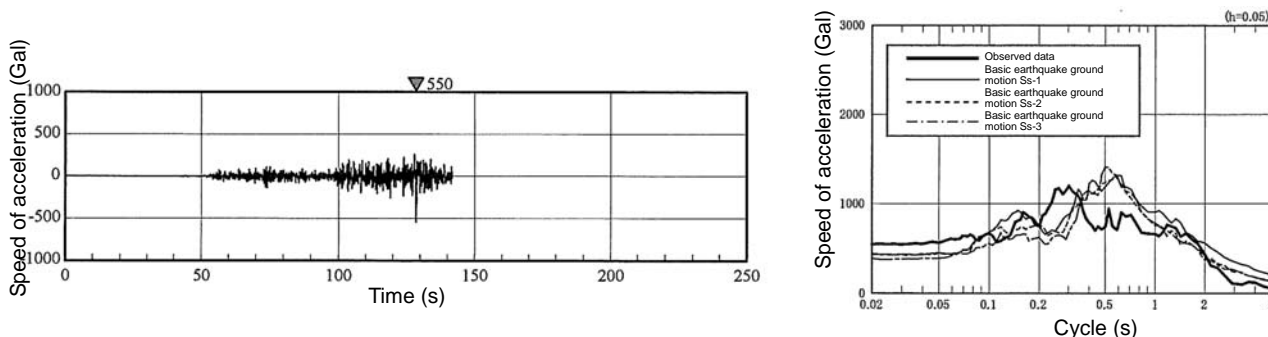
Figure 2.1-1 Ripple figure of instant acceleration history of reactor building and response spectrum (east-west direction)

Figure 2.1-1 shows the acceleration time history waveform and response spectrum observed on the reactor building's base mat for Unit 2, as an example. In this observed record, the acceleration exceeded the response spectrum by the basic design earthquake ground motion  $S_s$  in some periodic bands but it was almost in the same range.

(Note: The recording equipment was interrupted due to the earthquake)

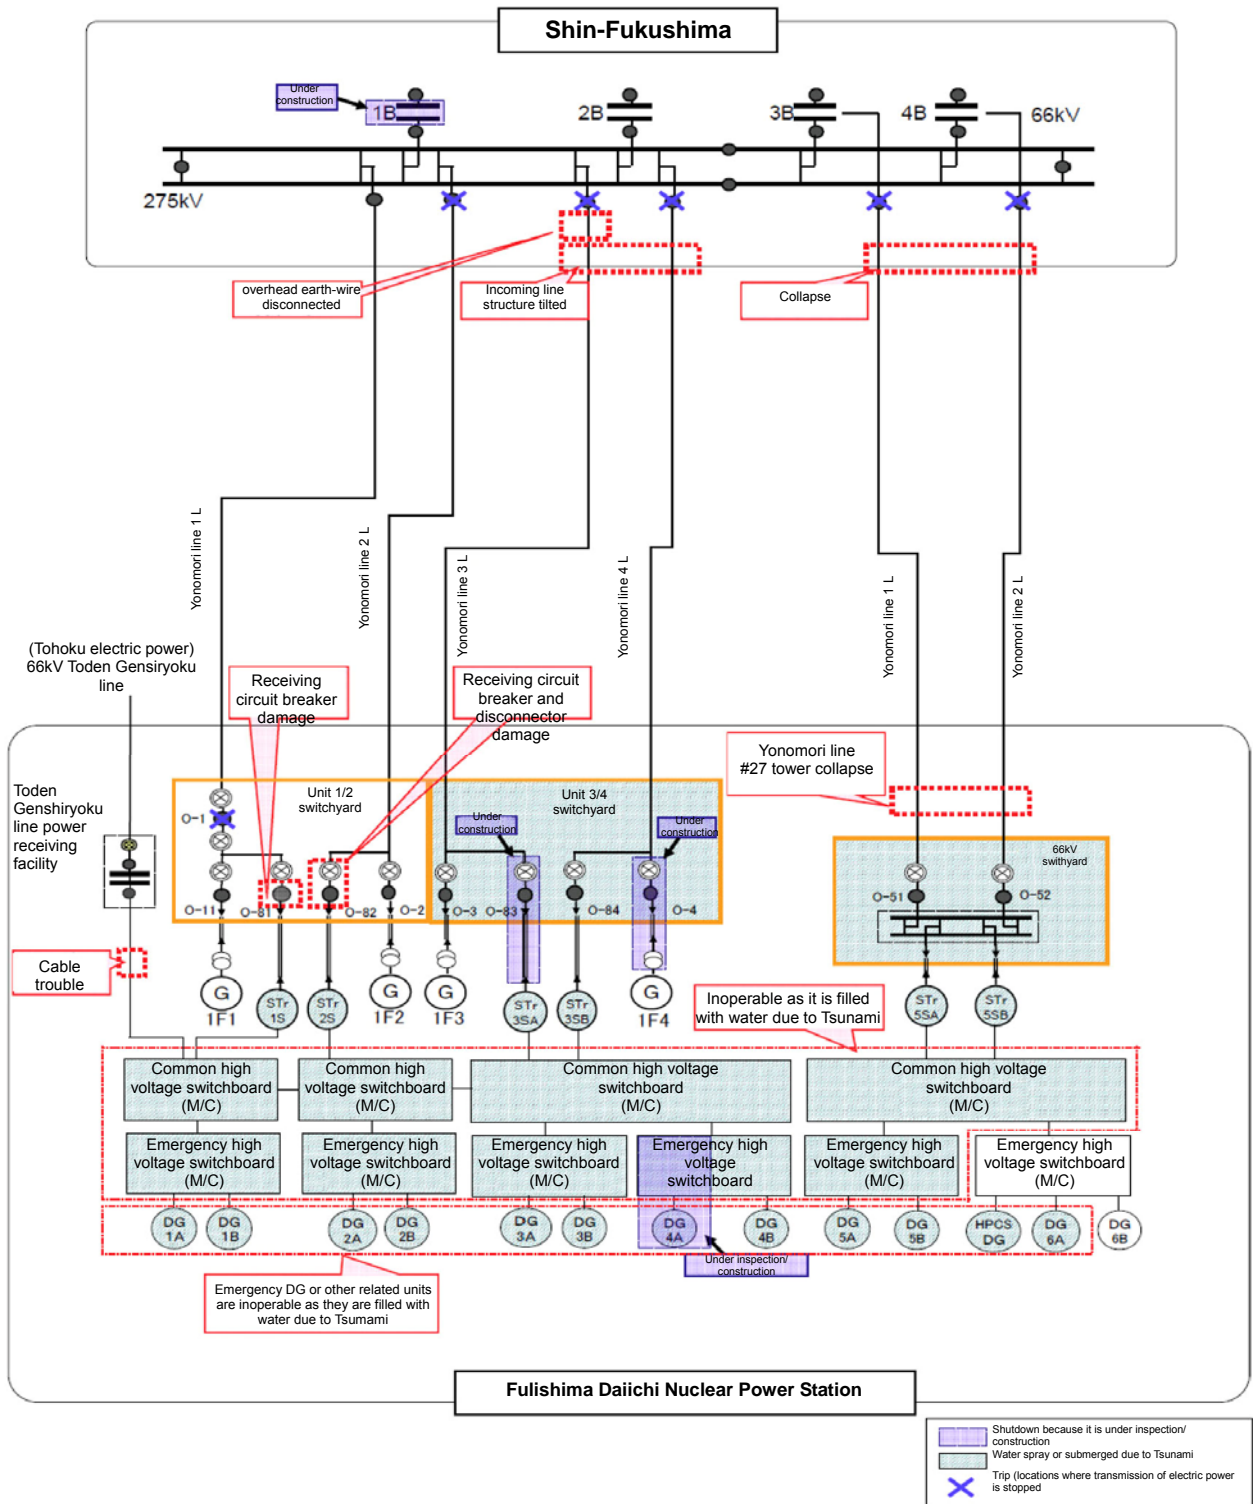
Figure 2.1-2 Outline figure of external power supply control system (after earthquake, before tsunami)

The earthquake damaged the breakers, and such like of the switchyards of Units 1 and 2 as well as the cable of TEPCO Genshiryoku line from Tohoku-Electric Power Company. For Units 3 and 4, the equipment for the No. 3 line and No. 4 line on the Shinfukushima substation side was damaged. For Units 5 and 6, one transmission tower connected to the switchyards collapsed. As a result, all the external power sources from Unit 1 through Unit 6 were lost.

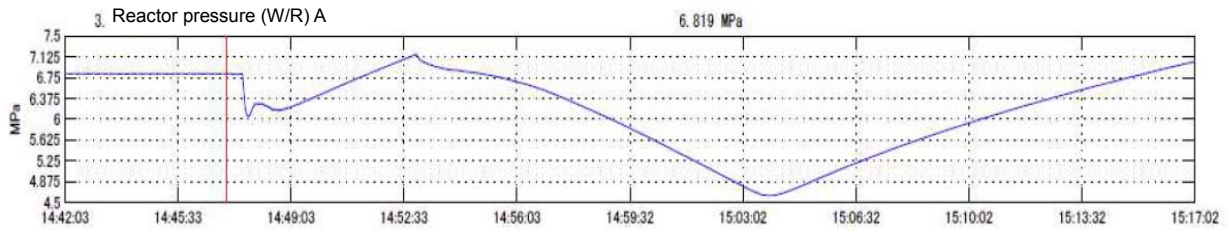
Fig. 2.1-3-1 Unit 1's reactor pressure (trend data by transient recorder)

As shown in Figs. 2.1-3-1 to -3, the RPV pressure of Units 1 to 3 fluctuated, according to the operation of each component, before the tsunami arrived following the earthquake. No rapid drop in pressure and no continuation of its decreasing tendency, as observed when the piping of the reactor coolant pressure boundary fractures, were shown. In a similar way, although a rise in the temperature in the PCV due to the stop of air conditioning was shown in Fig. 2.1-4-1 to 2.1-4-3, the temperature rise was not large in every case and a saturation tendency was seen in the rise. Therefore, it is judged that the temperature rise occurred, but not resulting from the fracture of the piping. Although there has been an argument to see whether the piping had fractured due to the earthquake before the tsunami arrived, we think the piping of the reactor coolant pressure boundary was sound.

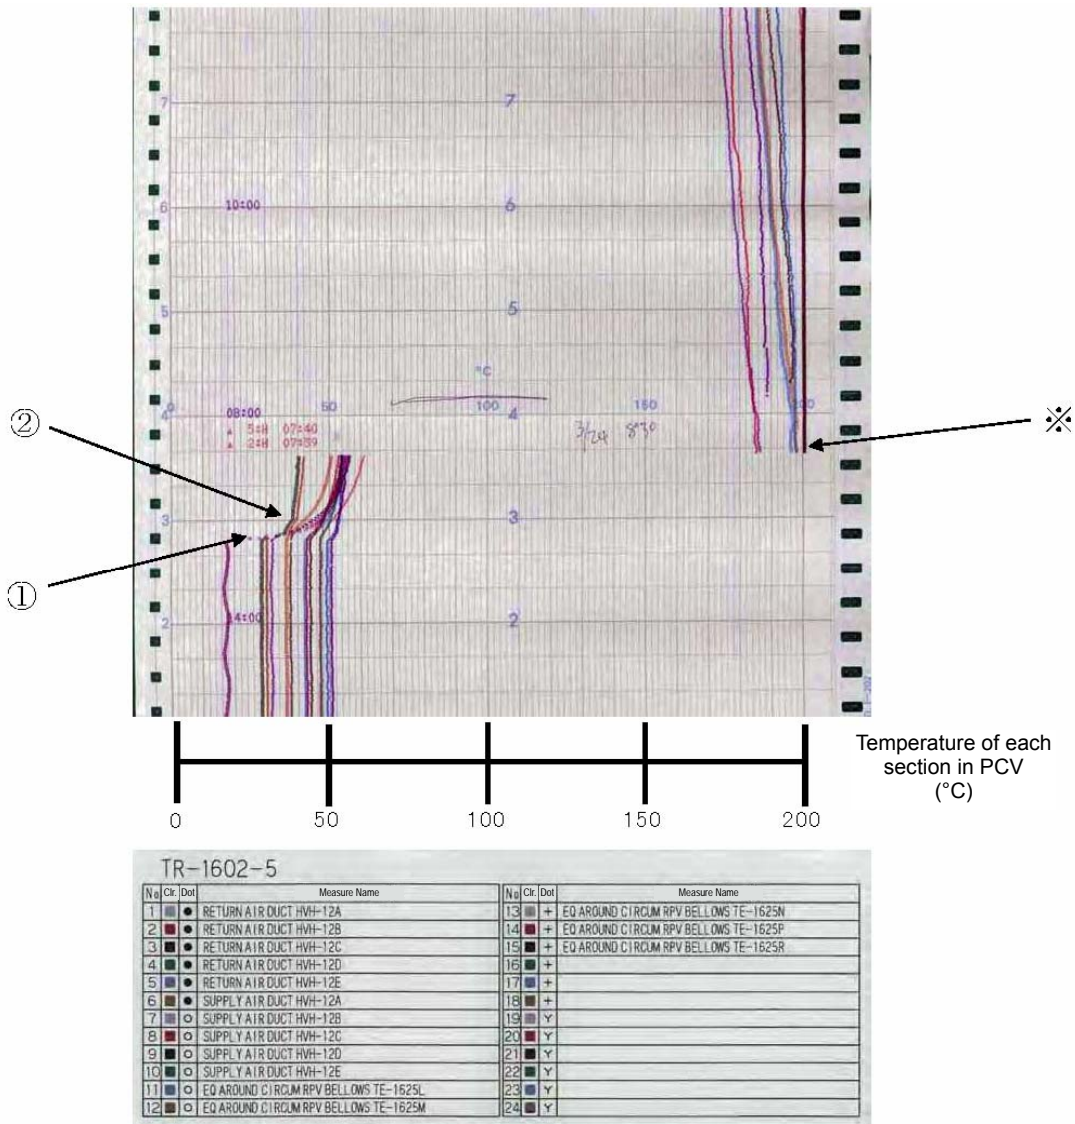
Fig. 2.1-4-1 Temperature of each section in Unit 1's primary containment vessel

- (1) 14:46 Scram due to the earthquake
  - (2) Temperature rise of the PCV because the containment air handling system stopped due to loss of power (no excessive rise in temperature attributable to piping rupture, and such like was observed).
- \* After 15:30, the recorder power was lost due to arrival of the tsunami and the recorder once stopped. Recording was resumed after the recorder power was restored on March

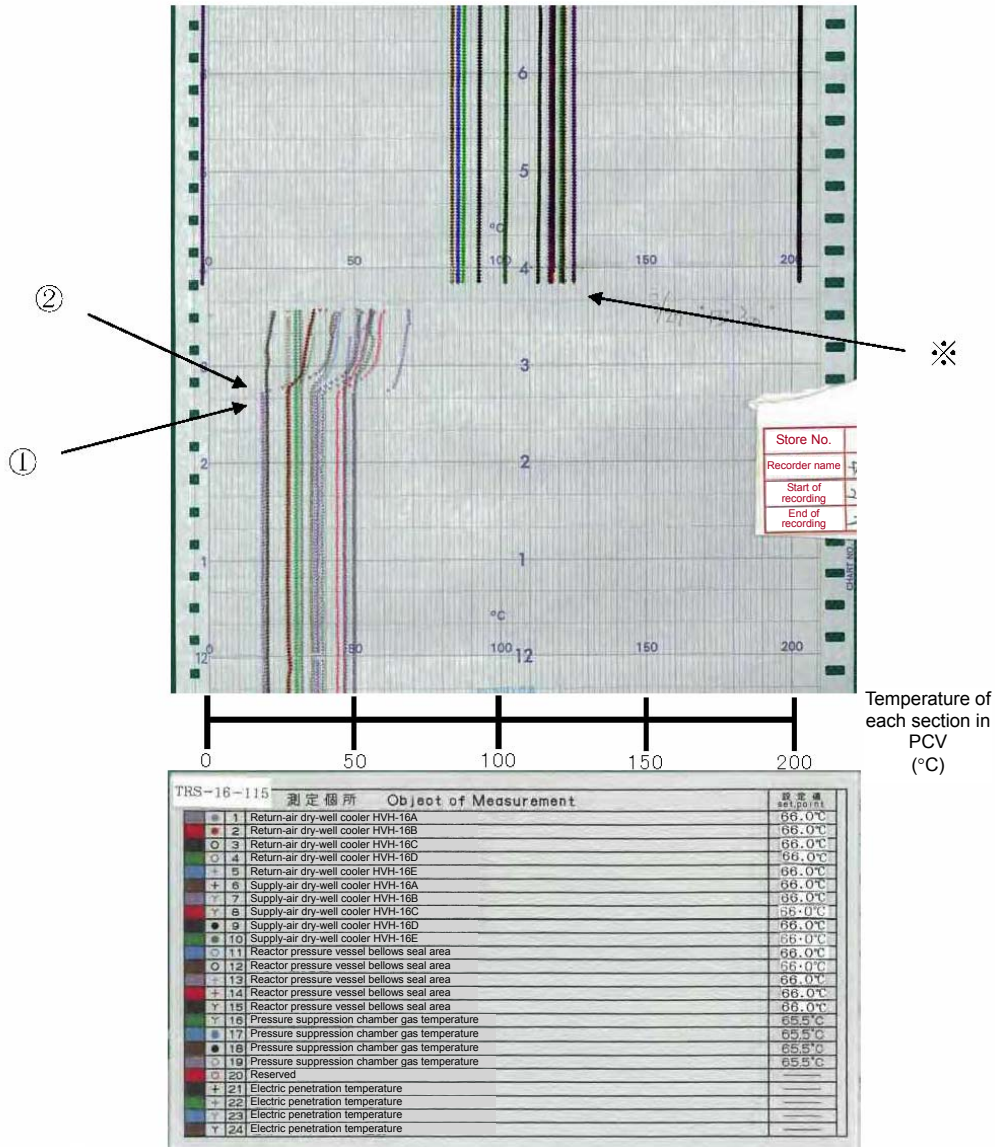
Fig. 2.1-4-2 Temperature of each section in Unit 2's primary containment vessel

(1) 14:47 Scram due to the earthquake  
 (2) Temperature rise of the PCV because the containment air handling system stopped due to loss of power (no excessive rise in temperature attributable to piping rupture, and such like was observed).  
 \*It is assumed that the tsunami arrived after 15:30. It is also assumed that an accurate indication was not shown due to the effect of the tsunami. However, the recorder continued recording for a while after that because there was a DC power supply.

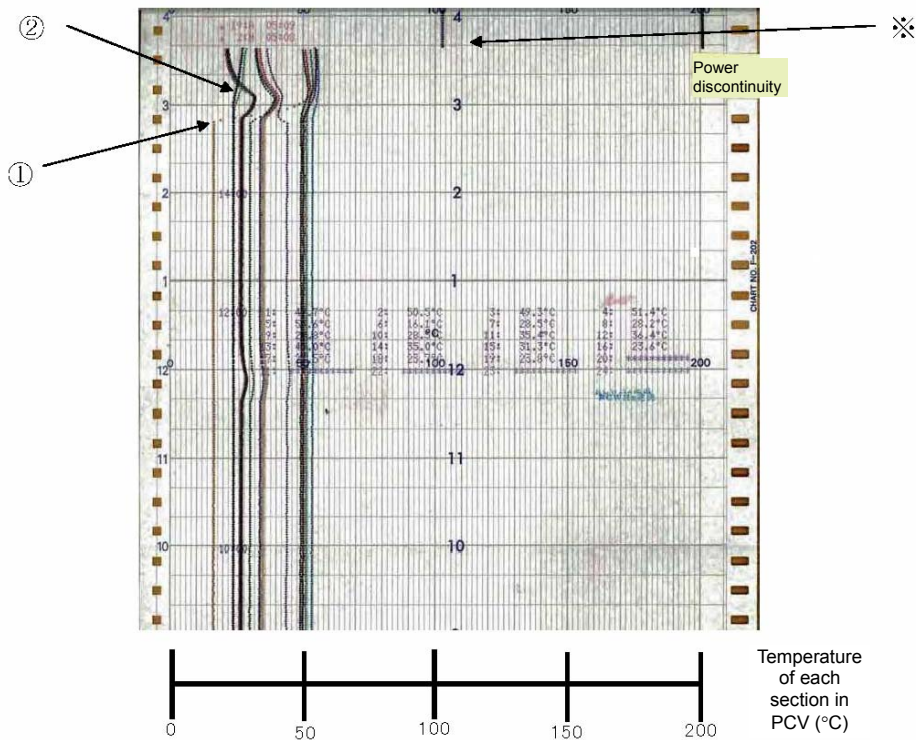
Fig. 2.1-4-3 Temperature of each section in Unit 3's primary containment vessel

- (1) 14:47 Scram due to the earthquake  
 (2) Temperature change in the containment vessel because the containment air handling system stopped due to loss of power and the power decreased due to a scram (no excessive rise in temperature attributable to piping rupture, and such like was observed).  
 \* After 15:30, it is considered that the recorder power was lost due to arrival of the tsunami and the recorder once stopped.

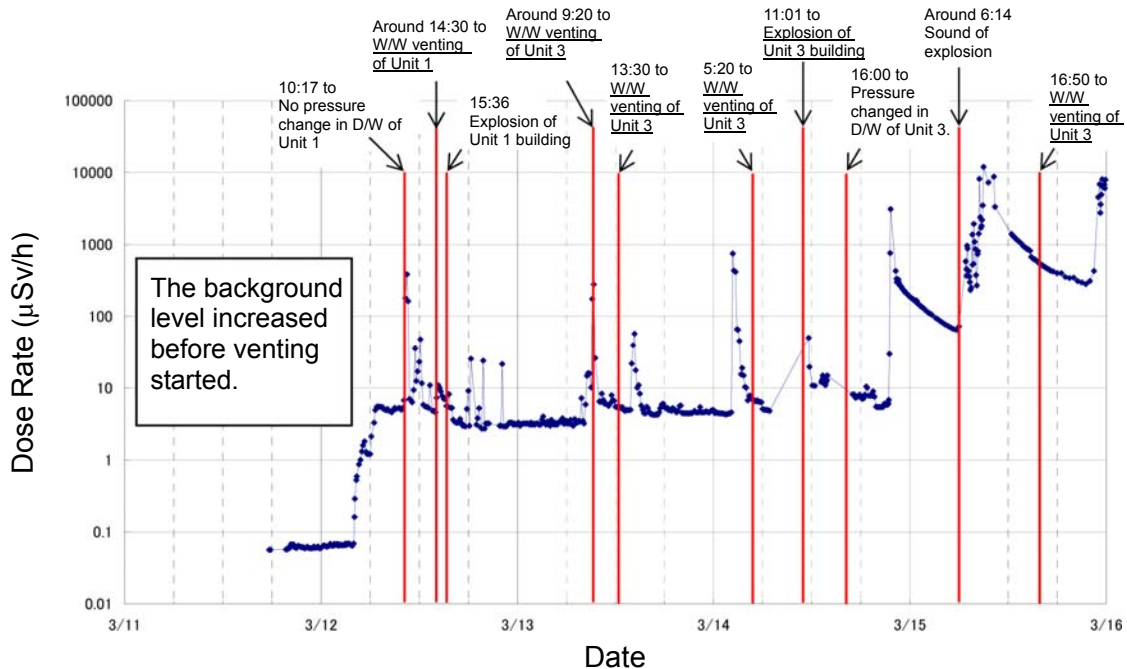
**Fig. 2.8-1 Fukushima Daiichi Nuclear Power Station Fukushima Daiichi Nuclear Power Station Nuclear Power Plant Dose Rate in the Vicinity of Main Gate**

As the MP halted, the dose rate around the power station could not be measured with MP. However, measurements were carried out with the monitoring car that was deployed as a replacement of MP in the vicinity of the main gate of the station. Figure 2.8-1 shows the measurement results.

For the dose rate, no big change in the background level before and after these vent operations was observed. However, from 4:00 to 7:00 on March 12, the dose rate increased. In addition, around 6:14 on March 15, the sound of an explosion was confirmed, and the background level of the dose rate increased before and after it.

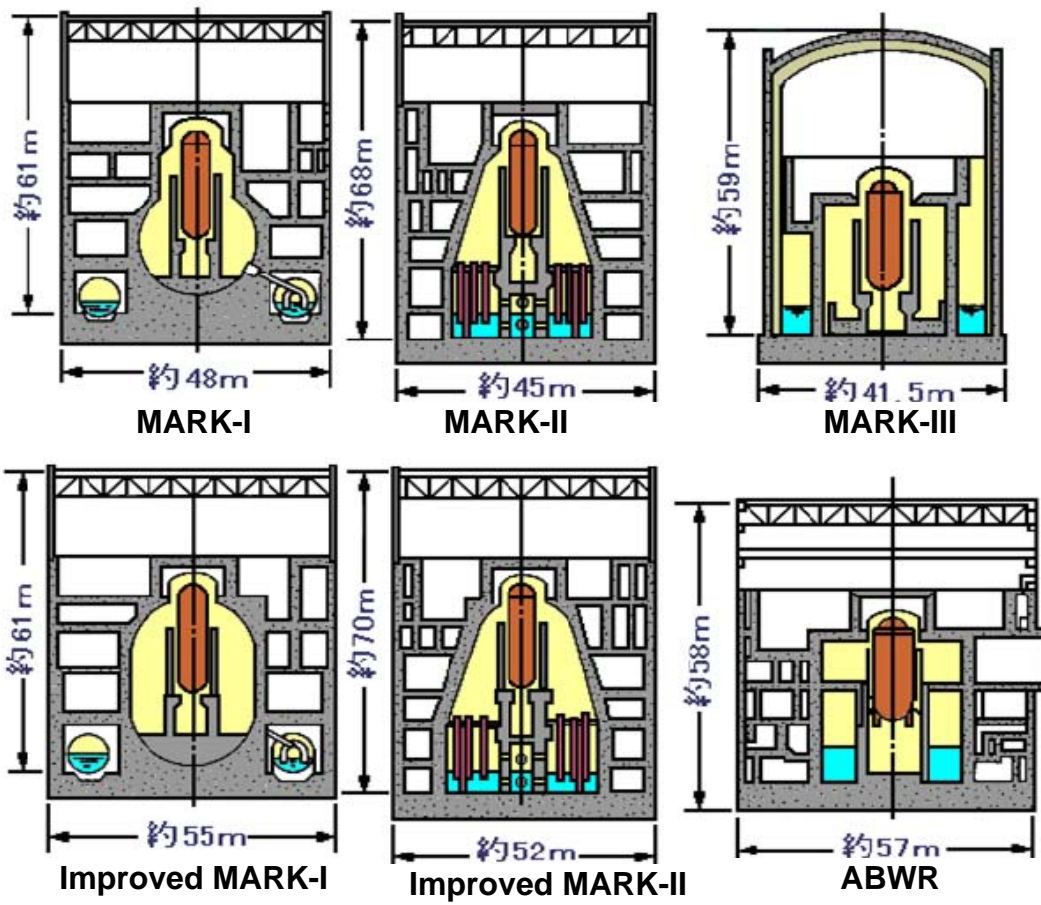
Figure Appendix 6-1

A comparison of MARK-I Containment and MARK-II Containment is indicated in Figure Appendix 6-1.

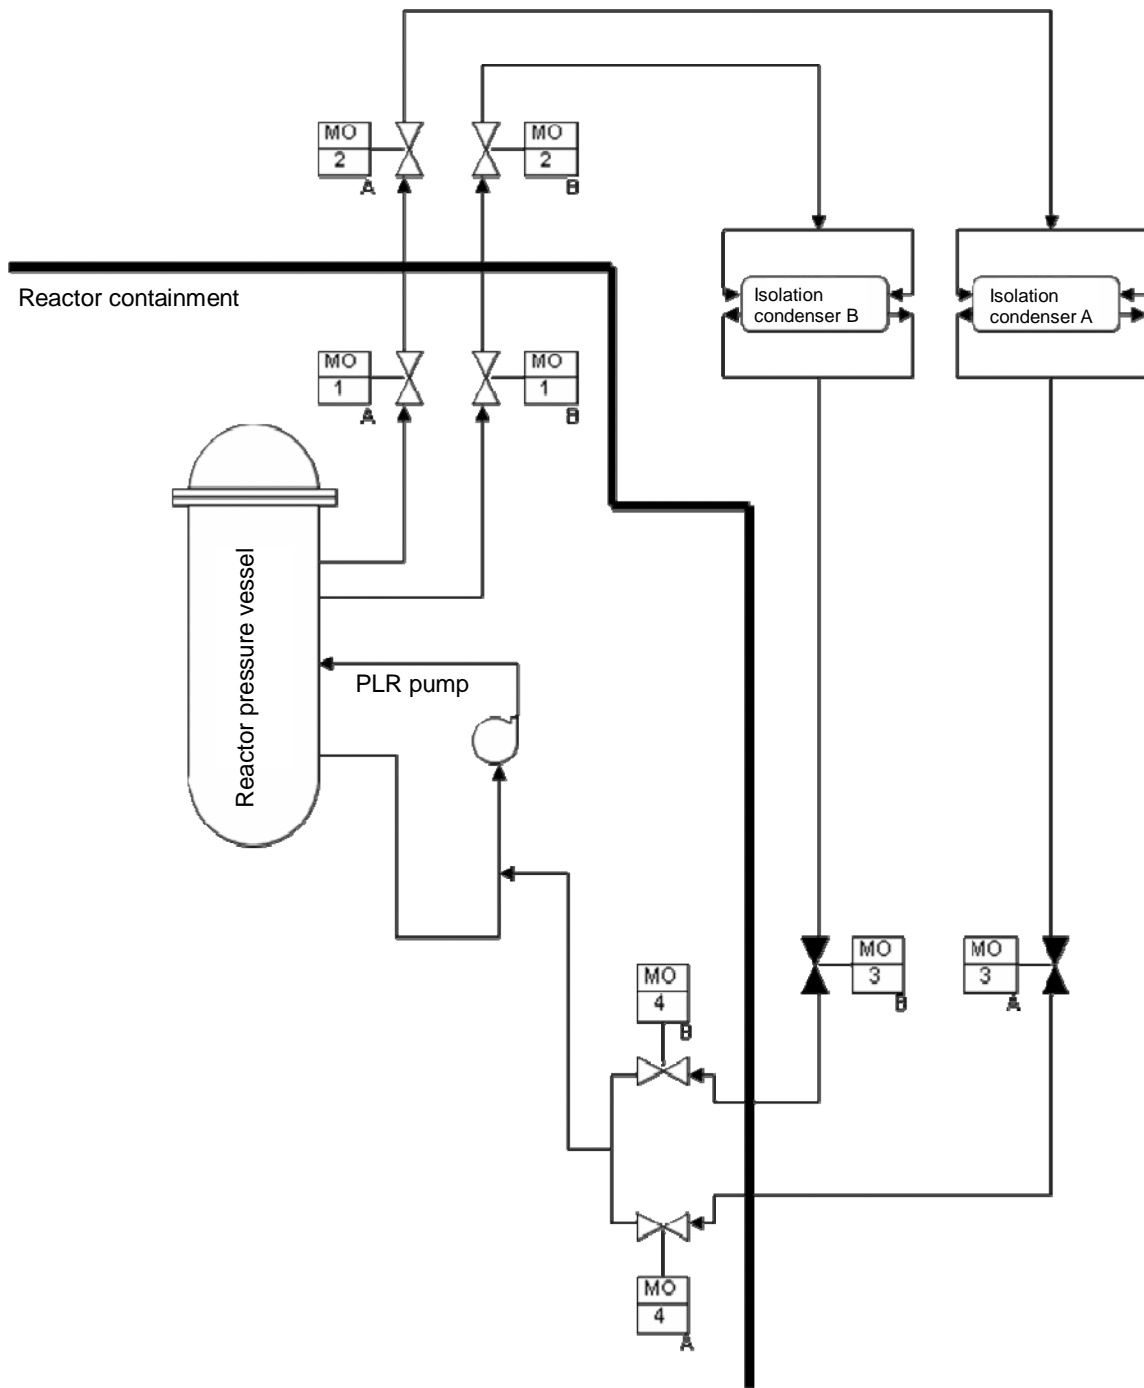
**Figure Reference1-3 Isolation condenser**

##### (1) About the operating condition of the Unit 1 IC (Description in the interim report)

Accurately realizing that the IC failed to function, we should have performed alternative water injection in an early point.

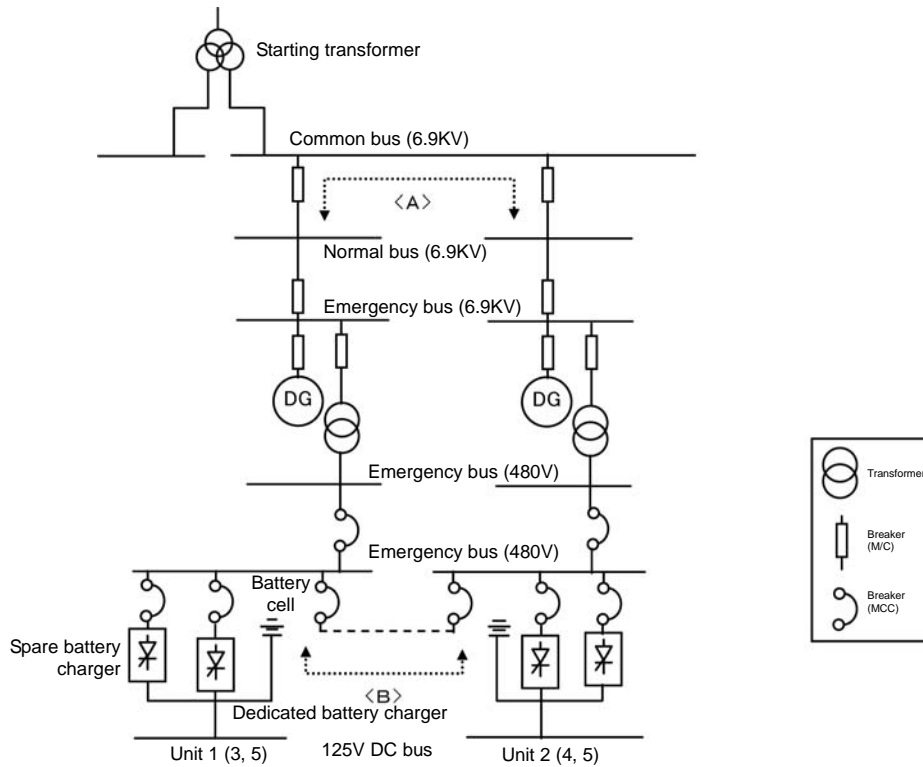
**Figure Reference 1-8 Power supply interchange**

- <A> Route: Interchanges 6.9KV AC power supply.  
(Operation at M/C is possible only if DC power is available)
- <B> Route: Interchanges 480V AC power supply.  
(MCC is manually operated. MCC is normally open and its access is controlled by key lock.)
