# **Examination of Accident at Tokyo Electric Power Co., Inc.'s Fukushima Daiichi Nuclear Power Station and Proposal of Countermeasures**

**October 2011**

**Japan Nuclear Technology Institute**

**Examination Committee on Accident at Fukushima Daiichi Nuclear  
Power Station**

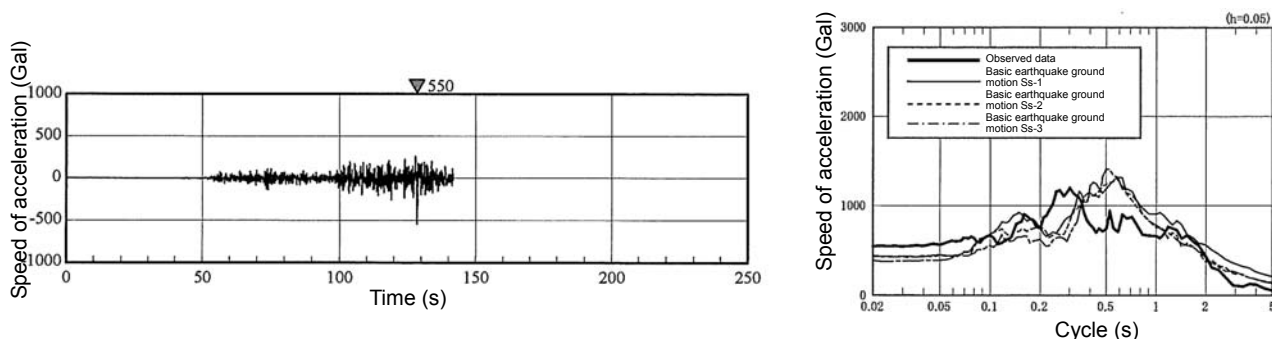
Figure 2.1-1 Ripple figure of instant acceleration history of reactor building and response spectrum (east-west direction)

Figure 2.1-1 shows the acceleration time history waveform and response spectrum observed on the reactor building's base mat for Unit 2, as an example. In this observed record, the acceleration exceeded the response spectrum by the basic design earthquake ground motion Ss in some periodic bands but it was almost in the same range.

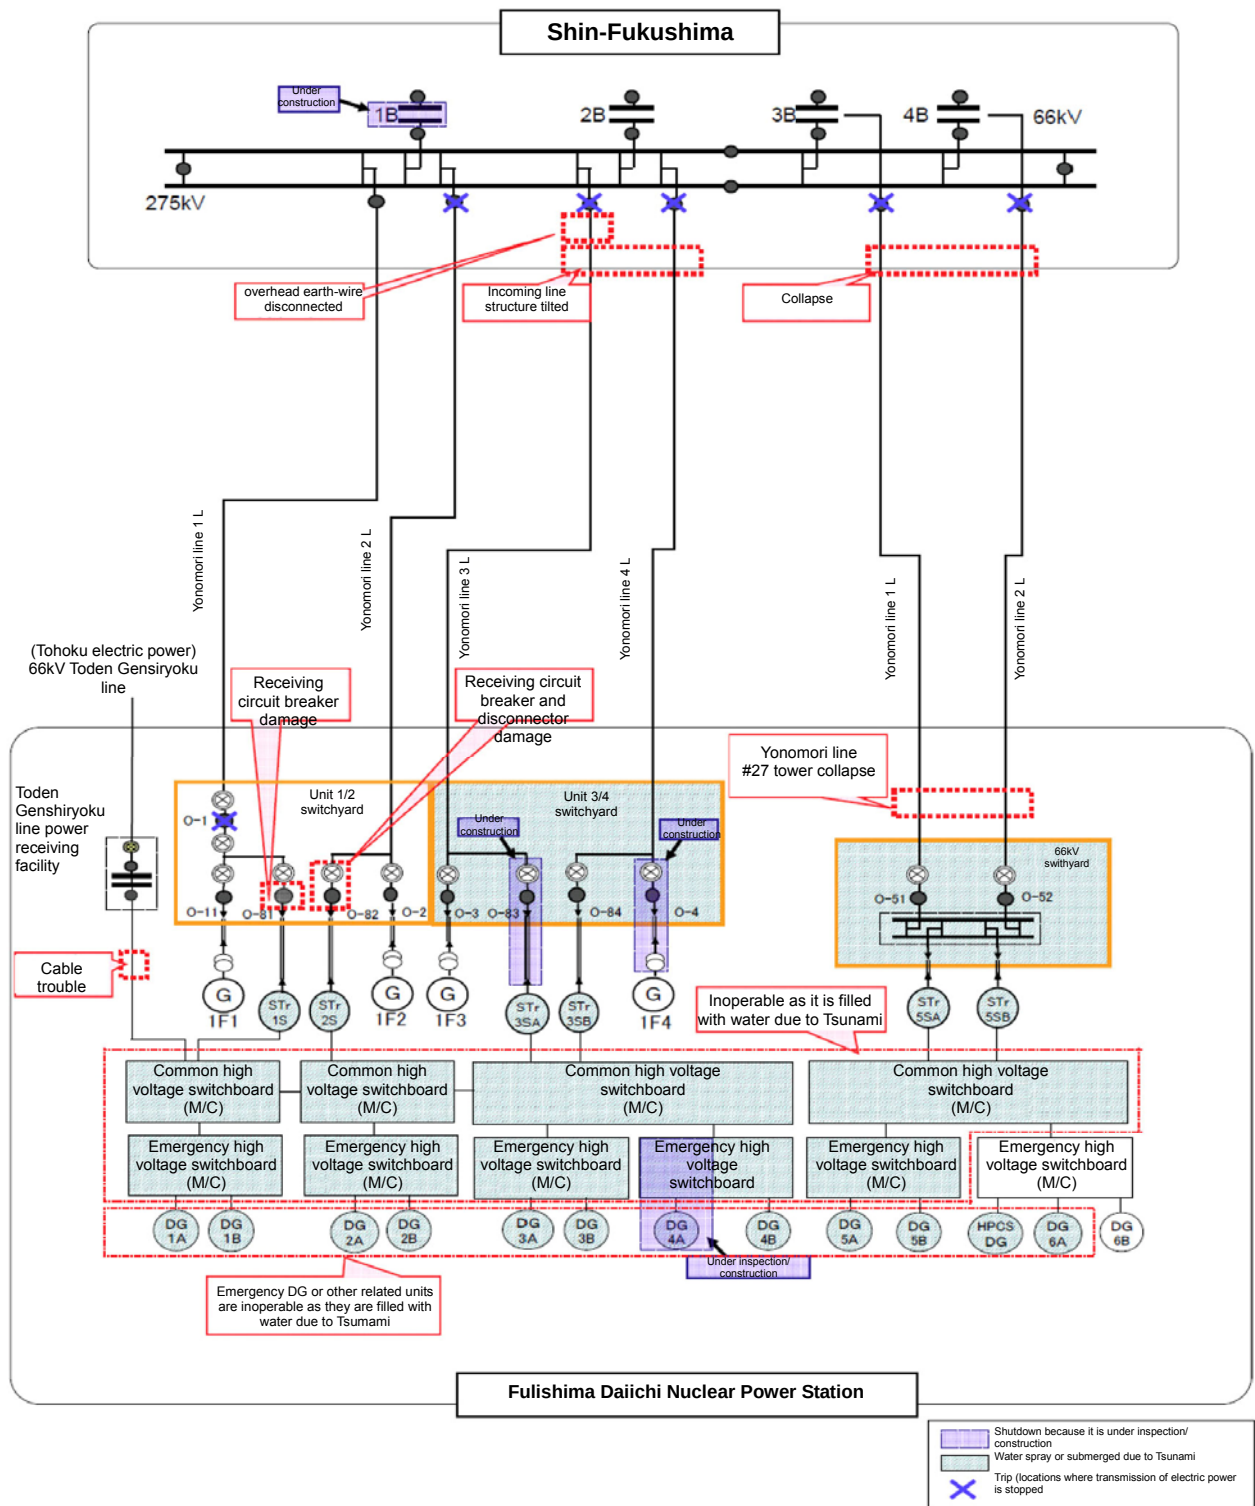
Figure 2.1-2 Outline figure of external power supply control system (after earthquake, before tsunami)

The earthquake damaged the breakers, and such like of the switchyards of Units 1 and 2 as well as the cable of TEPCO Genshiryoku line from Tohoku-Electric Power Company. For Units 3 and 4, the equipment for the No. 3 line and No. 4 line on the Shinfukushima substation side was damaged. For Units 5 and 6, one transmission tower connected to the switchyards collapsed. As a result, all the external power sources from Unit 1 through Unit 6 were lost.

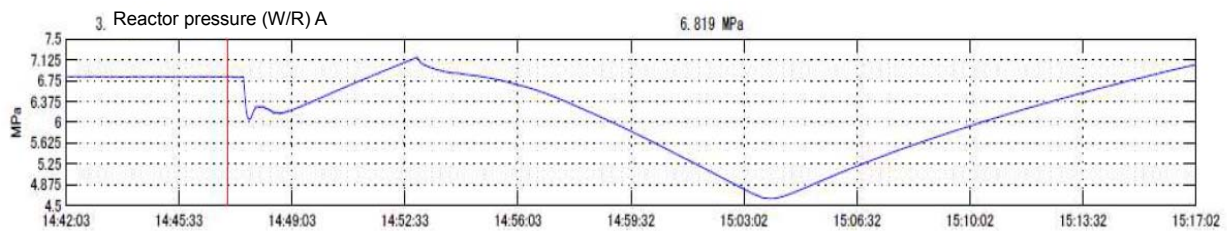
Fig. 2.1-3-1 Unit 1's reactor pressure (trend data by transient recorder)

As shown in Figs. 2.1-3-1 to -3, the RPV pressure of Units 1 to 3 fluctuated, according to the operation of each component, before the tsunami arrived following the earthquake. No rapid drop in pressure and no continuation of its decreasing tendency, as observed when the piping of the reactor coolant pressure boundary fractures, were shown. In a similar way, although a rise in the temperature in the PCV due to the stop of air conditioning was shown in Fig. 2.1-4-1 to 2.1-4-3, the temperature rise was not large in every case and a saturation tendency was seen in the rise. Therefore, it is judged that the temperature rise occurred, but not resulting from the fracture of the piping. Although there has been an argument to see whether the piping had fractured due to the earthquake before the tsunami arrived, we think the piping of the reactor coolant pressure boundary was sound.

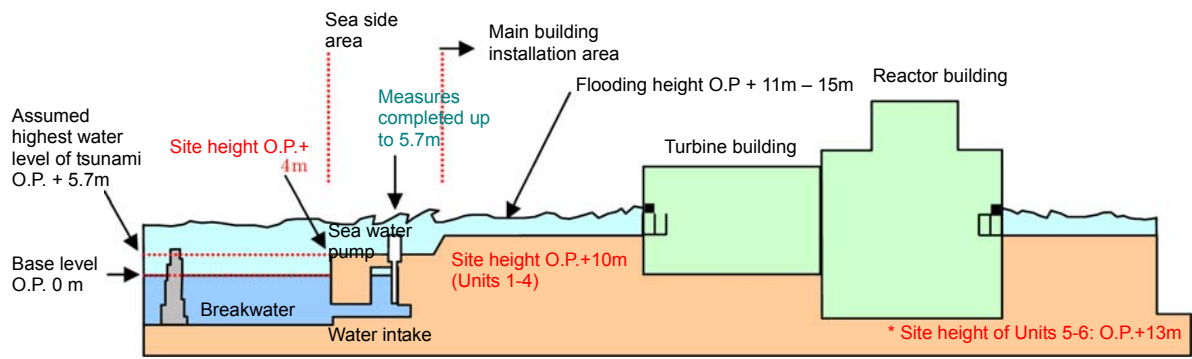
Figure 2.1-3 Situation of tsunami

It is thought that the surrounding area of the main building, which is on a site of O.P. +10 m and O.P. +13 m, was almost flooded by the tsunami. However, no significant damage was confirmed to the construction of the outer wall or pillars of the main building. However, mainly considering the east side (sea side) of the T/B of Unit 1 to 4, parts of the door or shutter and such like installed at the entrance, were damaged by the tsunami. Parts of the entrance above the ground of the main building (entrance and exit of the main building and the entrance for moving the instruments (hatch), exhaust outlet (louver) or entrance connecting to the trench or ducts laid underground on the site (the penetration entrance for cables or plumbing) came in the path of the flood water inside the building and the flood water flowed through the passages or the stairs and flooded a large underground area.

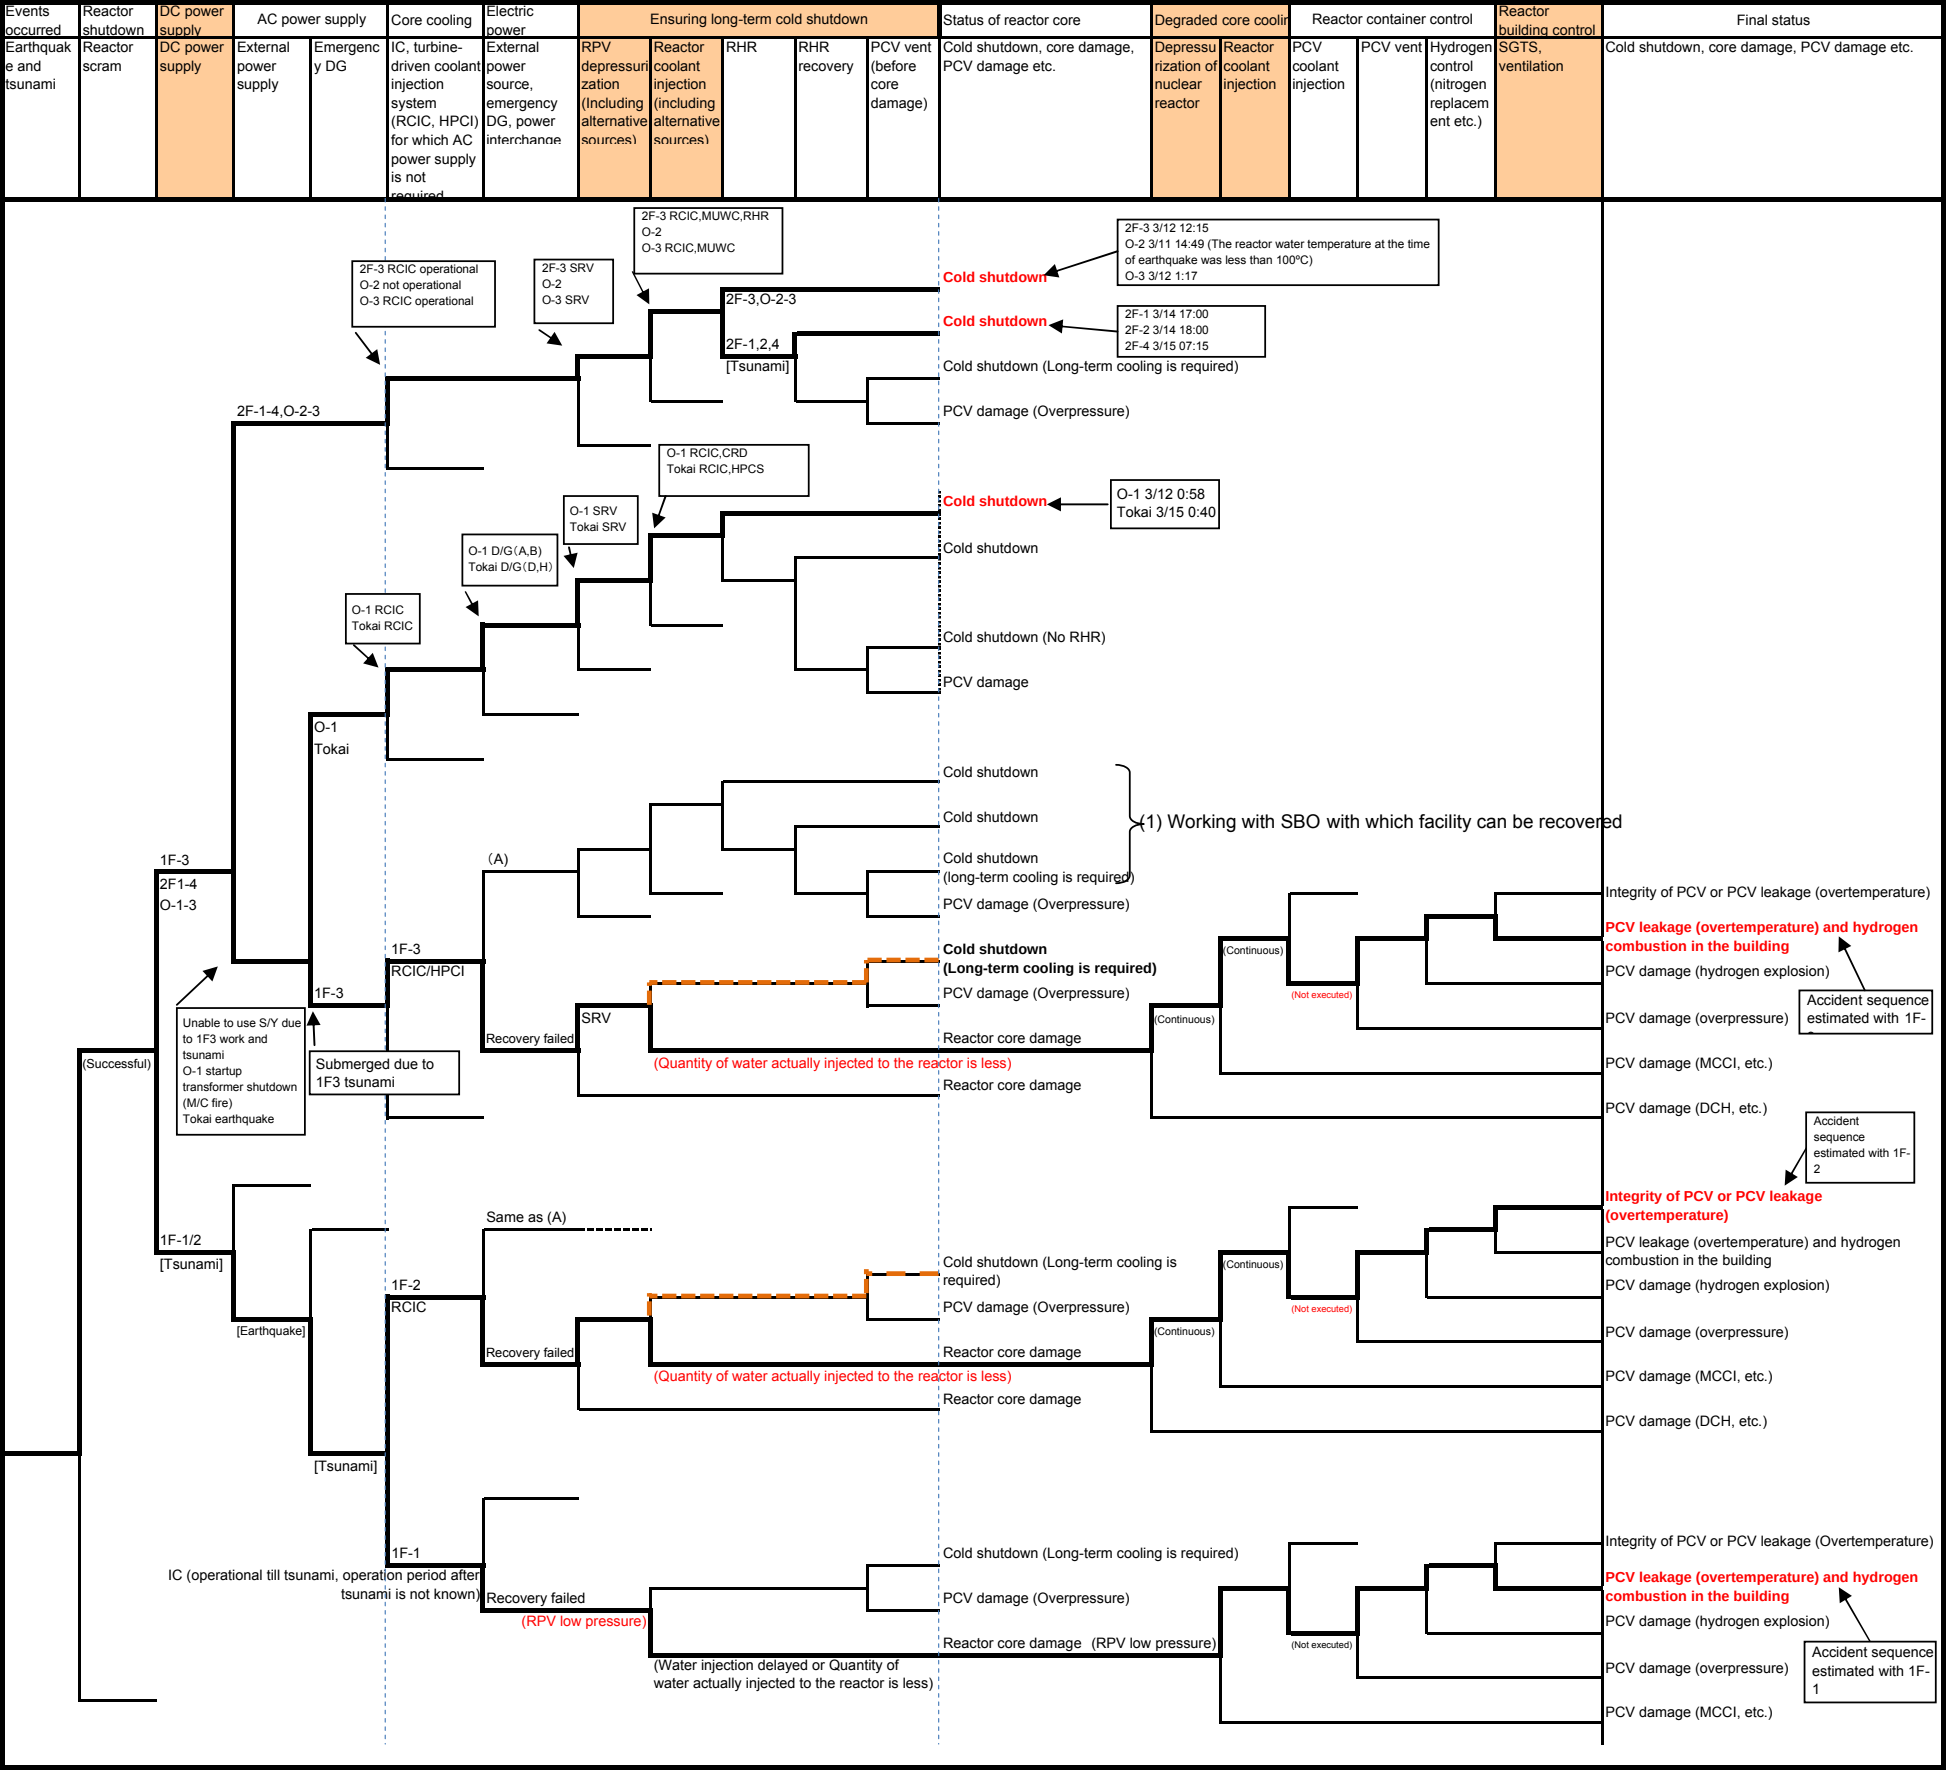
Figure 3.6-1 Disaster identification events tree in Fukushima Daiichi Nuclear Station Units 1 to 3, Fukushima Daini, Onagawa, Tokai Daini

As shown in Fig. 3.6-1, the course of events in Fukushima Daiichi Units 1 to 3 and other stations differ from the heading of the AC power supply (the external power supply or the emergency DG), and the power supply was secured in all the other stations as a result, which prevented the accident from escalating.

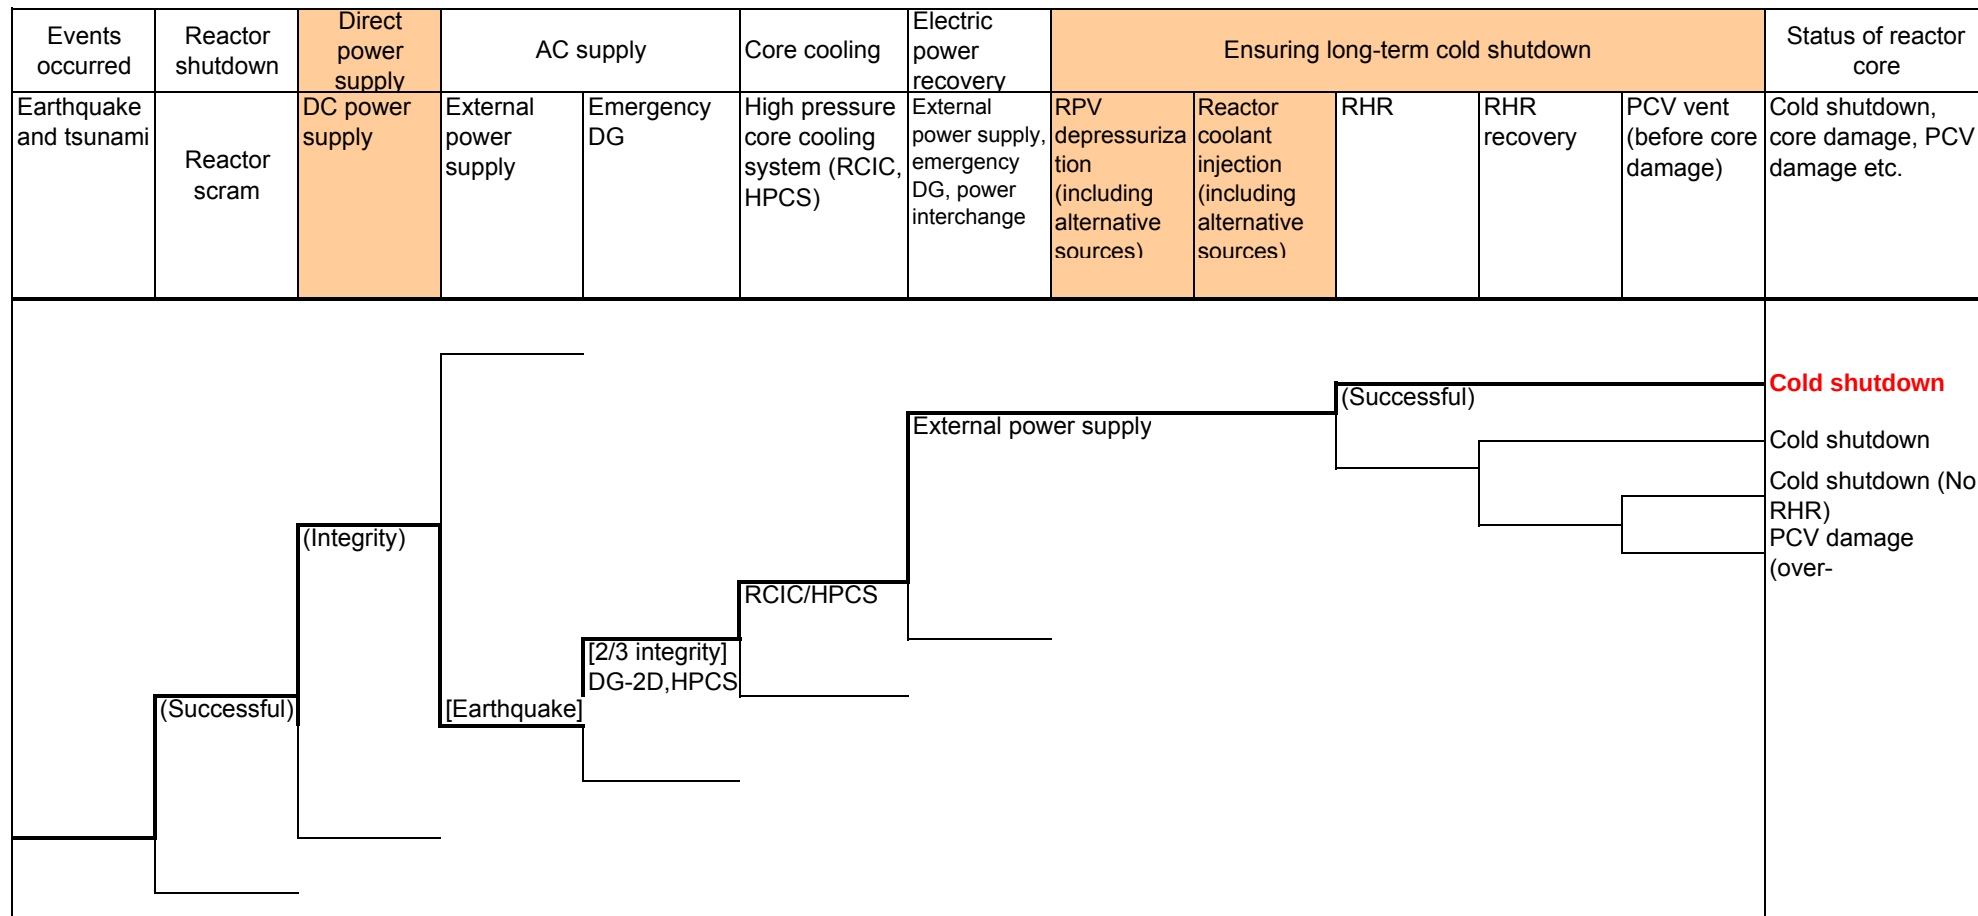
**Figure Appendix 1-3 Toukai Daini Nuclear Power Station disaster identification events tree**

Thereafter, under the impact of tsunami, seawater pumps for cooling Emergency DG2C were automatically shut down, which resulted in the Emergency DG2C becoming unusable. Nevertheless, emergency power could be secured by operating the remaining 2 emergency DGs without causing any disturbance to the cooling function for the reactor and SFP. At 00:40 on March 15, the cold shutdown of the reactor was achieved.

The Emergency DG seawater pump (2C) shut down due to the intrusion of seawater into the north pump tank under the impact of tsunami. This event caused the Emergency DG2C to become unusable, which led to the power loss of the Emergency AC Power Bus 2C.
