# **Examination of Accident at Tokyo Electric Power Co., Inc.'s Fukushima Daiichi Nuclear Power Station and Proposal of Countermeasures**

**October 2011**

**Japan Nuclear Technology Institute**

**Examination Committee on Accident at Fukushima Daiichi Nuclear  
Power Station**

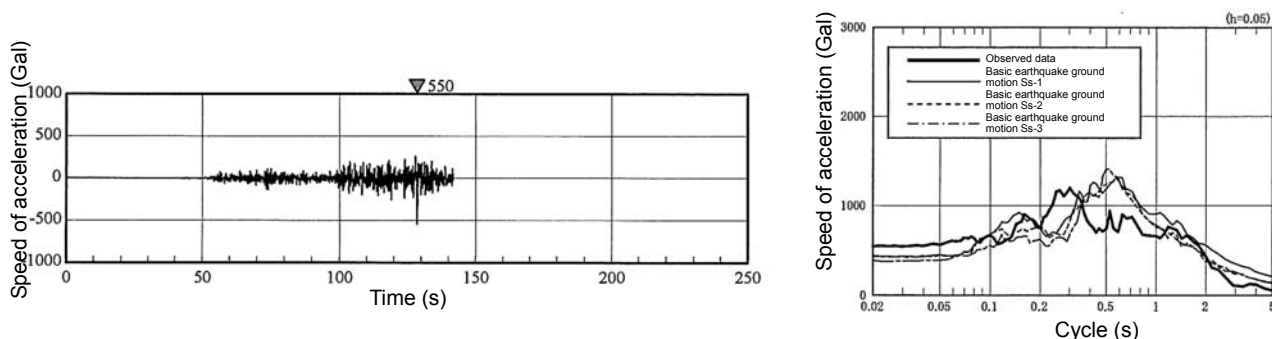
Figure 2.1-1 Ripple figure of instant acceleration history of reactor building and response spectrum (east-west direction)

Figure 2.1-1 shows the acceleration time history waveform and response spectrum observed on the reactor building's base mat for Unit 2, as an example. In this observed record, the acceleration exceeded the response spectrum by the basic design earthquake ground motion Ss in some periodic bands but it was almost in the same range.

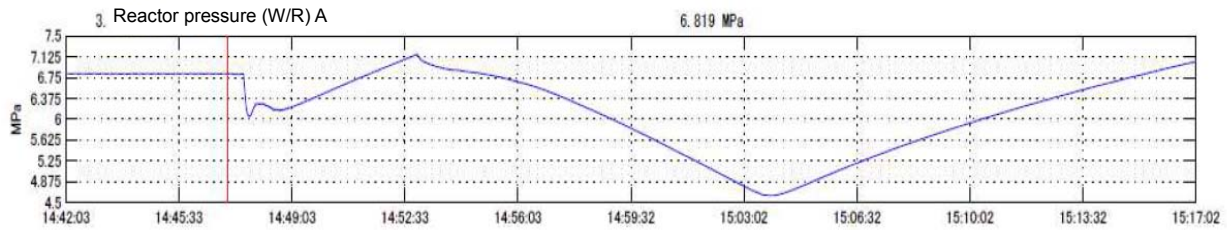
Fig. 2.1-3-1 Unit 1's reactor pressure (trend data by transient recorder)

As shown in Figs. 2.1-3-1 to -3, the RPV pressure of Units 1 to 3 fluctuated, according to the operation of each component, before the tsunami arrived following the earthquake. No rapid drop in pressure and no continuation of its decreasing tendency, as observed when the piping of the reactor coolant pressure boundary fractures, were shown. In a similar way, although a rise in the temperature in the PCV due to the stop of air conditioning was shown in Fig. 2.1-4-1 to 2.1-4-3, the temperature rise was not large in every case and a saturation tendency was seen in the rise. Therefore, it is judged that the temperature rise occurred, but not resulting from the fracture of the piping. Although there has been an argument to see whether the piping had fractured due to the earthquake before the tsunami arrived, we think the piping of the reactor coolant pressure boundary was sound.

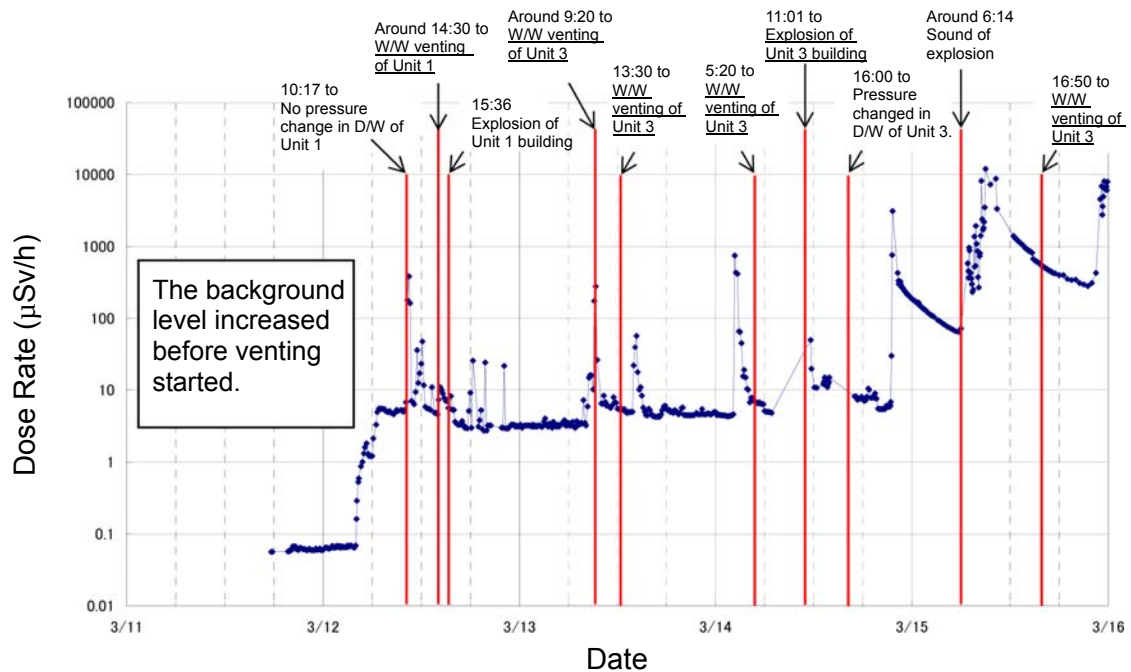
**Fig. 2.8-1 Fukushima Daiichi Nuclear Power Station Nuclear Power Plant  
Dose Rate in the Vicinity of Main Gate**

For the dose rate, no big change in the background level before and after these vent operations was observed. However, from 4:00 to 7:00 on March 12, the dose rate increased. In addition, around 6:14 on March 15, the sound of an explosion was confirmed, and the background level of the dose rate increased before and after it.
