Examination of the Accident of the Tokyo Electric Power Co., Inc.'s Fukushima Daiichi Nuclear Power Station and Proposal of Countermeasures (Draft)

October, 2011

Japan Nuclear Technology Institute

Examination Committee on the Accident of Fukushima Daiichi Nuclear Power Station

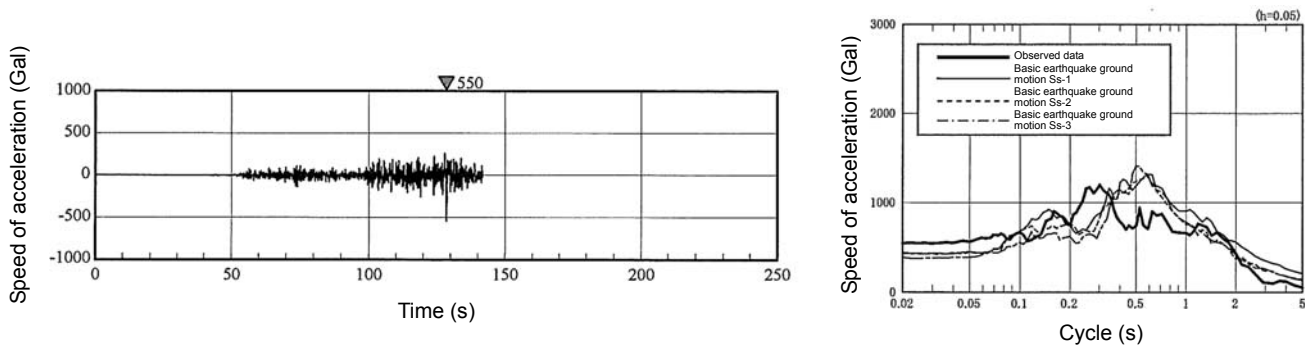
Figure 2.1-1 Ripple Figure of instant acceleration history of reactor building and response spectrum (East-west direction)

As shown in the Figure 2.1-1, the peak acceleration values obtained at the lowest basement of the nuclear reactor buildings at the time of this earthquake exceed the values specified in one section of the table corresponding basic earthquake ground motion Ss.

The acceleration time history waveform and response spectrum observed for the basic nuclear reactor unit 2, is displayed as an example, in Figure 2.1-1. In general, the response spectrum exceeds with respect to basic earthquake ground motion similar to what shown by a specific period in this record.

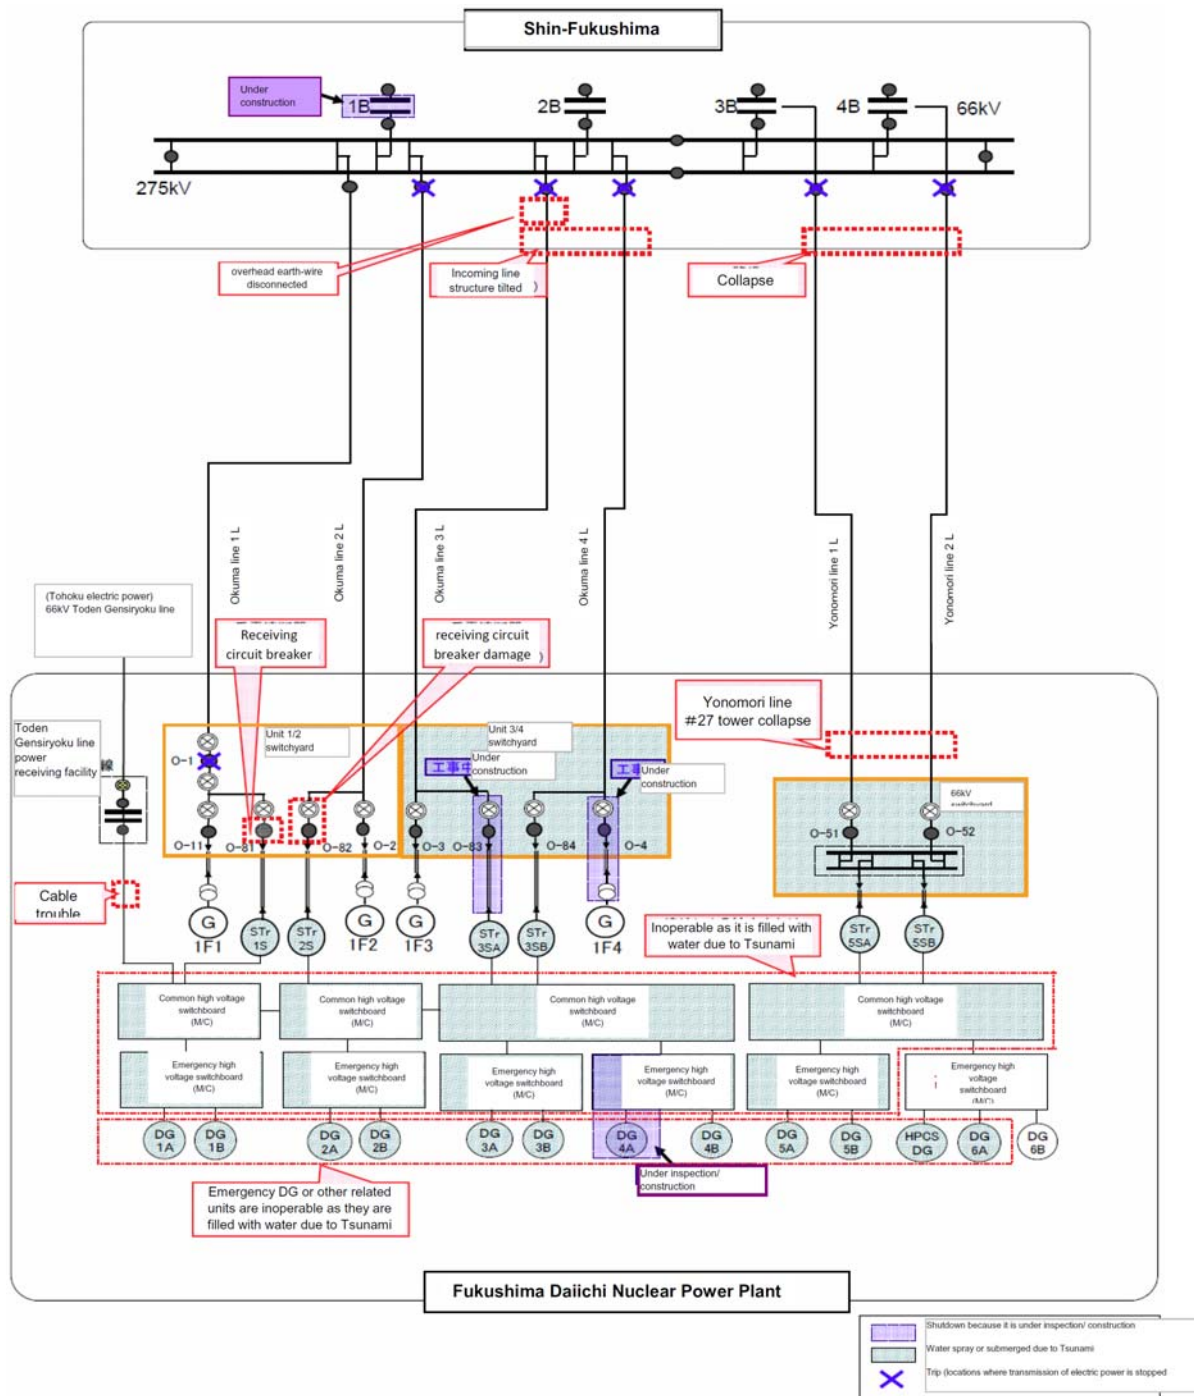
Figure 2.1-2 Outline Figure of external power supply control system (After earthquake, Before tsunami)

Due to this earthquake, the circuit breakers in the switchyard of unit 1 and 2 were damaged; the cables of TEPCO nuclear line from north east power supply also got damaged. One power line connecting to the switchyard of unit 5 and 6 was also destructed. As a result, all the external power supply from unit 1 to unit 6 was lost.

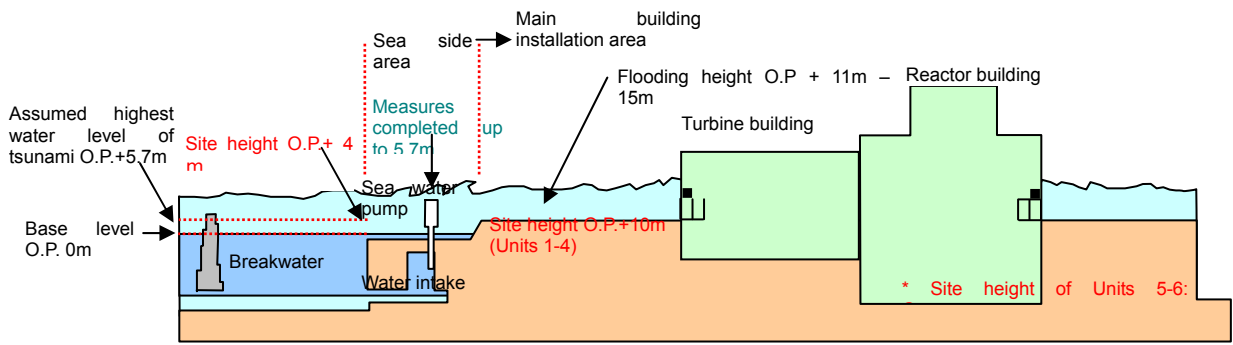
Figure 2.1-3 Situation of Tsunami

It is thought that the surrounding area of the main building which is on the site O.P.+10m as well as O.P.+ 13m, was almost flooded by the tsunami, however, no significant damage is confirmed to the construction of the outer wall as well as pillars of the main building. However, mainly considering the east side (sea side) of the T/B of unit 1~4, parts of the door or shutter etc. installed at the entrance, got damaged due to tsunami. Parts of the entrance above the ground of the main building (entrance and exit of the main building and the entrance for moving the instruments (hatch), exhaust outlet (louver) or entrance connecting to the trench or ducts laid underground on the site (the penetration entrance for cables or plumbing) came in the path of the flood water inside the building and the flood water flow through the passages or the stairs and flooded lot of underground area.

Large number of emergency DGs as well as switchboards which were installed at the basement (height 0m ~ 5.8m) of the reactor building or T/B, got damaged by tsunami, all the units except unit 6 lost the emergency electric supply. Out of the three emergency DGs in unit 6, the DG installed in reactor building did not stop and could get the emergency electric power supply. The main DC busbar of unit 1, 2, 4 was under the flood water and that of 3,5,6 was not under the flood water. The extent of flooding of emergency electric supply, emergency diesel power generation device as well as DC busbar and the impact is described in table 2.1-2.

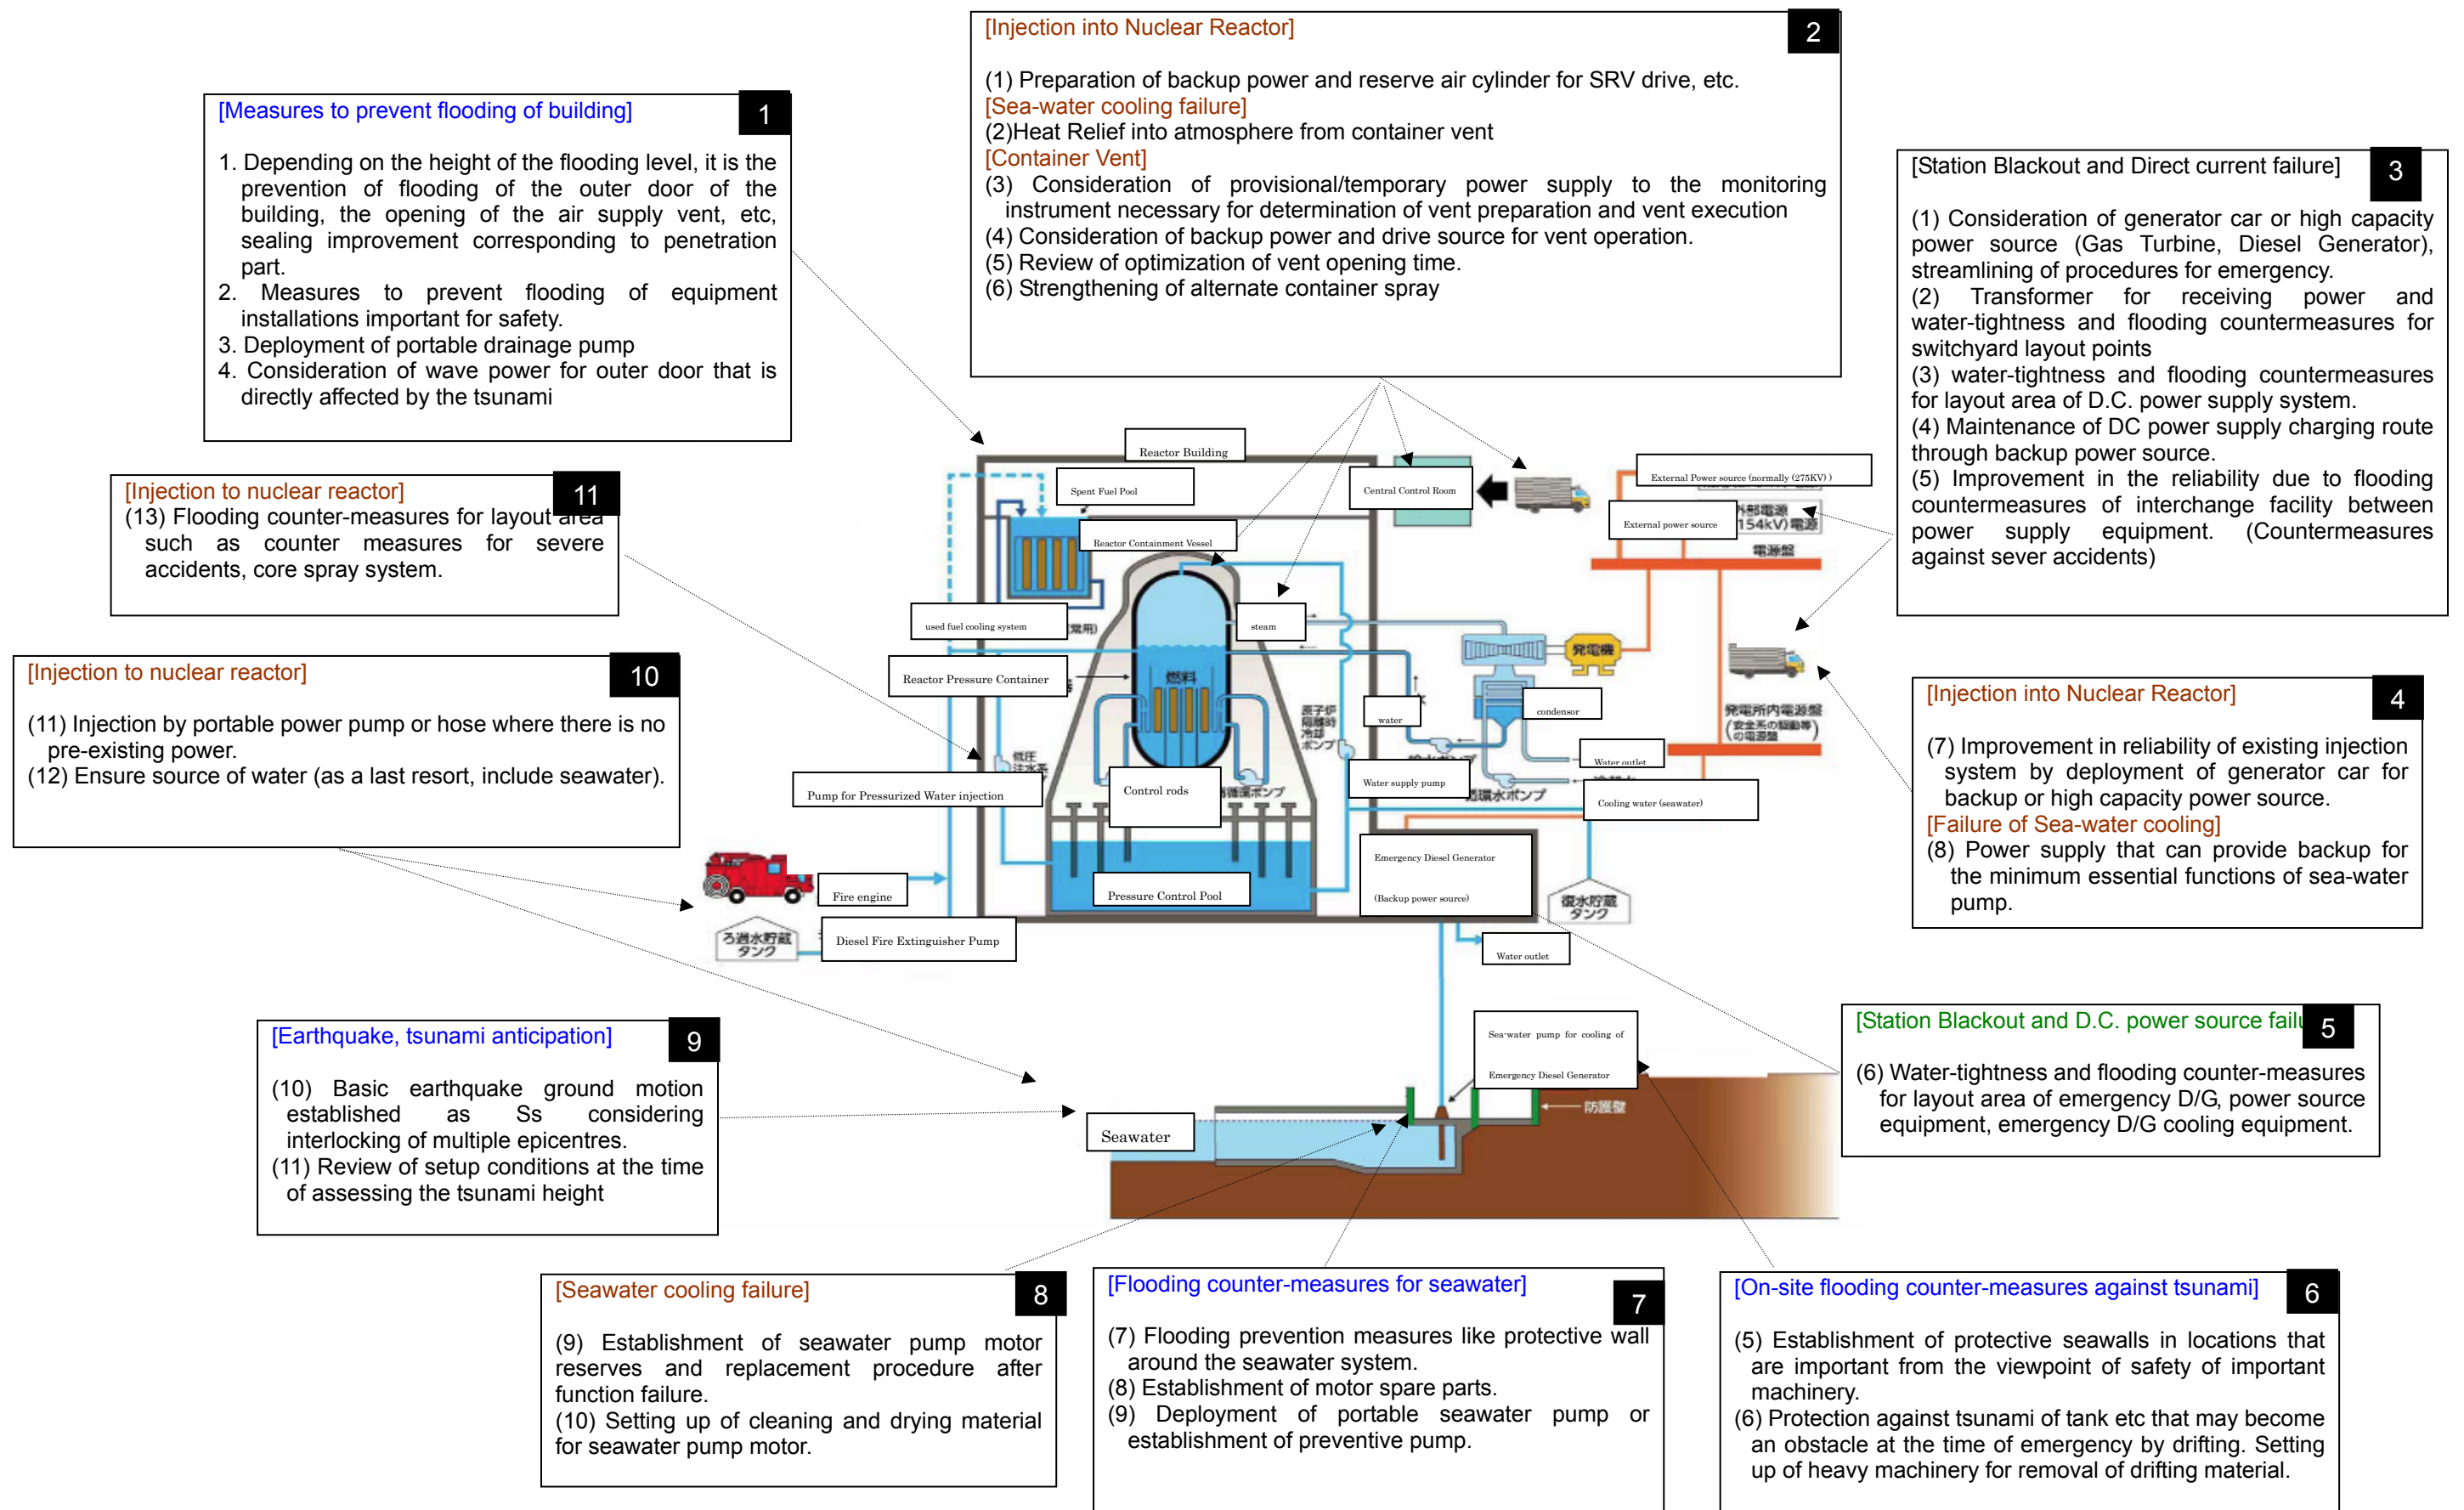
Figure 4.12-1 Examples of Countermeasures 1/3

— PREPARATION AGAINST EARTHQUAKES, TSUNAMI 1, 6, 7, 9, POWER SUPPLY PREPARATION 3, 5, CORRESPONDING HEAT SINK LOSS (BWR) 2, 4, 8, 10, 11

Further, countermeasures are combined by considering safety of the plant as a whole and selecting for implementation. Various combinations of the countermeasures can be considered corresponding to the condition of each power station and the strategy for securing safety, and they are not limited to the above-described countermeasures. All countermeasures that were identified are summarized and shown in Fig. 4.12-1.

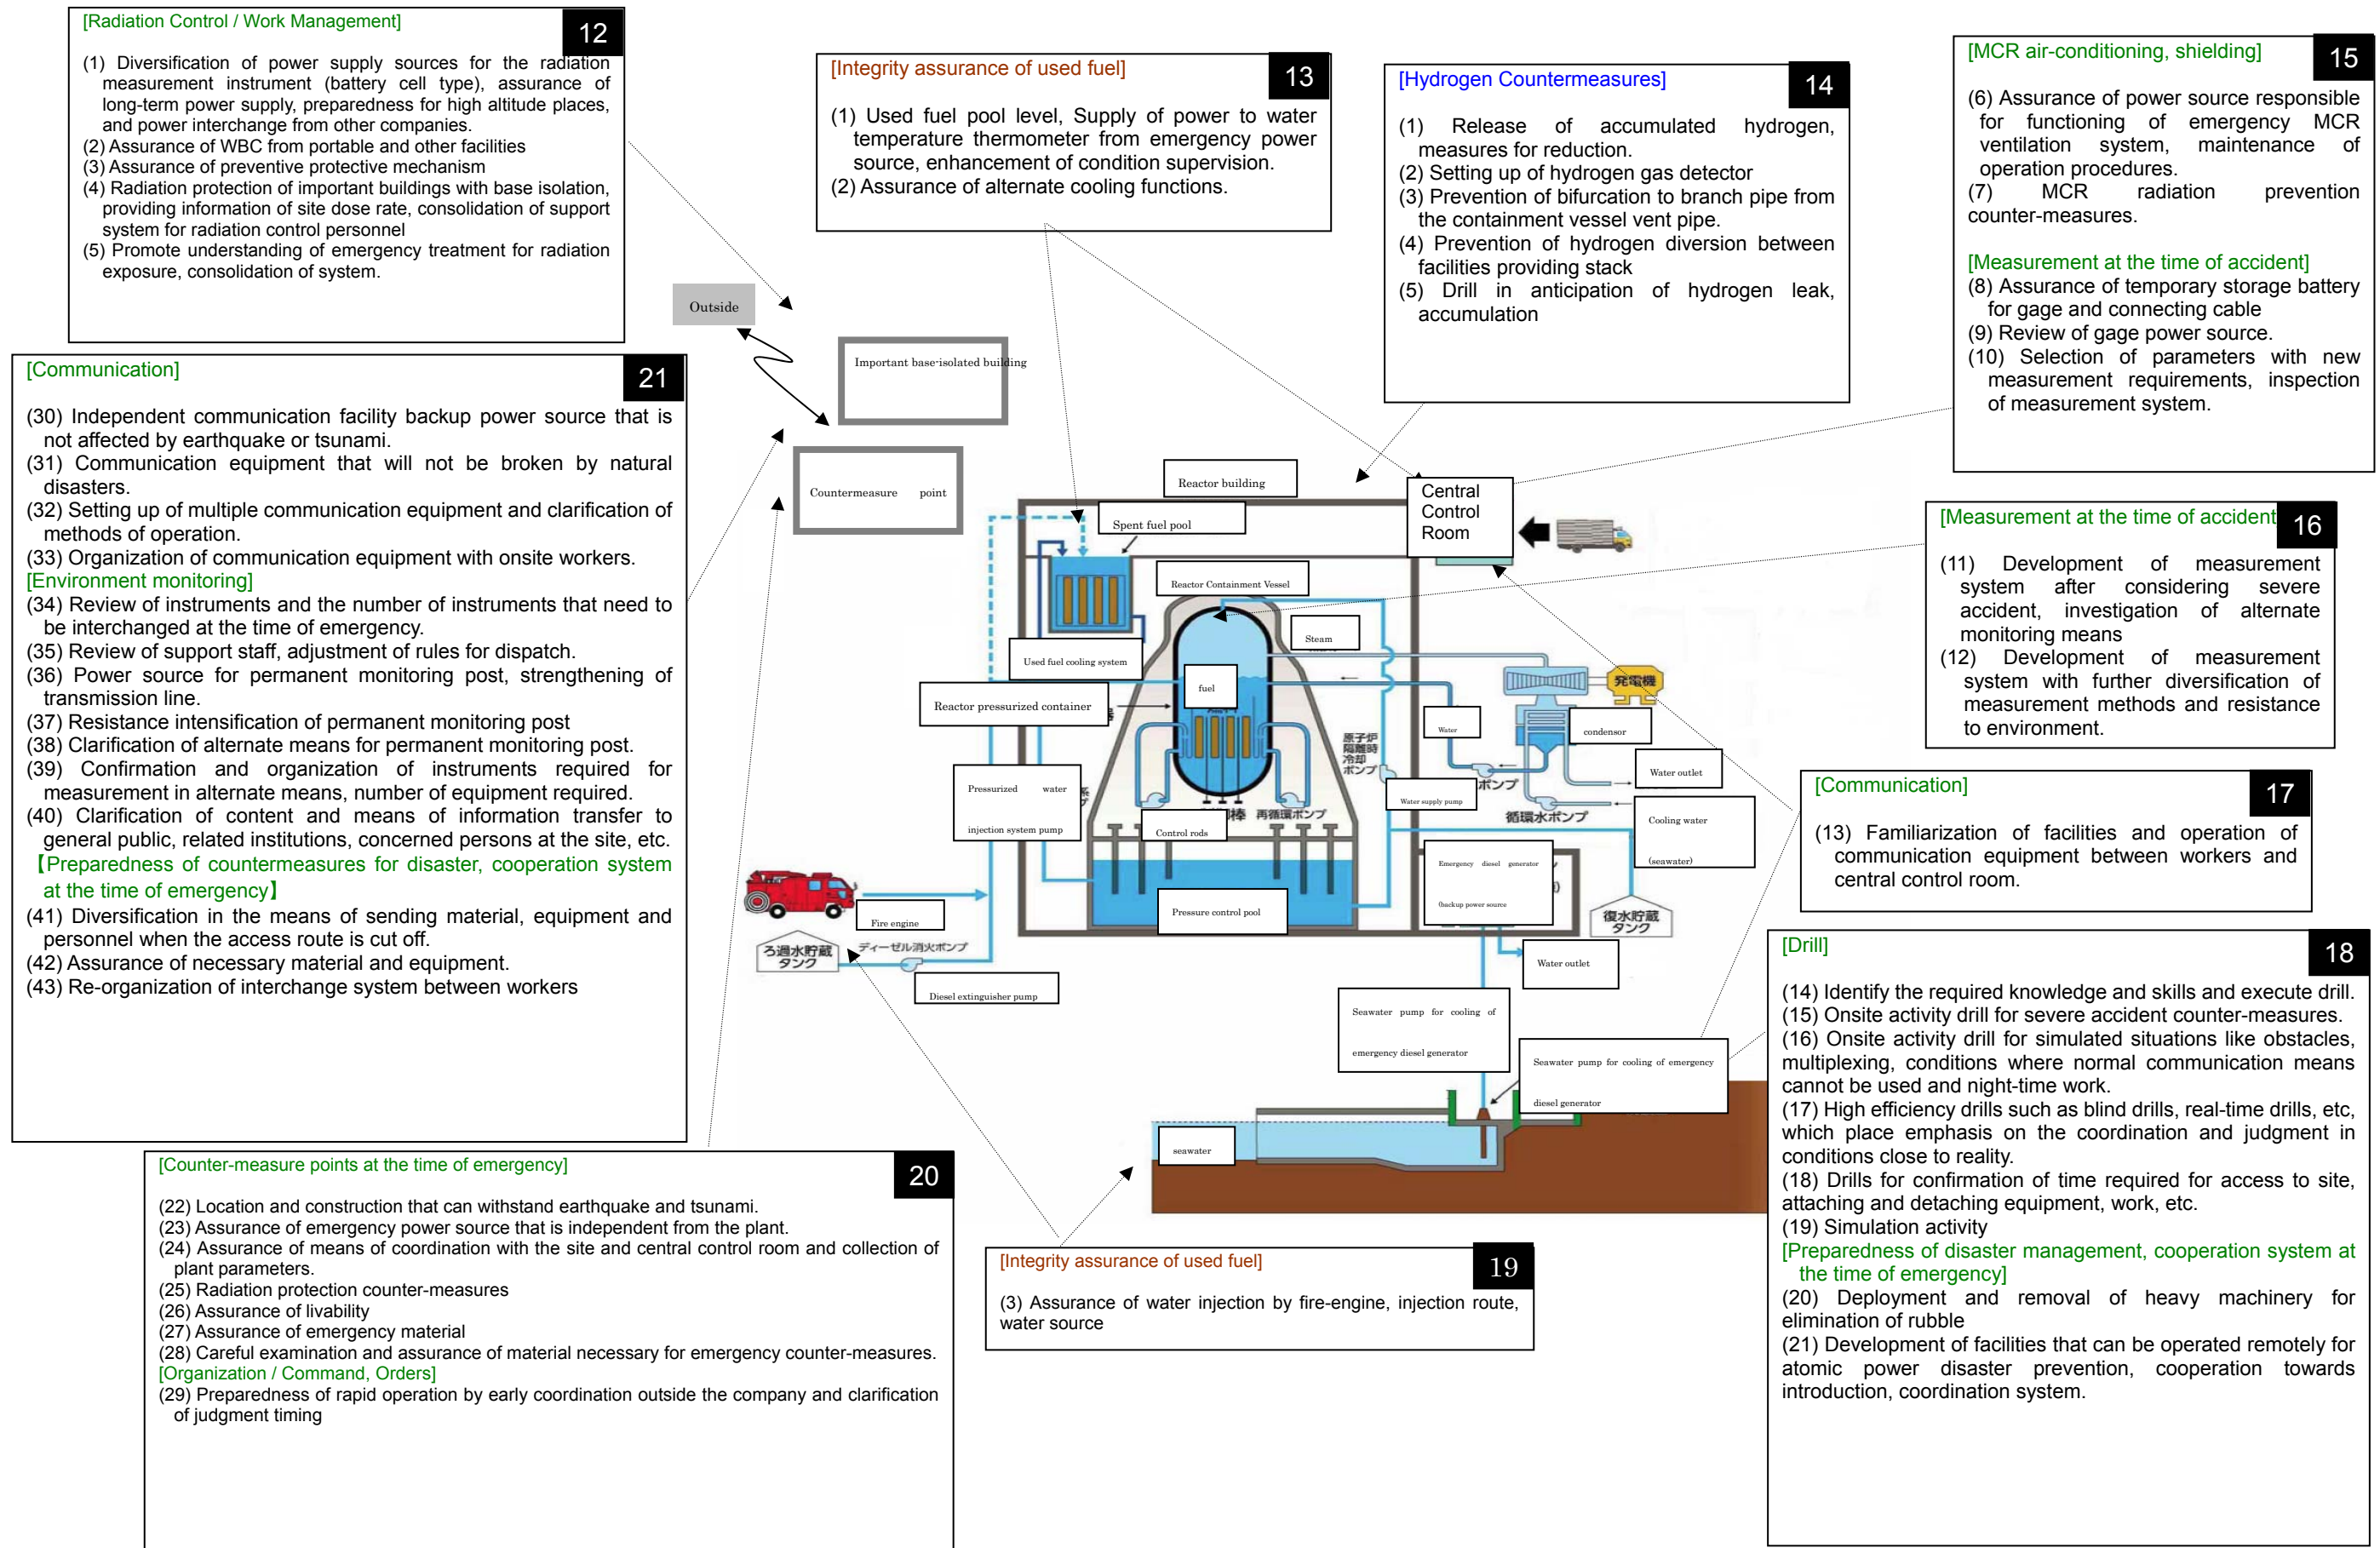
Figure 4.12-1 Examples of Counter-measures 2/3

- Hydrogen Countermeasures 14 | Emergency Preparedness 12, 15, 16, 17, 18, 20, 21, Integrity Assurance of Used Fuel 13, 19 -
