# **Examination of Accident at Tokyo Electric Power Co., Inc.'s Fukushima Daiichi Nuclear Power Station and Proposal of Countermeasures (Draft)**

**October 2011**

**Japan Nuclear Technology Institute**

**Examination Committee on Accident at Fukushima Daiichi Nuclear Power Station**

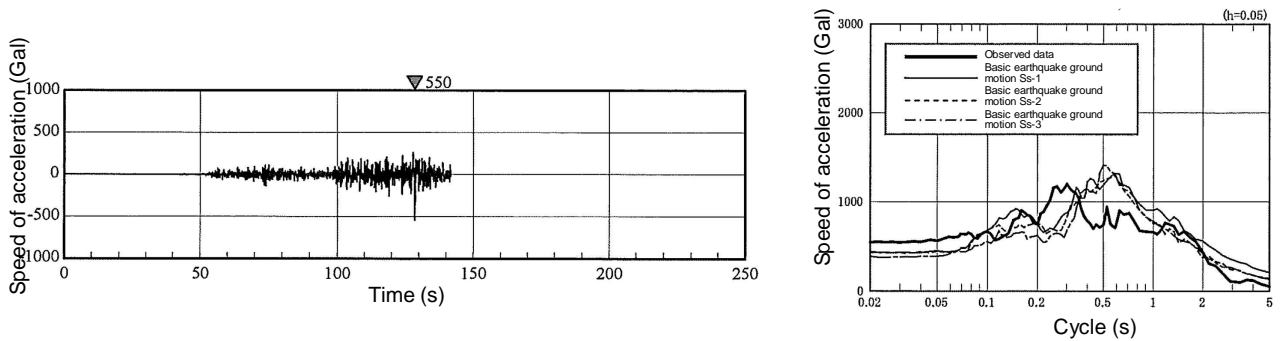
Figure 2.1-1 Ripple figure of instant acceleration history of reactor building and response spectrum (east-west direction)

As shown in Figure 2.1-1, the peak acceleration values obtained at the lowest basement of the nuclear reactor buildings at the time of this earthquake exceeded the values specified in one section of the table corresponding to basic earthquake ground motion Ss.

The acceleration time history waveform and response spectrum observed for the basic nuclear reactor Unit 2, is displayed as an example in Figure 2.1-1. In general, the response spectrum exceeds the basic earthquake ground motion similar to what is shown by a specific period in this record.

(Note: The recording equipment was interrupted due to the earthquake)

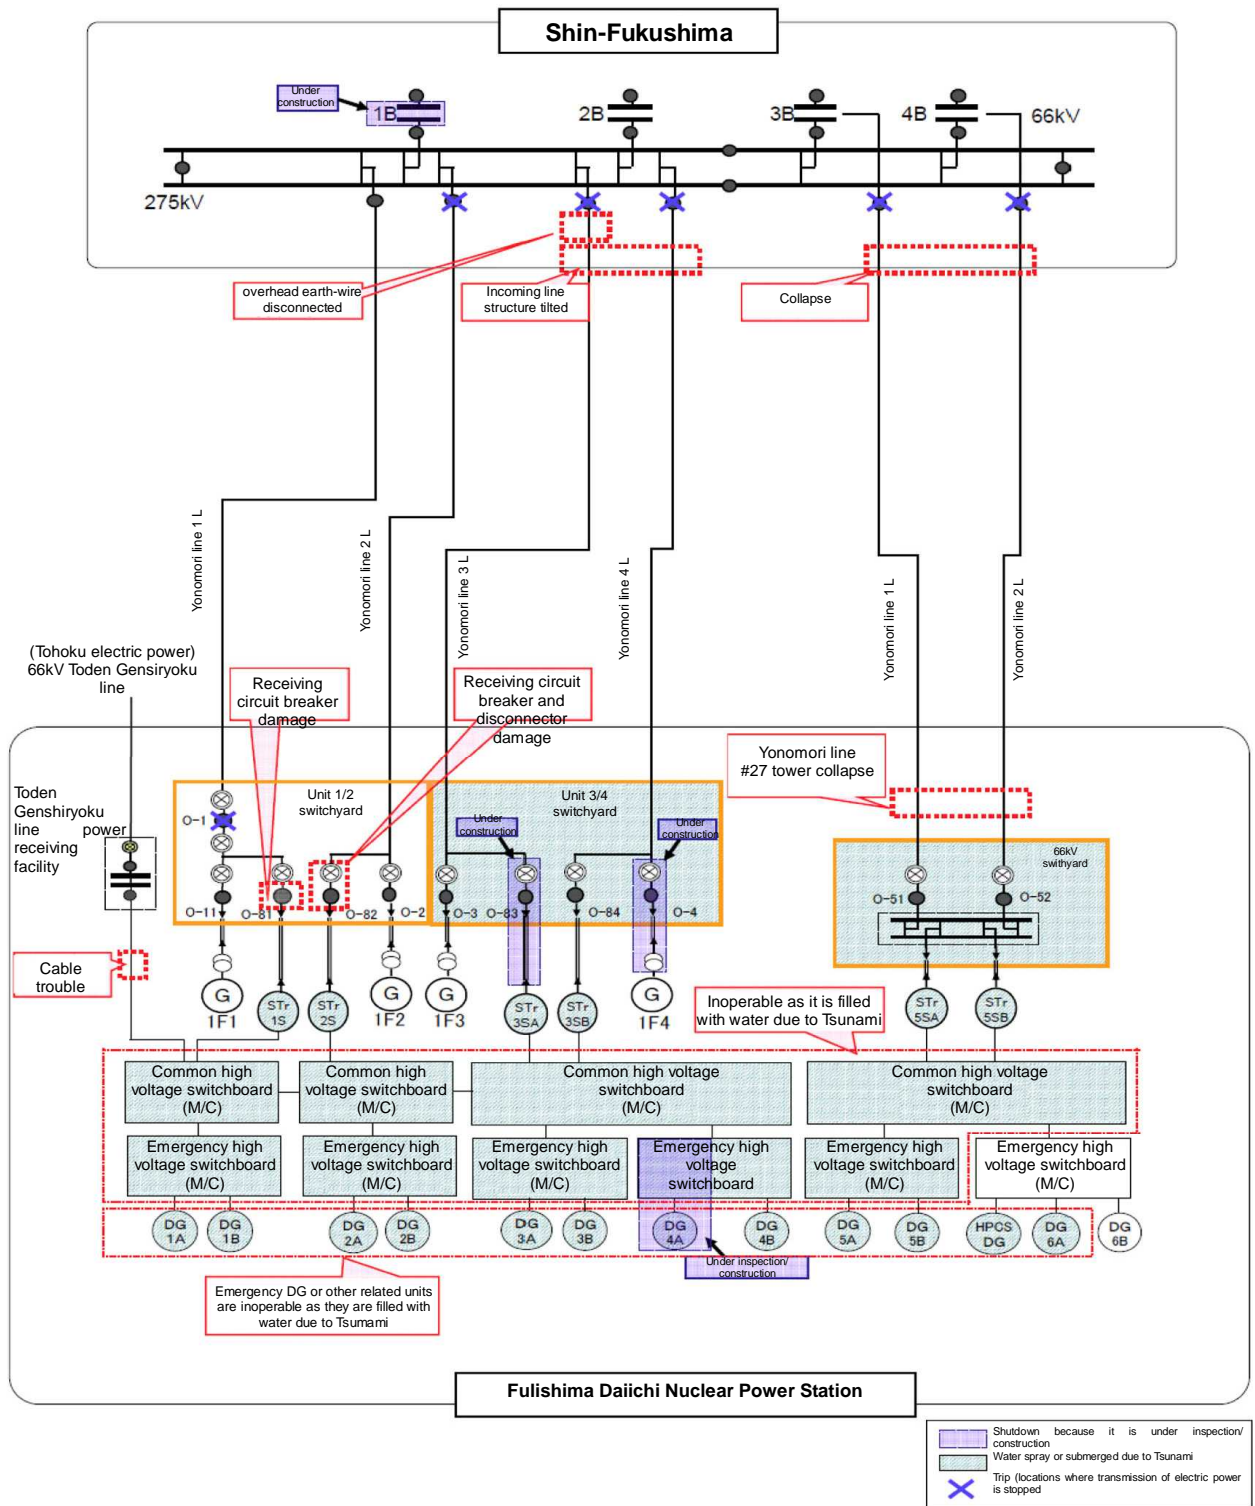
Figure 2.1-2 Outline figure of external power supply control system (after earthquake, before tsunami)

Due to this earthquake, the circuit breakers in the switchyard of Unit 1 and 2 were damaged; the cables of the TEPCO nuclear line from the north-east power supply also got damaged. One power line connecting to the switchyard of Unit 5 and 6 was also destroyed. As a result, all the external power supply to units 1 to Unit 6 was lost.

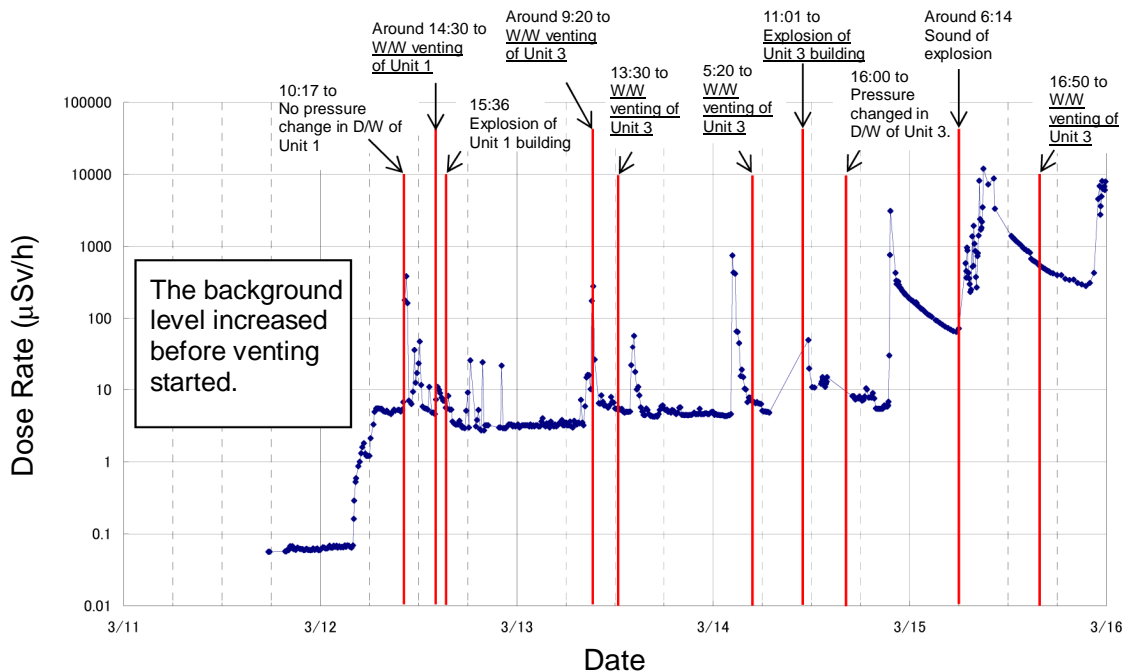
**Fig. 2.8-1 Fukushima Daiichi Nuclear Power Station Fukushima Daiichi Nuclear Power Station Nuclear Power Plant Dose Rate in the Vicinity of Main Gate**

As the MP halted, the dose rate around the power station could not be measured with MP. However, measurements were carried out with the monitoring car that was deployed as a replacement of MP in the vicinity of the main gate of the station. Figure 2.8-1 shows the measurement results.

For the dose rate, no big change in the background level before and after these vent operations was observed. However, from 4:00 to 7:00 on March 12, the dose rate increased. In addition, around 6:14 on March 15, the sound of an explosion was confirmed, and the background level of the dose rate increased before and after it.
